MUNICIPAL STRUCTURE INSPECTION FORM

BRIDGE

Site No.: B2

INVENTORY DATA:			
Structure Name	Walley Bridge		
Main Hwy/Road #	Peddlers Drive	Under Structure:	Navigable Water <input type="checkbox"/> Non- Navigable Water <input checked="" type="checkbox"/>
			Rail <input type="checkbox"/> Road <input type="checkbox"/> Pedestrian <input type="checkbox"/> Other <input type="checkbox"/>
Road Name:	Peddlers Drive	On Structure:	Rail <input type="checkbox"/> Road <input checked="" type="checkbox"/> Pedestrian <input type="checkbox"/> Other <input type="checkbox"/>
Structure Location	1.65 km West of Graham Road		
Latitude	46° 14' 33" N	Longitude	78° 55' 07" W
Owner(s)	Township of Calvin	Heritage Designation	Not Cons. <input checked="" type="checkbox"/> Cons./Not App. <input type="checkbox"/> List/Not Desig. <input type="checkbox"/>
			Desig./not List <input type="checkbox"/> Desig. & List <input type="checkbox"/>
MTO Region	-	Road Class:	Freeway <input type="checkbox"/> Arterial <input checked="" type="checkbox"/> Collector <input type="checkbox"/> Local <input type="checkbox"/>

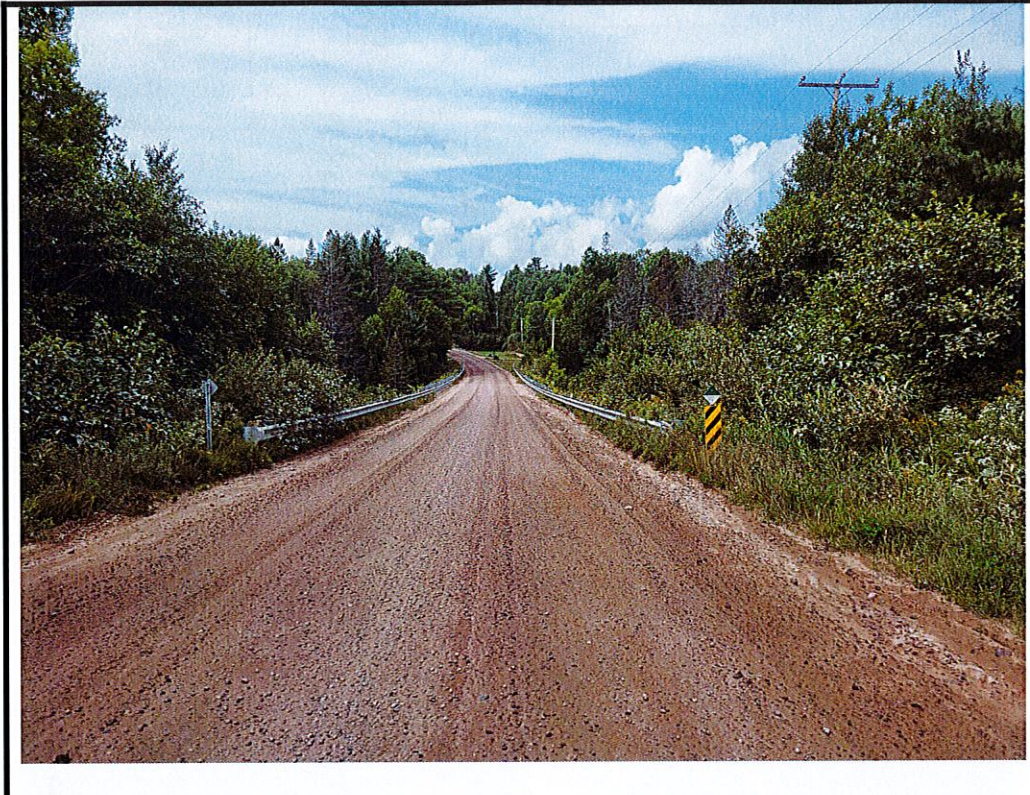
Photo 1 Structure from east approach

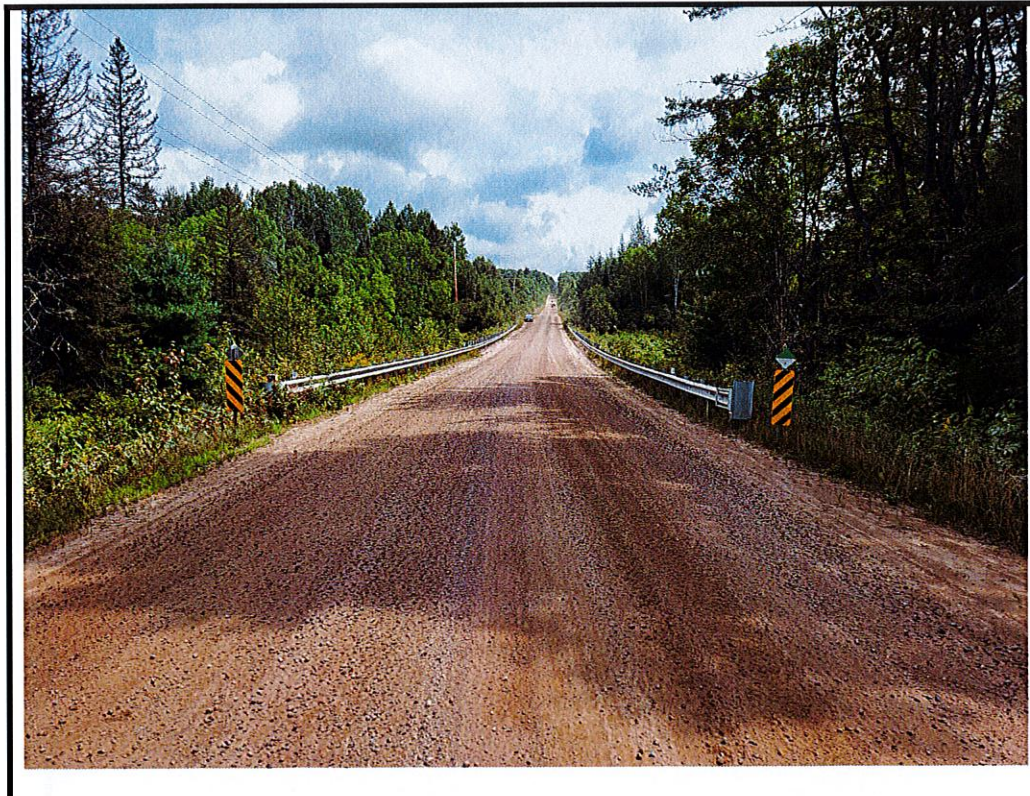
Photo 2 Structure from west approach

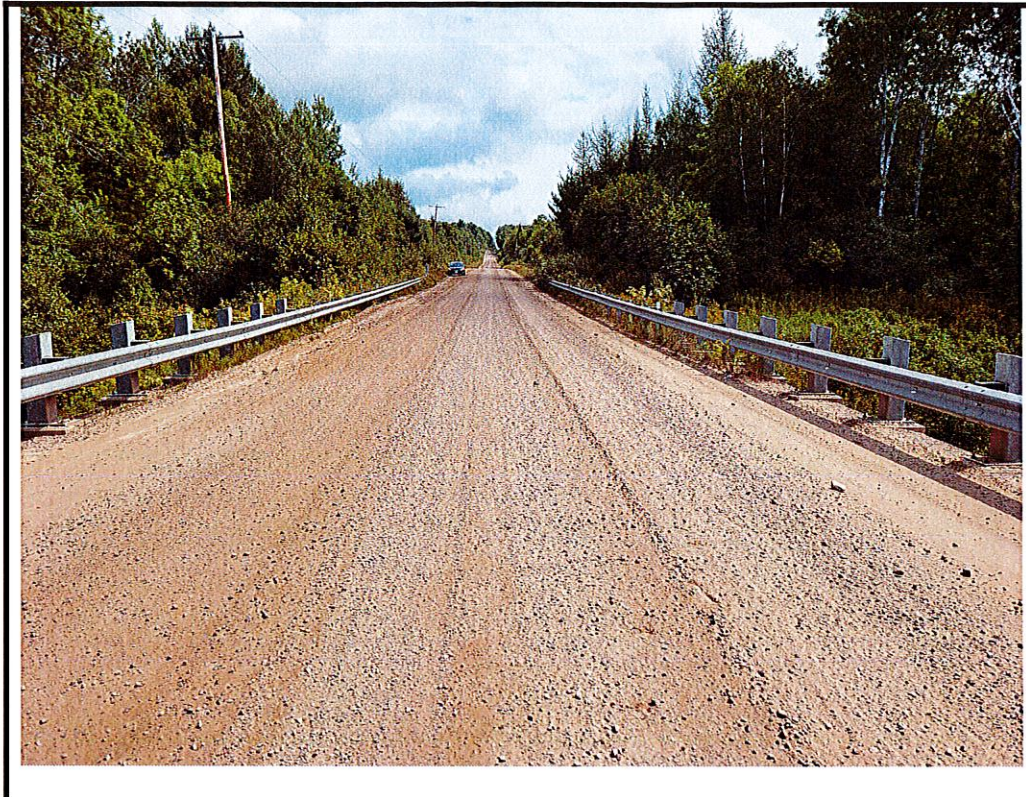
Photo 3 East approach from center of structure

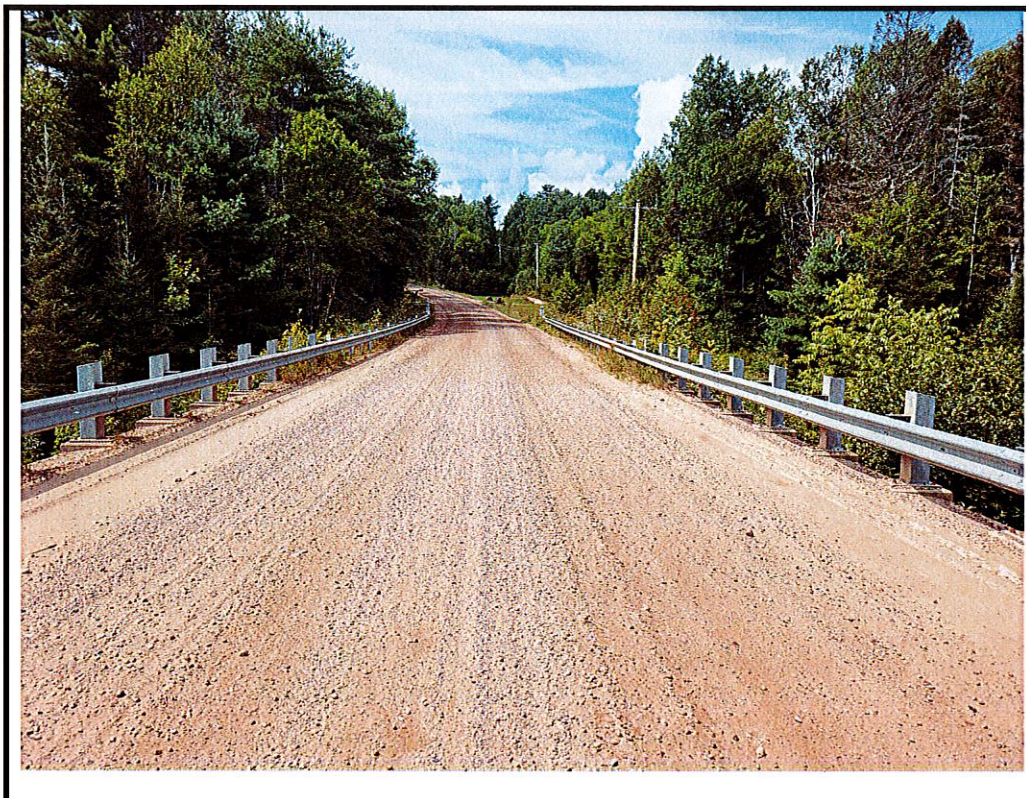
Photo 4 West approach from center of structure

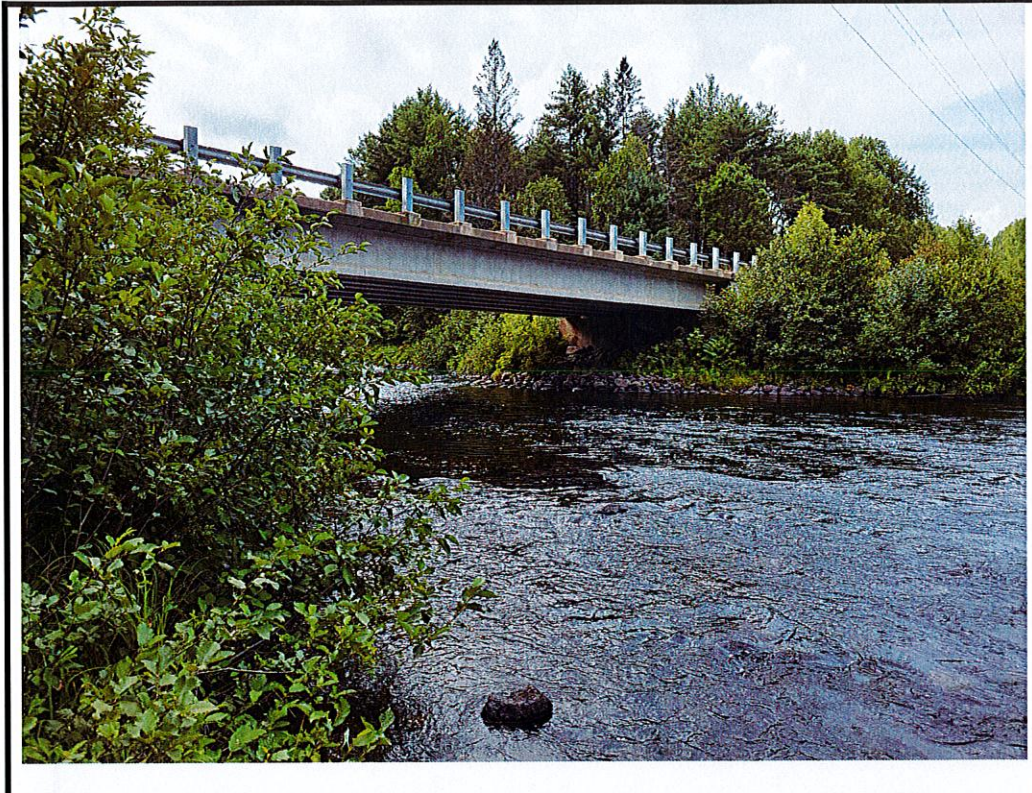
Photo 5 North elevation

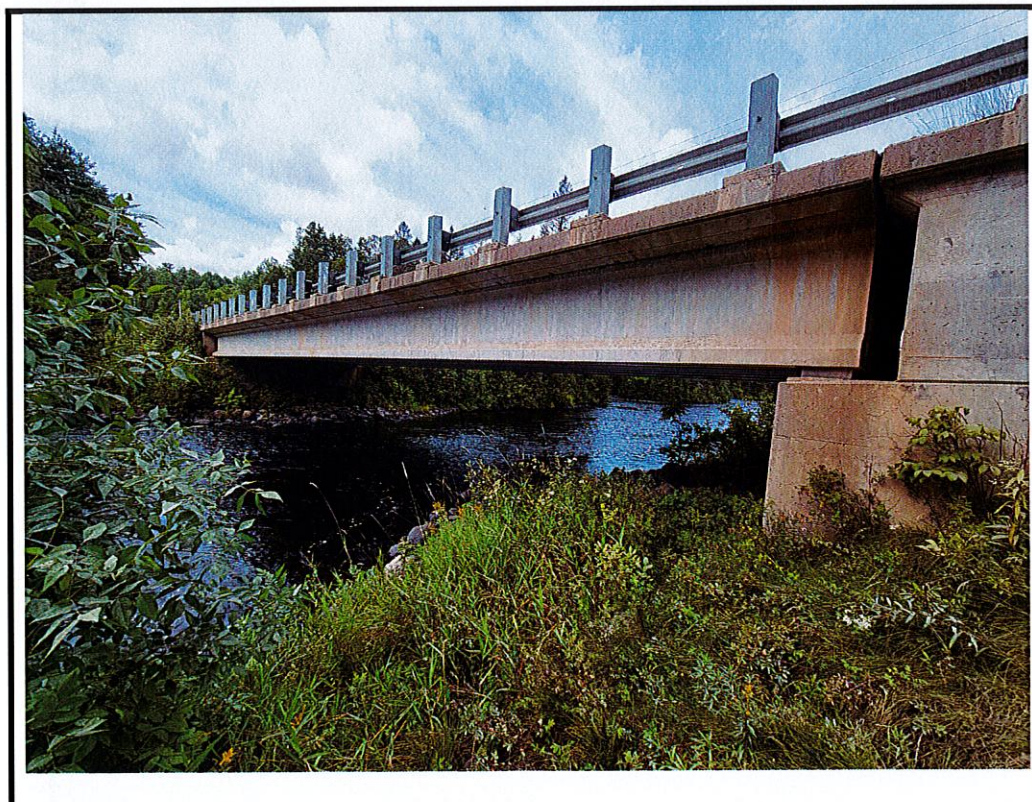
Photo 6 South elevation

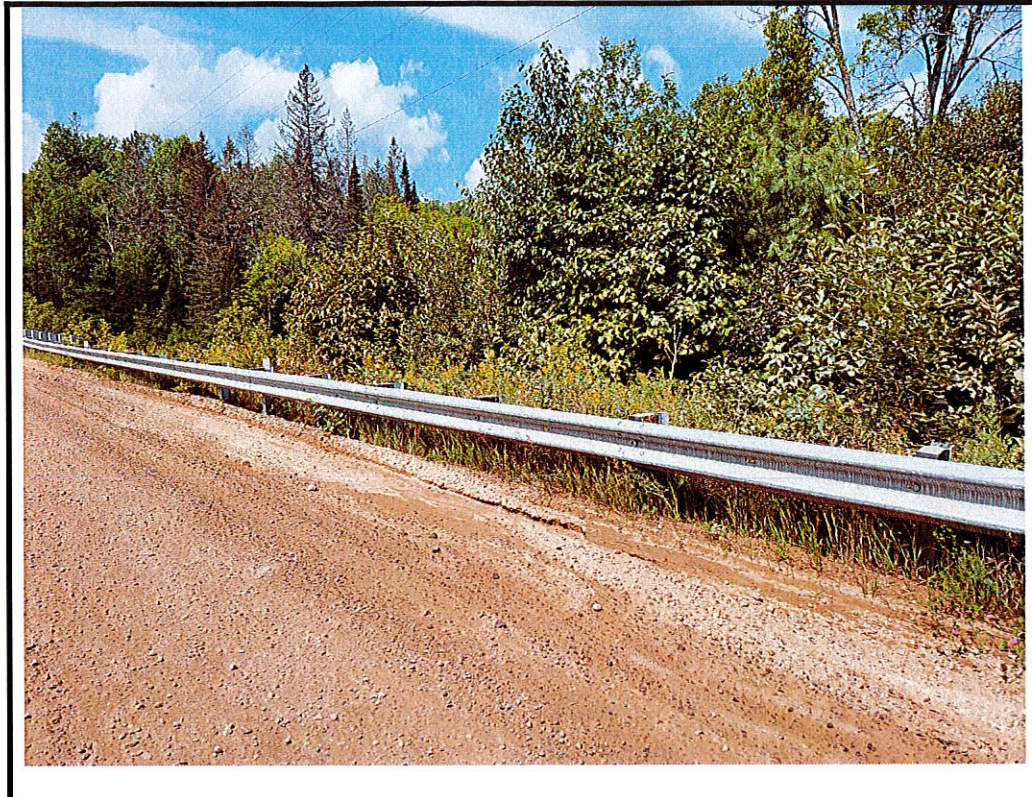
Photo 7 Accumulation of dirt below approach guide rail

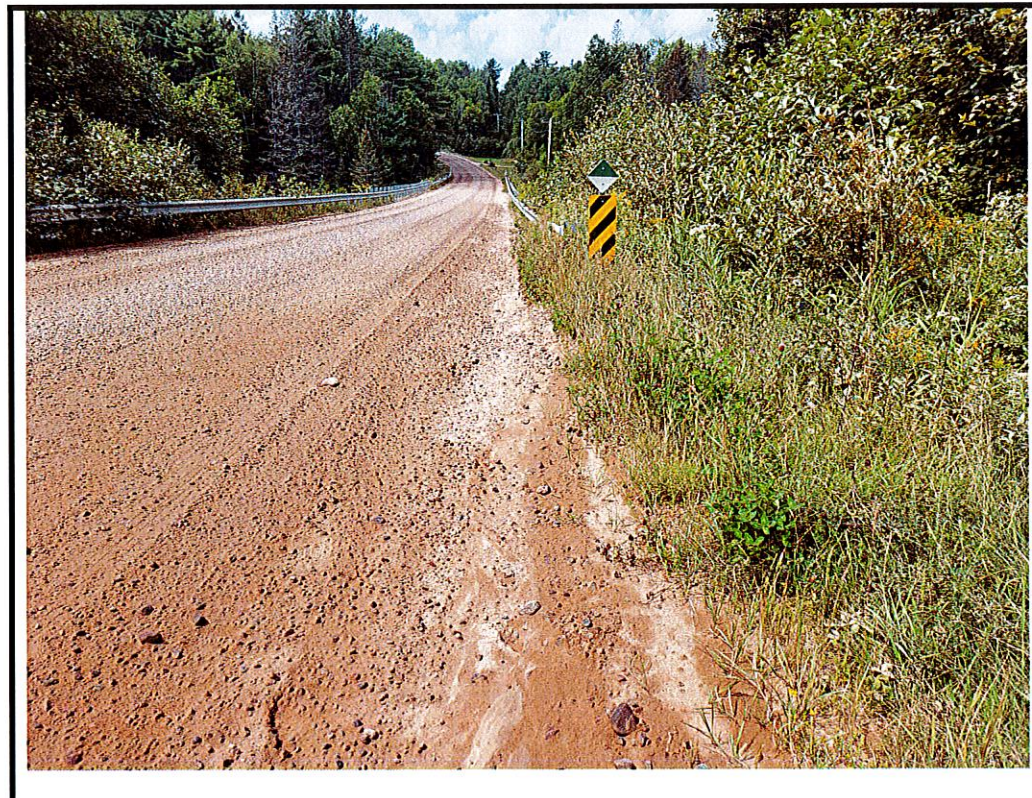
Photo 8 Vegetation overgrowing approach guide rail

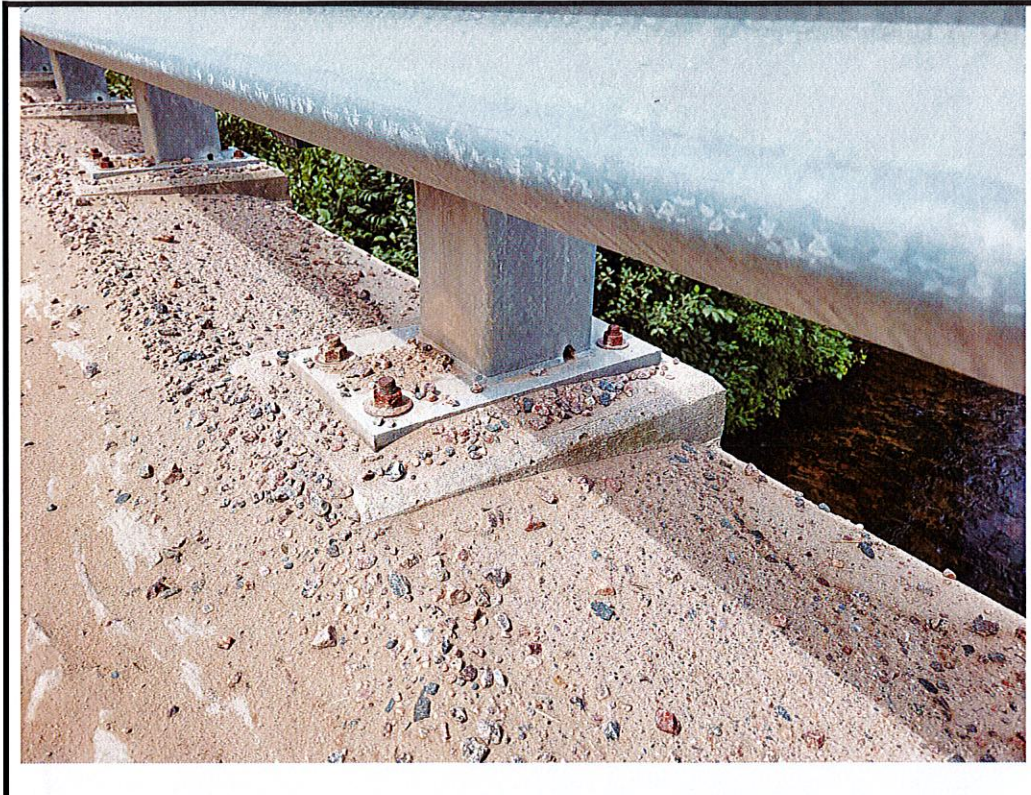
Photo 9 Light corrosion of anchor bolts on deck post base-plates

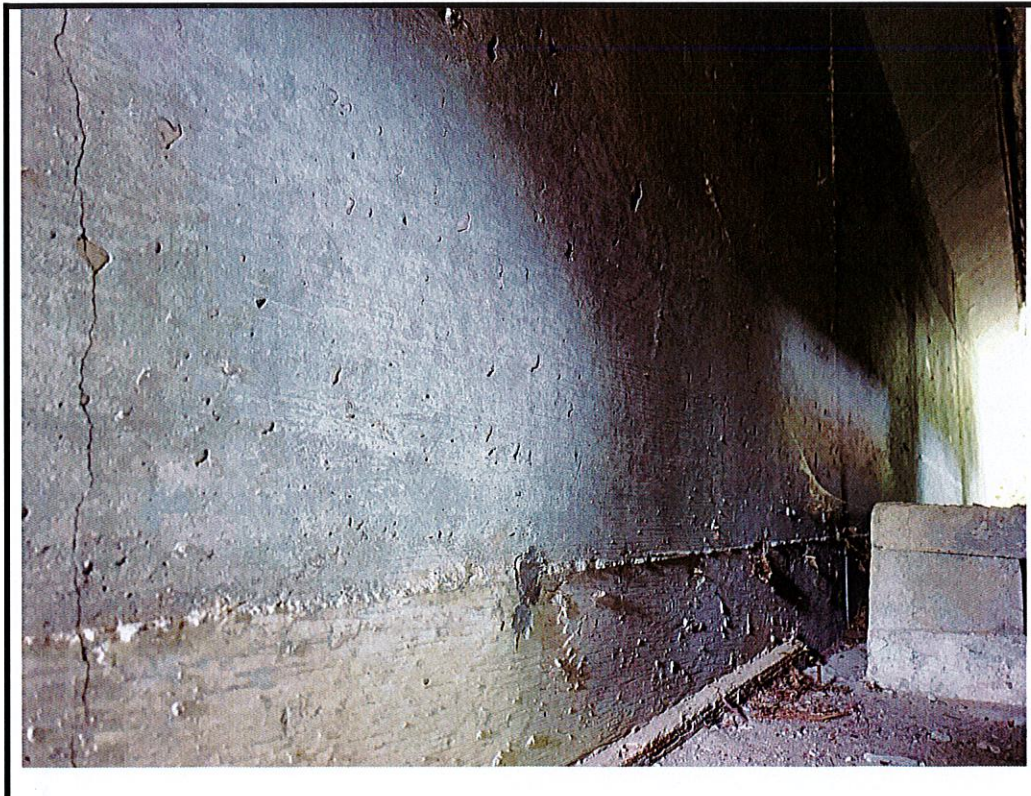
Photo 10 Narrow vertical crack on east ballast wall

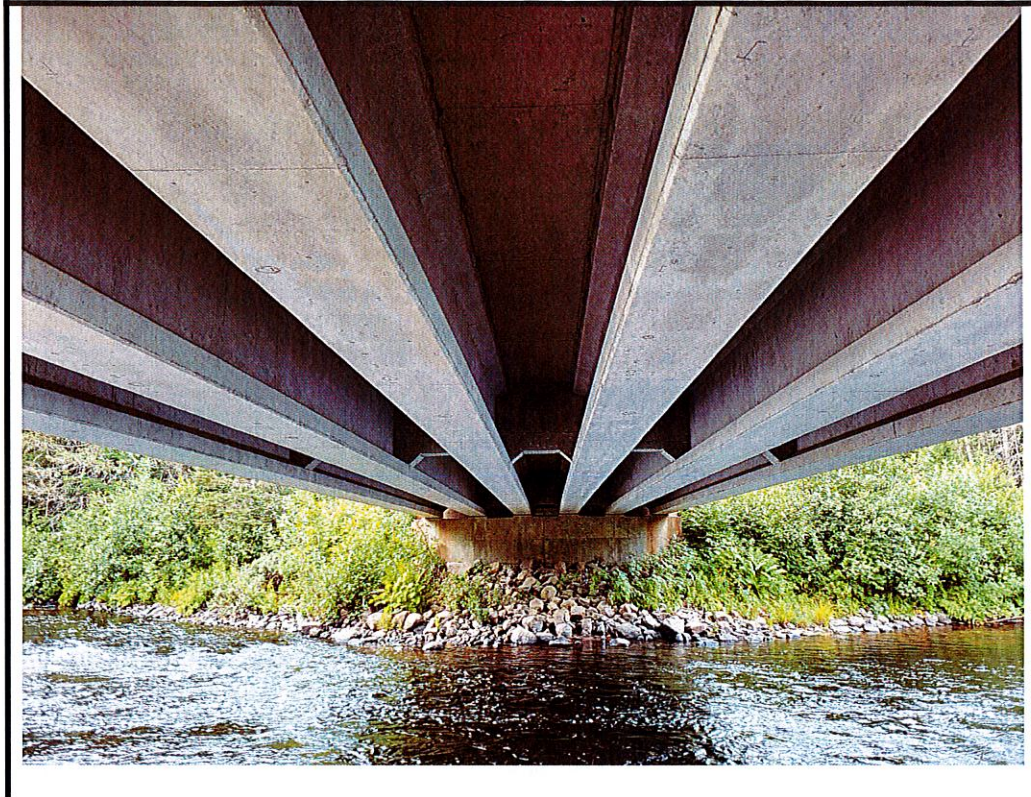
Photo 11 General view of girders and soffit

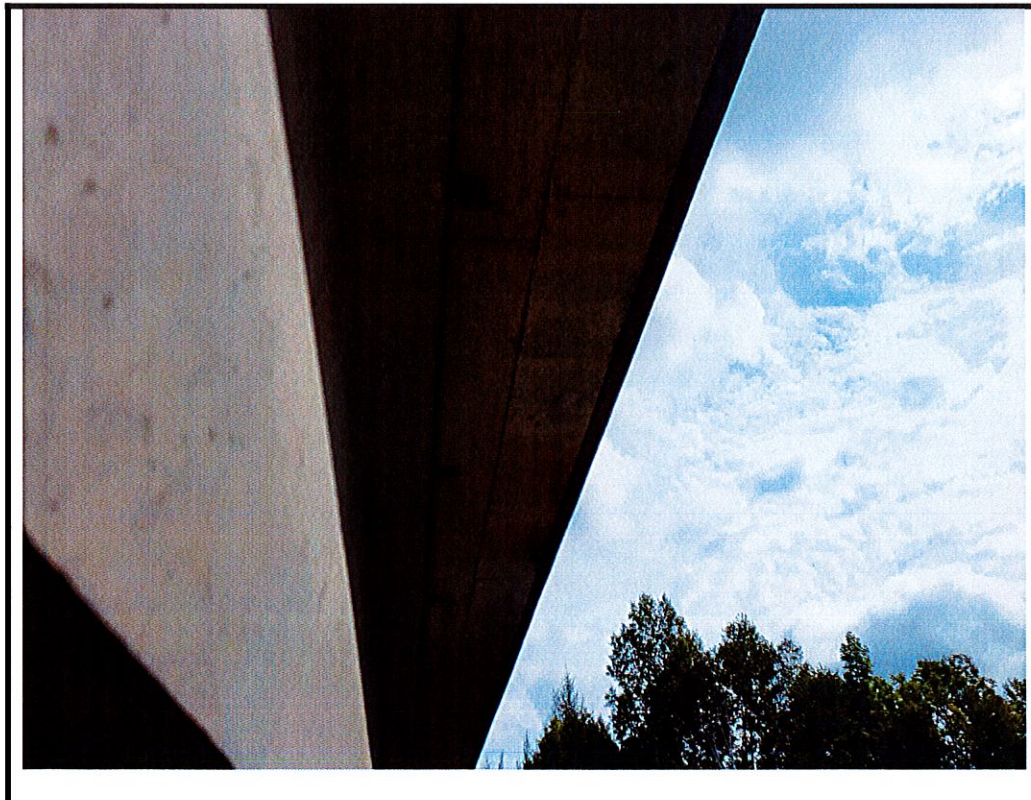
Photo 12 Isolated small spalls and rust staining on exterior soffit

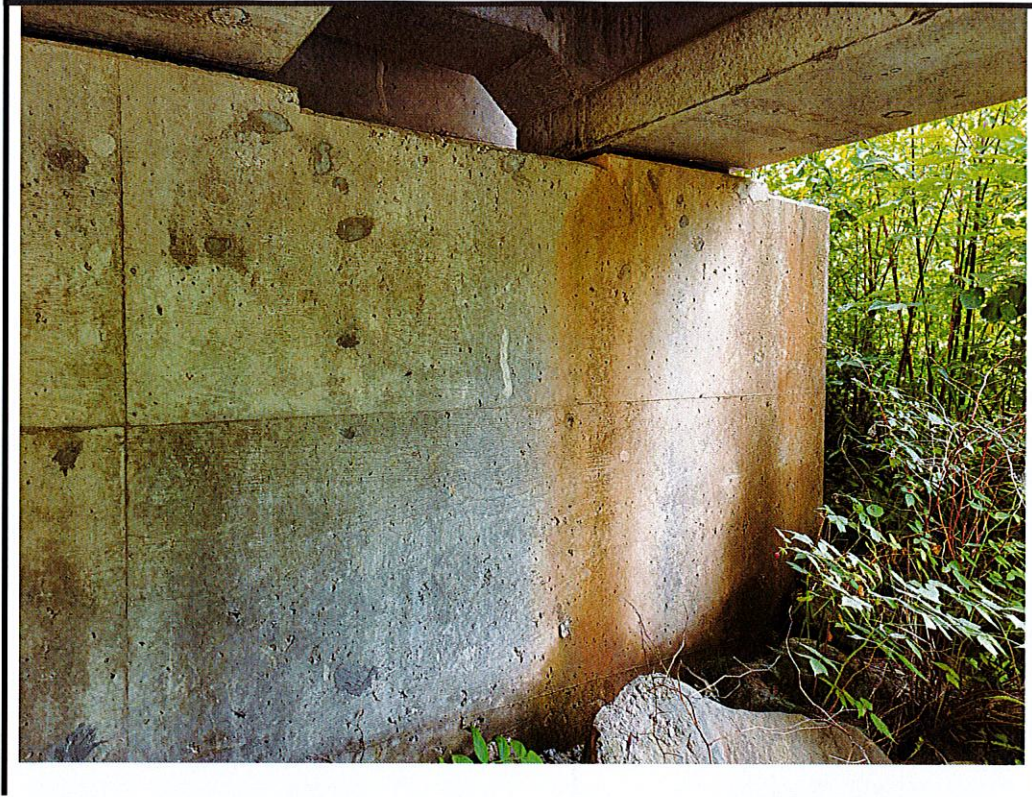
Photo 13 Damp staining and rust staining on east abutment wall

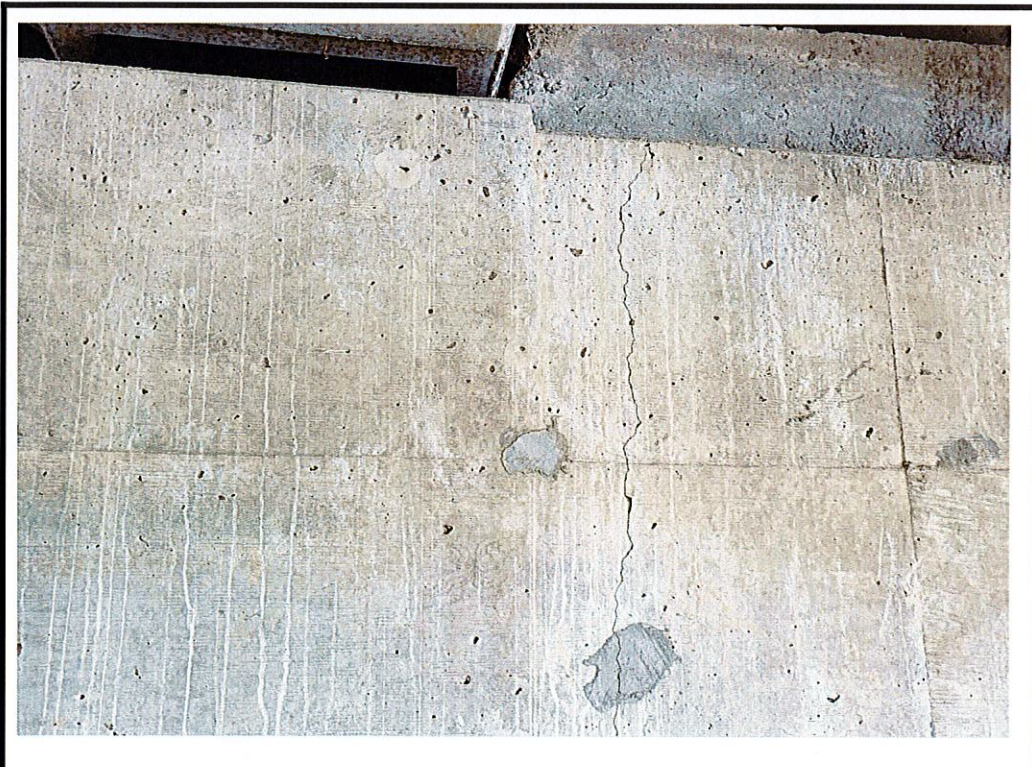
Photo 14 Narrow vertical crack on abutment wall
