Municipality of Calvin

1355 & 1238 Peddlers Drive Facility and Building Condition Assessment – Draft V2

1355 & 1238 Peddlers Drive
Mattawa, Ontario

March 03, 2026
RJC No. KIN.143609.0001

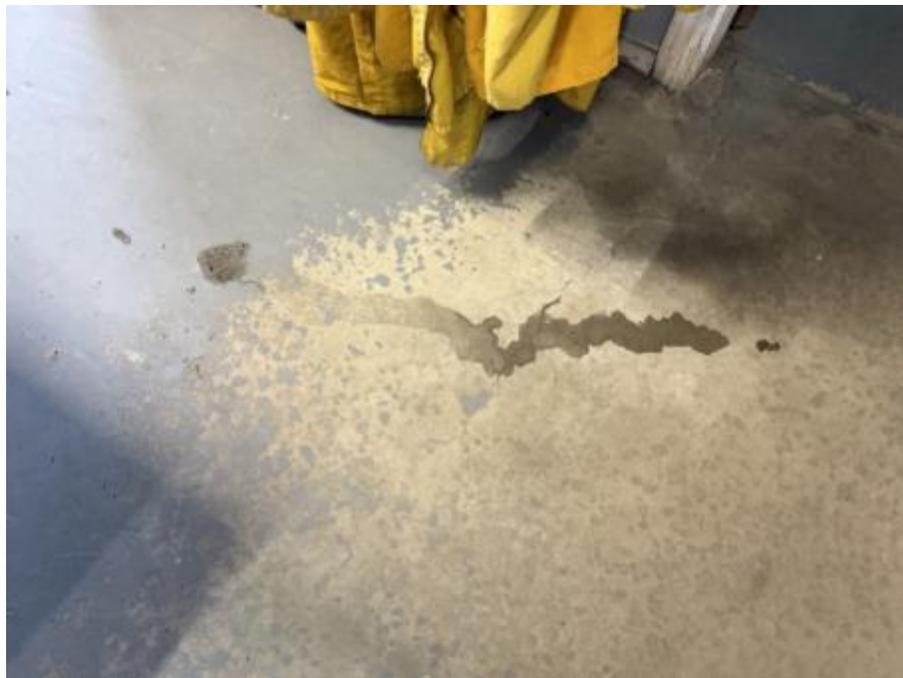
Based on our visual review, the slab-on-grade and foundation systems appear to be in fair condition, suffering from localized signs of deterioration in the form of slight slab-on-grade cracking within the fire hall, and localized spalling/impact damage at the slab edge at the overhead vehicle doors. (Refer to Photographs 2-3, in Appendix A).

Photo 2: Fire Hall – Slab-on-Grade Cracking

While slab-on-grade shrinkage cracking is generally not a structural concern, and the slab is expected to perform beyond the timeframe of this assessment, it is recommended that the municipality budget to complete slab-on-grade localized crack repairs, and resurfacing in the long-term (11-20 years), in order to maintain a state of good repair, and avoid potential risk to safety in the form of trip hazards and vehicle damage if the deterioration increases.

Our opinion of probable present cost at a class D level (+/-25%) to complete the localized slab-on-grade repairs in the long-term (11-20 Years), in Q1 2026 dollars is **\$25,000.00 + H.S.T.**

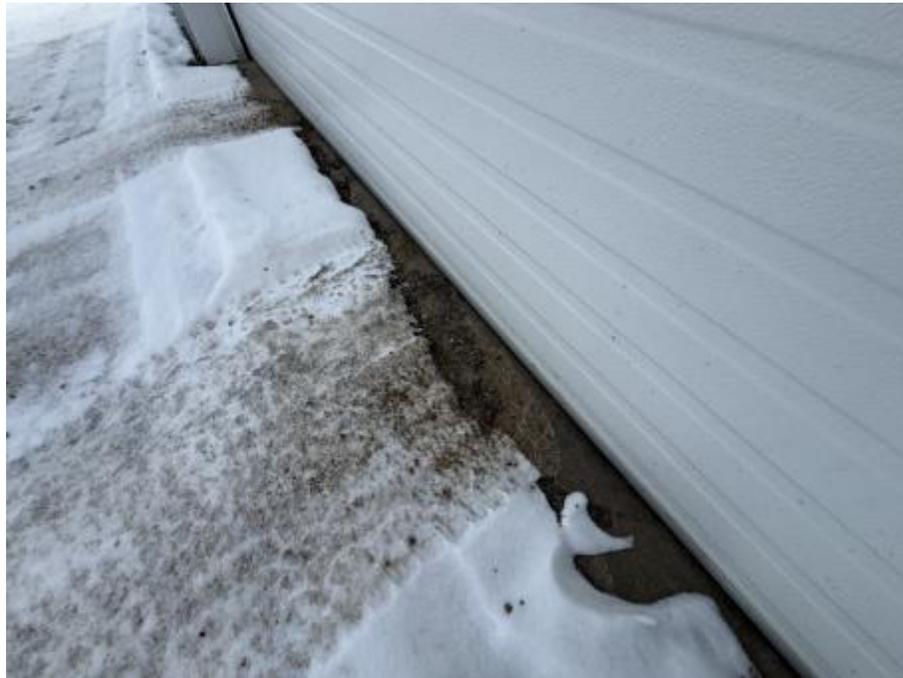
Photo 3: Fire Hall – Slab Spall at Overhead Door

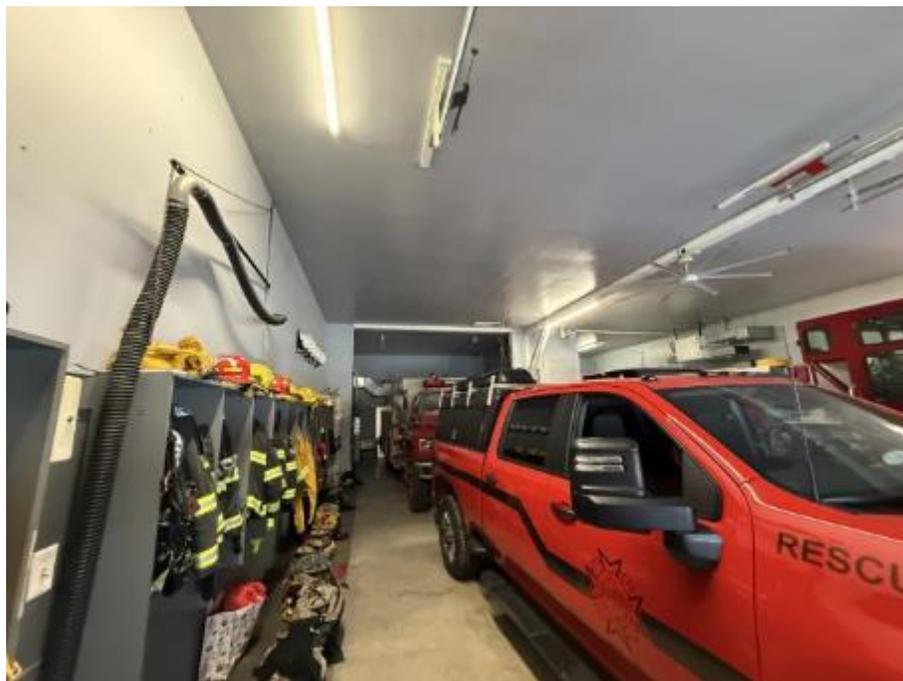
At the time of our review, the interior of the structure was fully enclosed with gypsum board interior finishes, preventing a visual review of the present condition of the underlying wood structure. No significant signs of undesirable displacement or cracking was observed in the finishes at the time of our review, which can be indicative of structural deterioration. (*Refer to Photograph 4, in Appendix A*).

Photo 4: Fire Hall – Overview of Interior Finishes and Existing Vehicle Exhaust Tube

If well constructed and waterproofing is maintained, the structural framing can be expected to last the lifespan of the structure without significant capital repairs. The municipality is recommended to have periodic reviews conducted over the lifespan of the structure, to monitor its continued performance.

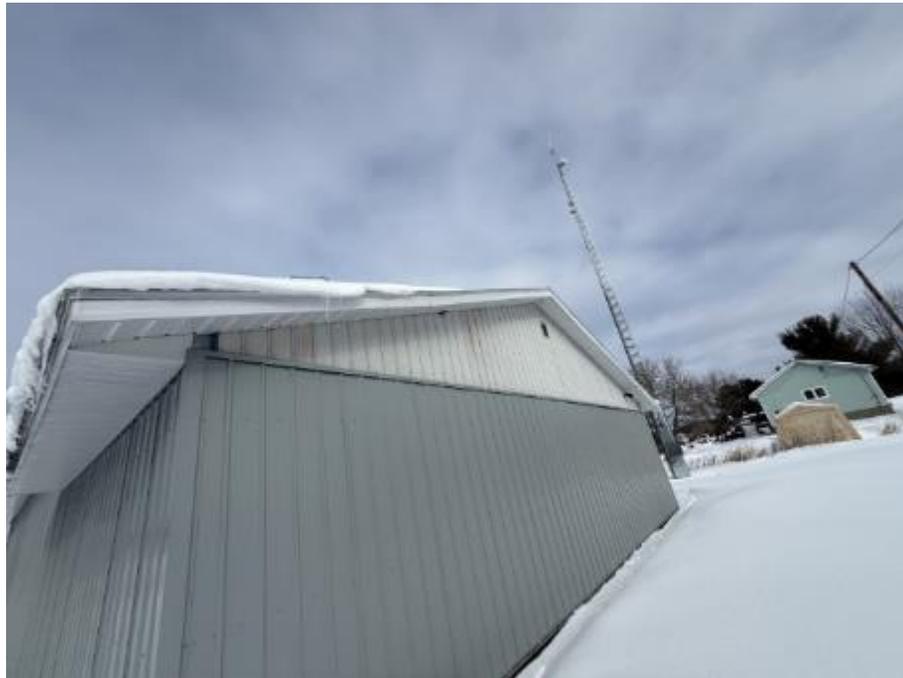
The grey painted metal siding which is installed at/around the ground floor area appears to be in good-fair condition and is assumed to be what was repaired/replaced most recently in 2018.

The white painted siding which is installed within the upper gable roof area appears to be in fair condition showing signs of moisture related deterioration in the form of staining and mild corrosion.

Photo 5: Fire Hall – Overview of Two Vintages of Siding

The upper-level siding which was not replaced in 2018 is anticipated to require replacement in the intermediate-term (6-10 years)

Our opinion of probable present cost at a class D level (+/-25%) to complete replacement of the upper gable cladding, in Q1 2026 dollars is **\$25,000.00 + H.S.T.**

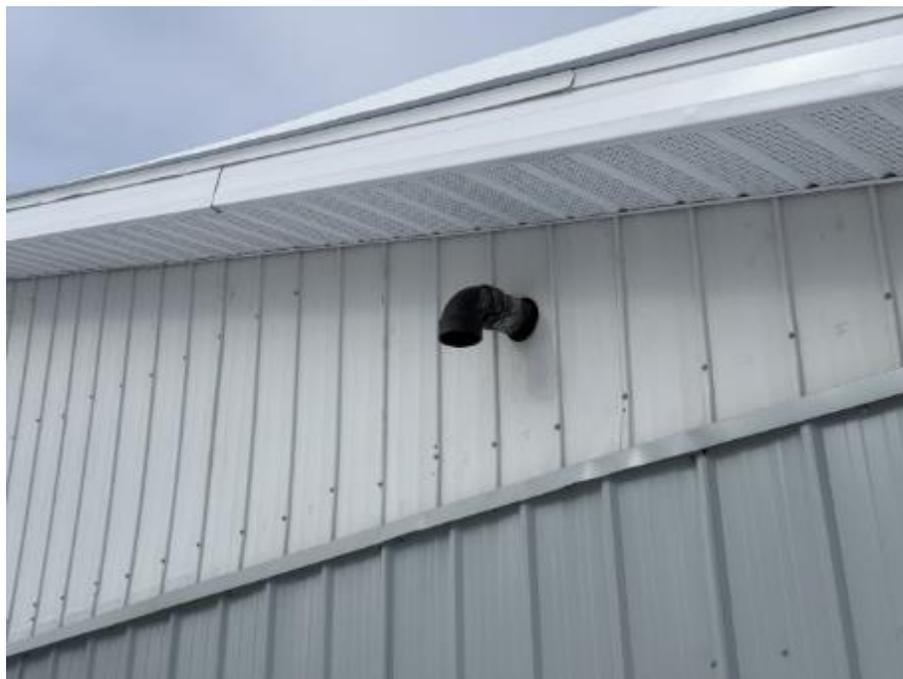
Within both vintages and types of siding, there appear to be localized penetrations in the system, typically for mechanical and electrical services, which are unsealed or poorly sealed, leaving potential avenues for moisture and pest infiltration into the wall assembly.

Photo 6: Fire Hall – Typical Penetration

The municipality is recommended to complete a wholesale building envelope sealant repair program at all penetrations, windows and door rough openings in the immediate term (0-2 years) to prevent moisture and pest infiltration, and maintain overall building thermal energy performance.

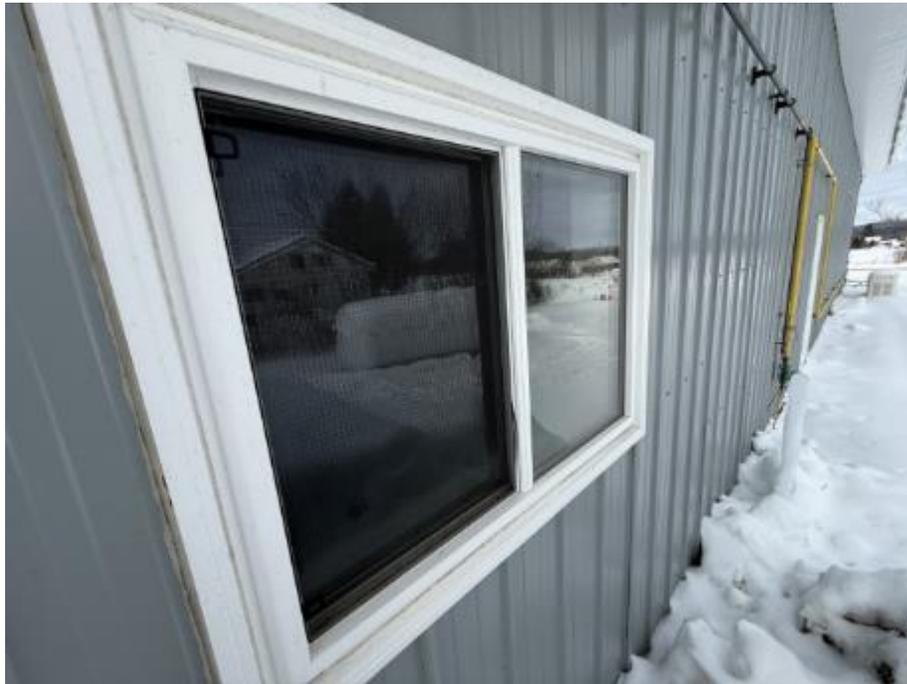
The windows appear to be in good condition, however the sealant around the windows appears to be in fair condition, suffering from deterioration in the form of gaps, and cracking.

Photo 7: Fire Hall – Typical Windows and Sealants

The municipality is recommended to plan for the replacement of the windows at the end of their service life in the long-term (11-20 years).

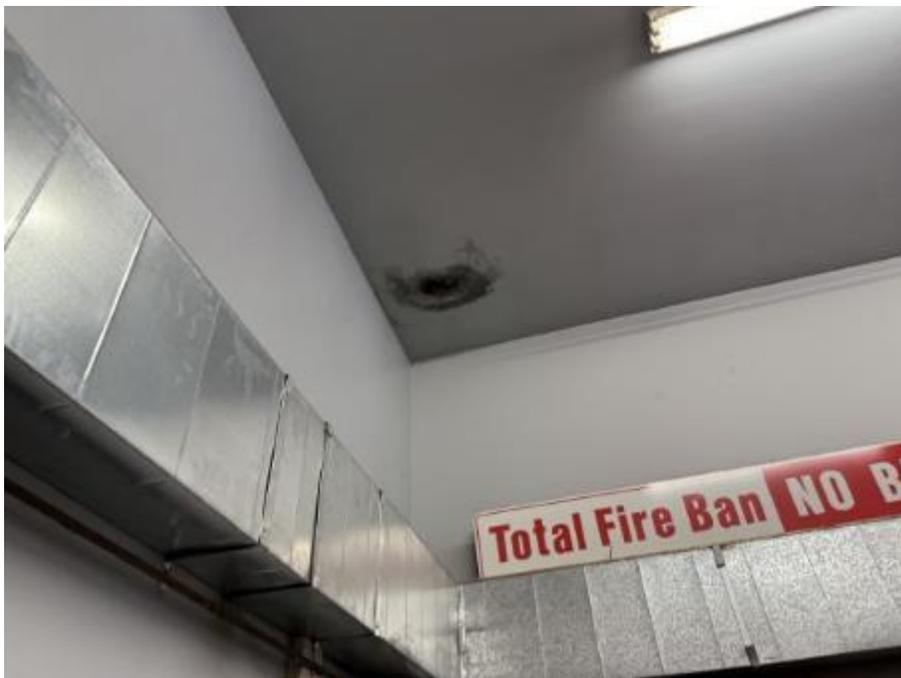
- In one location there was localized moisture staining on the gypsum board ceiling, which can indicate either a localized roof leak, or plumbing leak. It is currently unknown if the leak is active or if source of this stain has since been repaired.
- One location of metal flashing on the roof edge fascia appears to have failed, leading a portion of the edge wood fascia exposed to the elements.
- Moderate icicle and snow buildup was noted at the edges of the roof, which can be indicative of excess heat and energy loss through the roof.

Photo 10: Fire Hall – Stain in Ceiling

As part of general low-cost maintenance, we recommend that the municipality complete localized repairs on the potential leak and damaged flashing to protect the roof structure from moisture ingress. The cost for this work is below the threshold of this report.

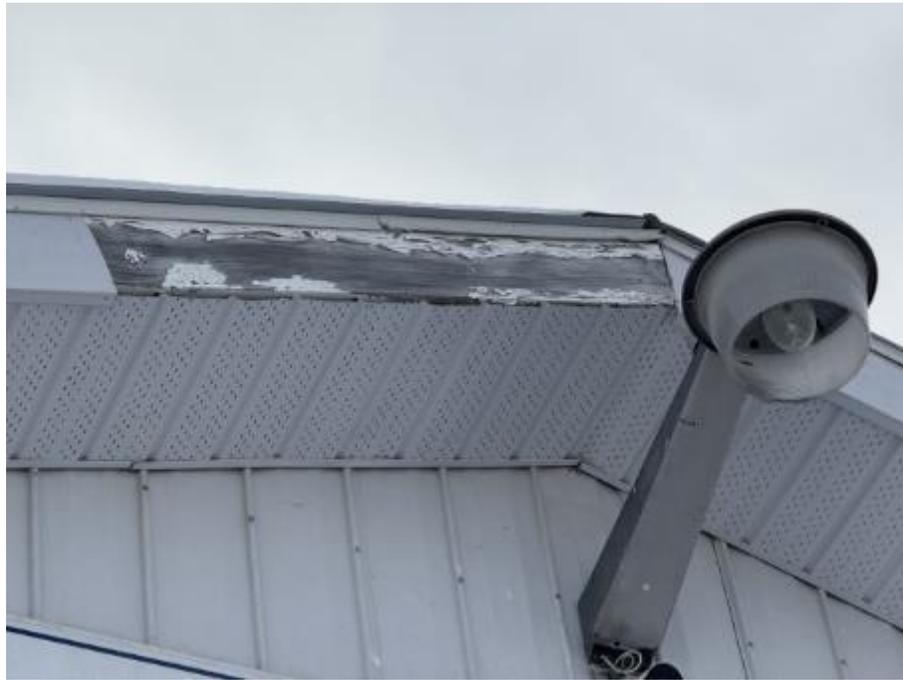
Photo 11: Fire Hall – Unprotected Fascia and existing HID Lighting

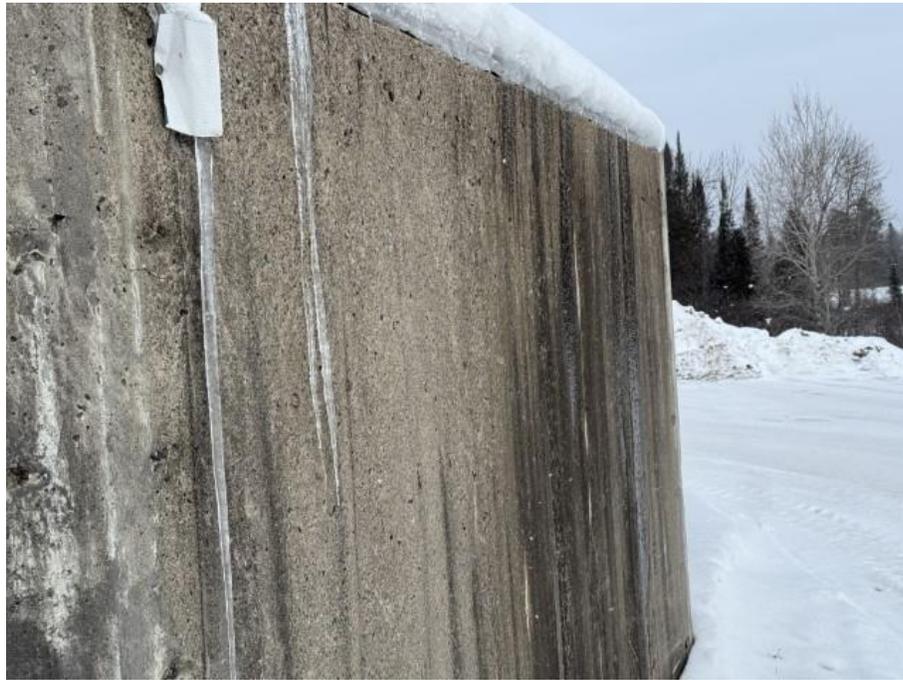
Photo 3: Sand Dome –Concrete Wall Staining

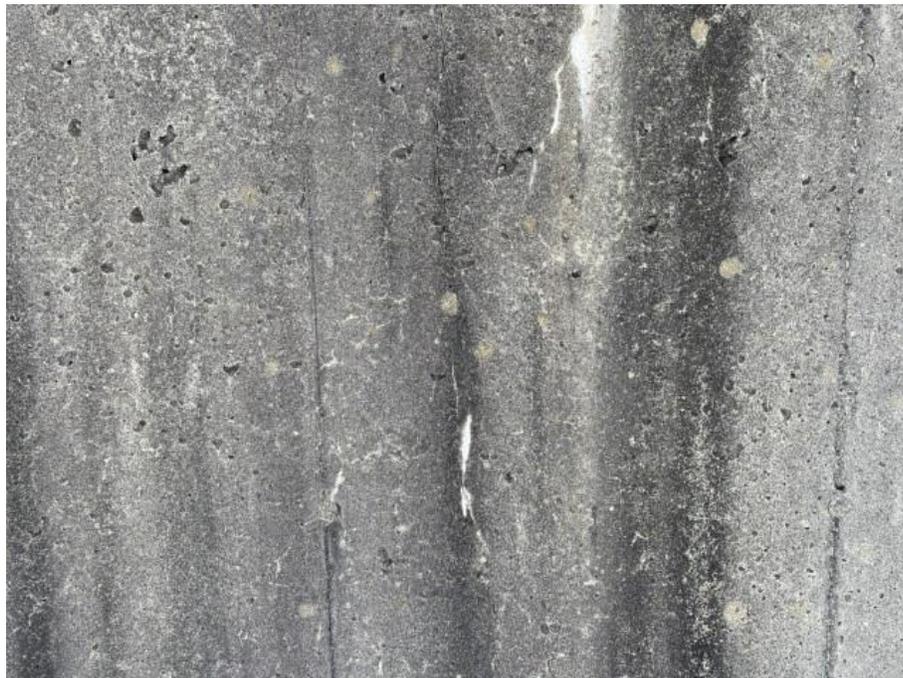
Photo 4: Sand Dome – Concrete Wall Cracking

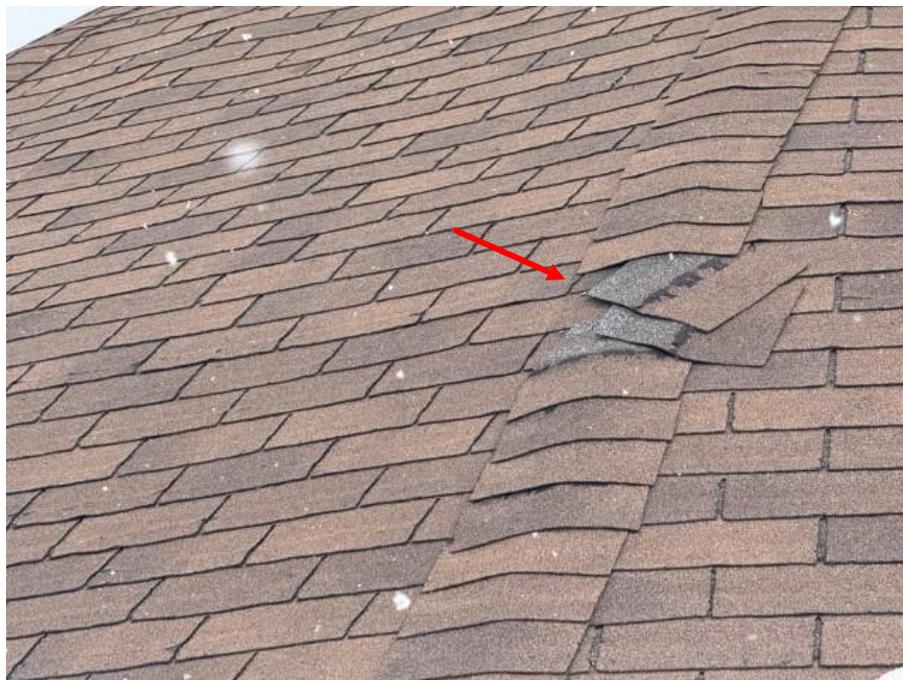
Photo 6: Sand Dome –Localized Shingle Failure

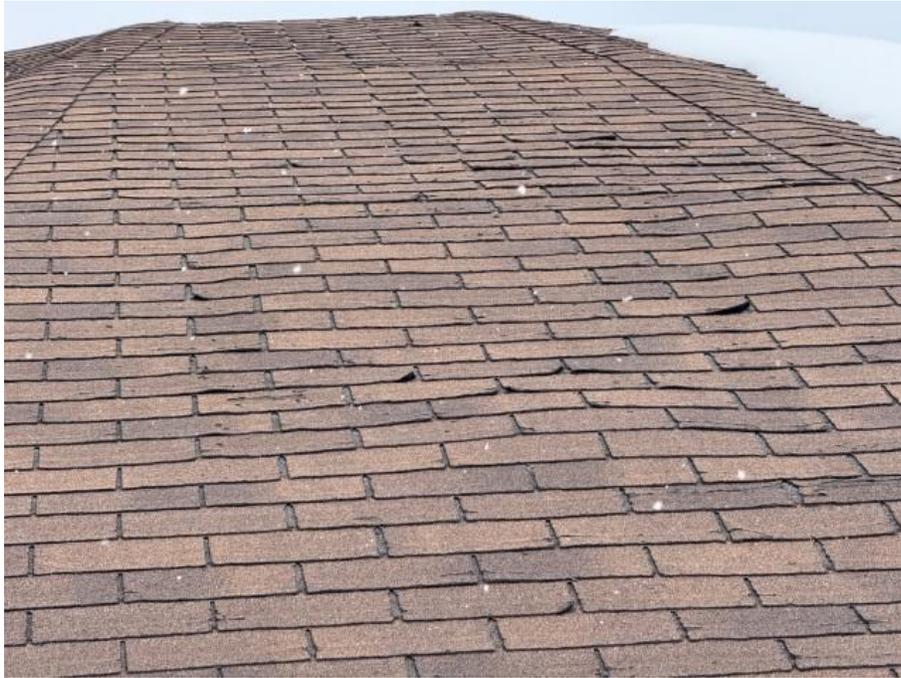
Photo 7: Sand Dome – Severe Asphalt Shingle Deterioration

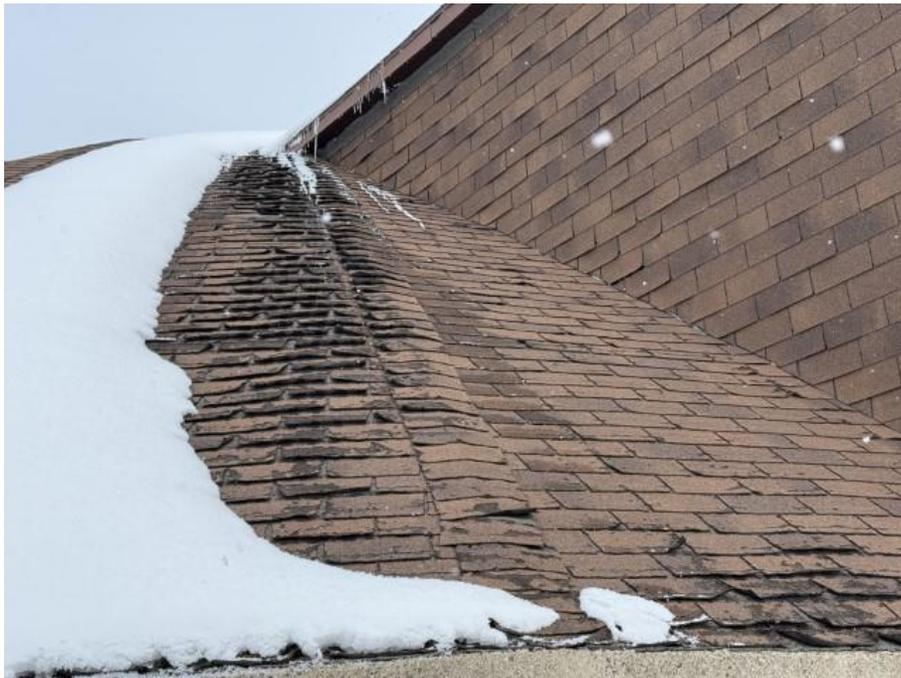
Photo 8: Sand Dome – Severe Shingle Deterioration

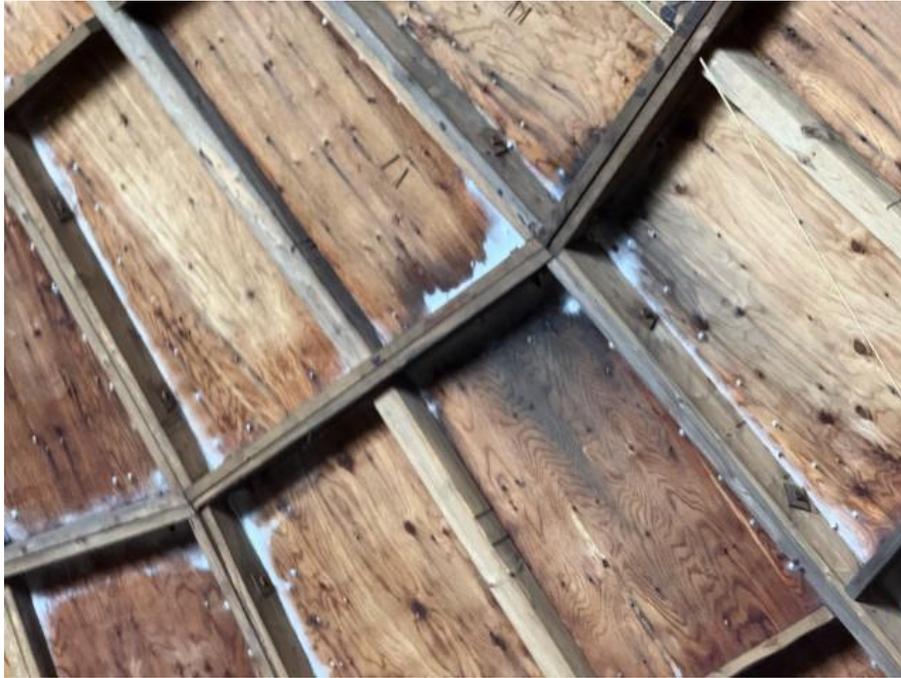
Photo 9: Sand Dome – Localized Sheathing and Framing Moisture Staining

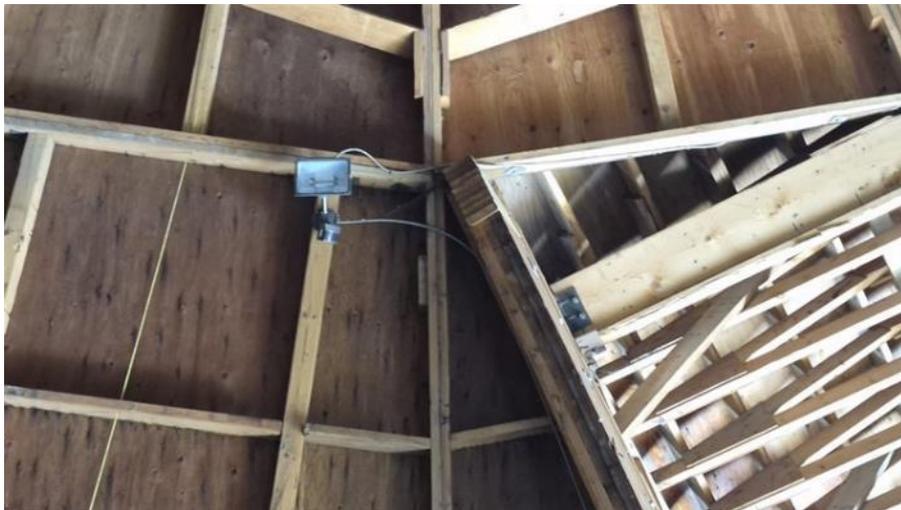
Photo 10: Sand Dome – Non-Functional Interior Light Fixture. Typical of 2

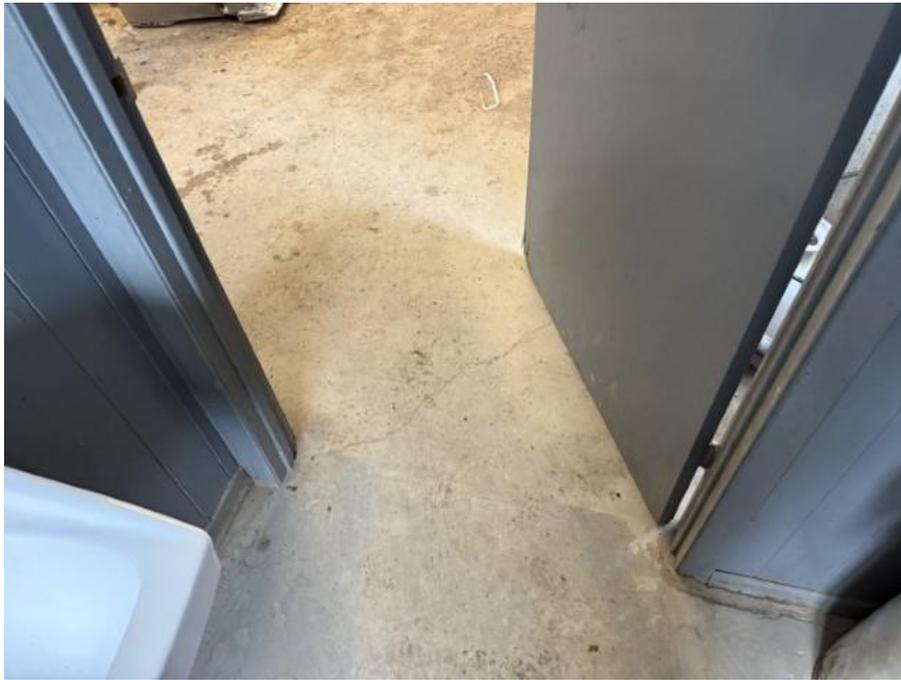
Photo 3: Municipal Garage – Typical Slab Cracking

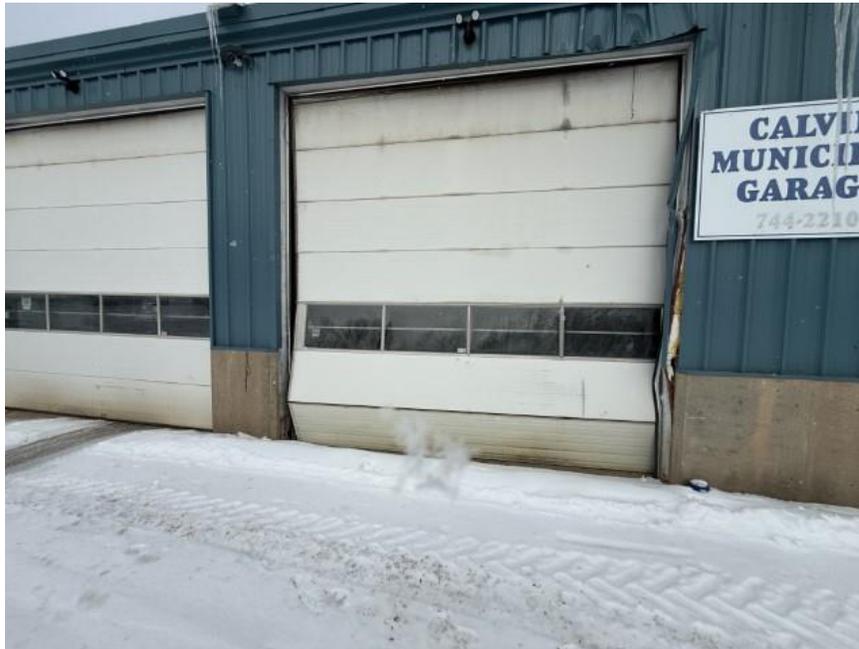
- A small rear addition to the Municipal Garage was completed in 2004 to provide additional interior machinery parking space.
- Snowplough impact damage recently occurred at the side of the middle overhead garage door in the Municipal Garage. It is further understood plans are in place to complete a door replacement and associated repairs through insurance.

Photo 7: Municipal Garage – Overview of Impact Damage

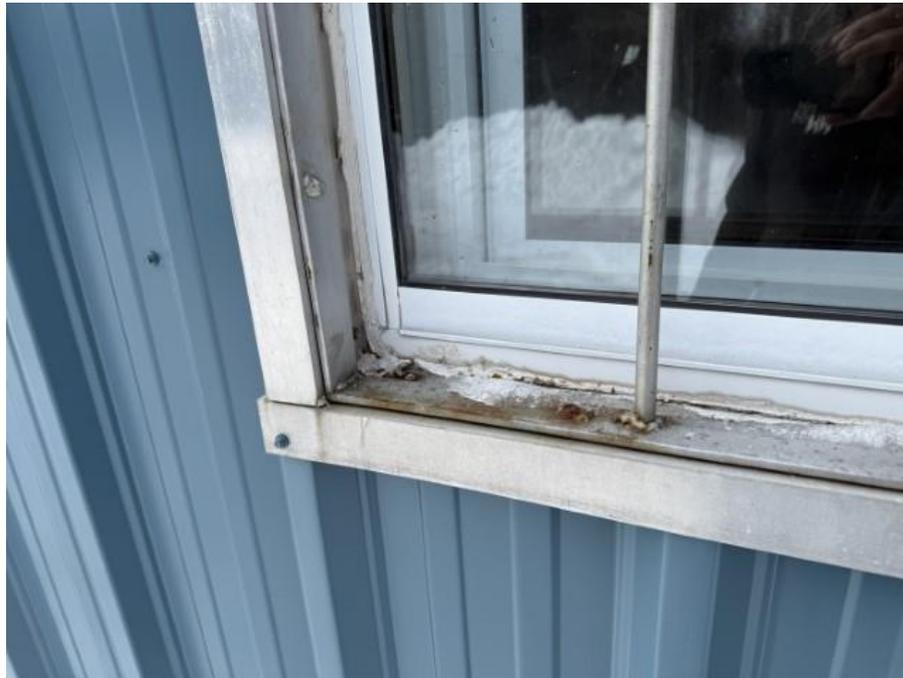
Photo 9: Municipal Garage – Overview of Exterior Windows and Sealant

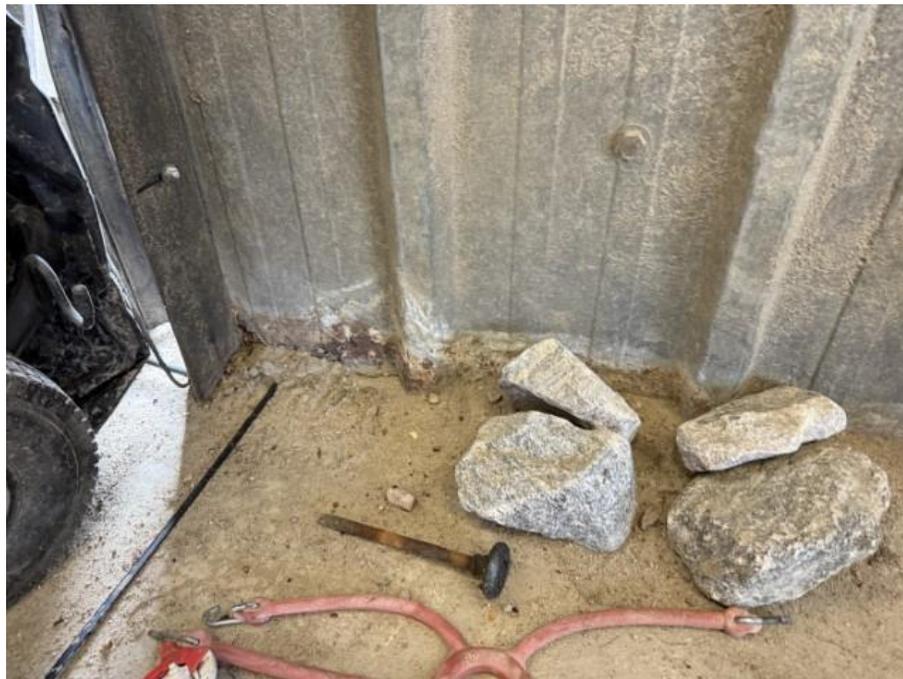
Photo 12: Municipal Garage –Base Cladding Corrosion

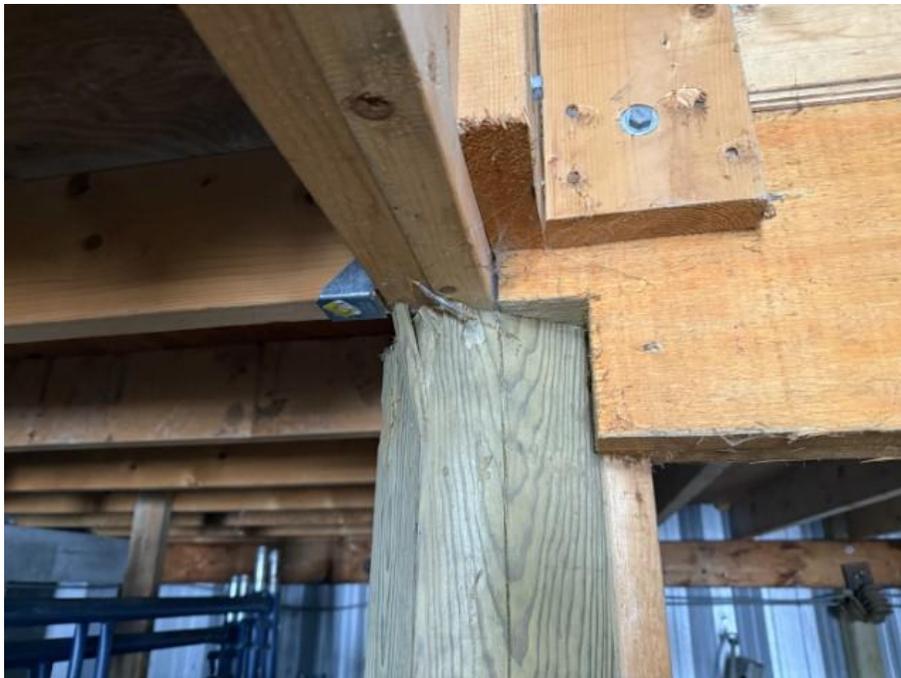
Photo 4: Quonset Hut – Localized Post Displacement

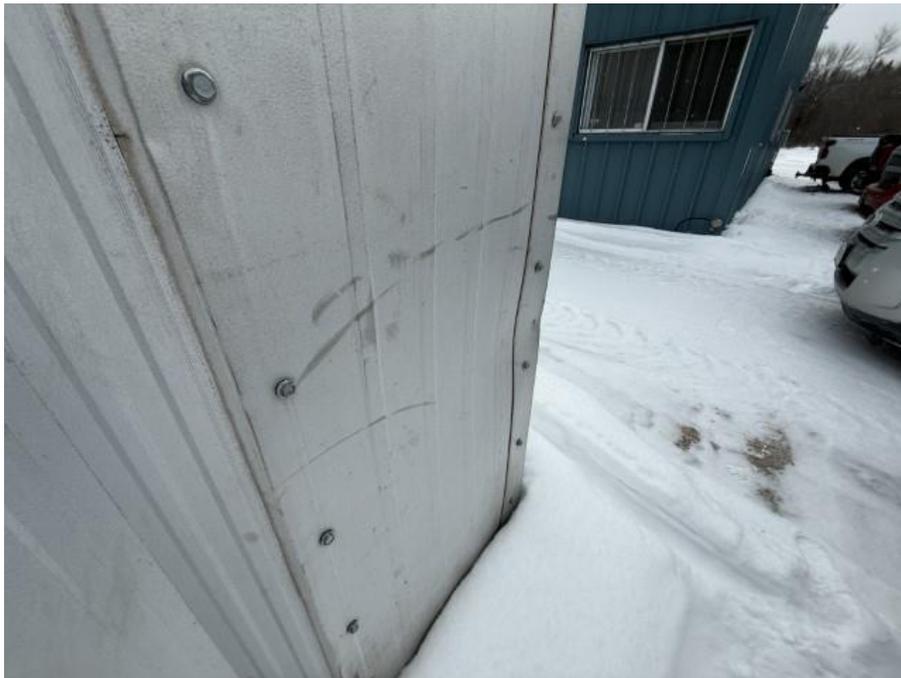
Photo 6: Quonset Hut – Localized siding Damage

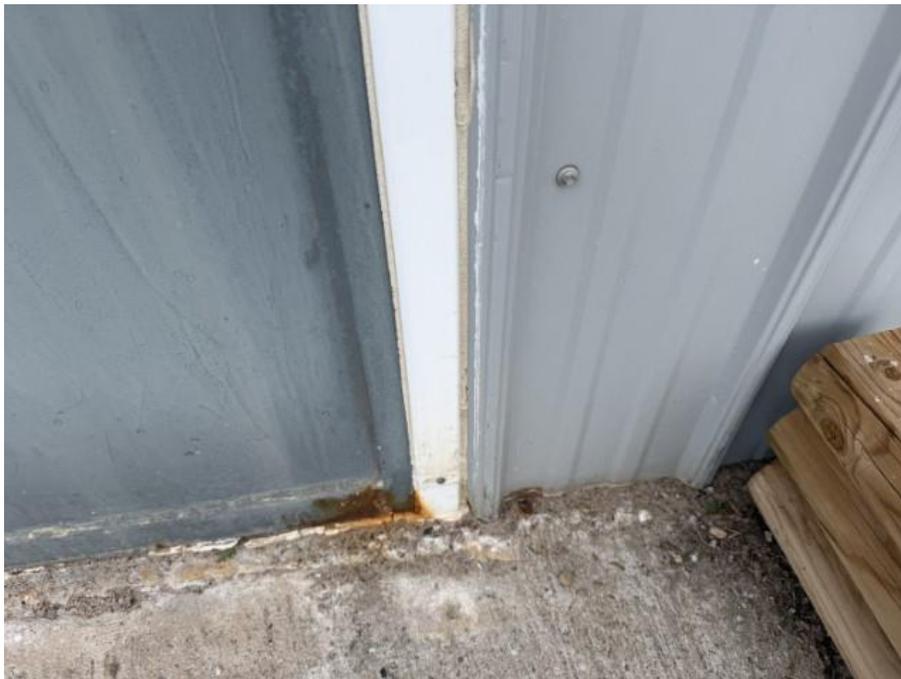
Photo 4: Recreation Hall - Typical Base of Door/Cladding Corrosion

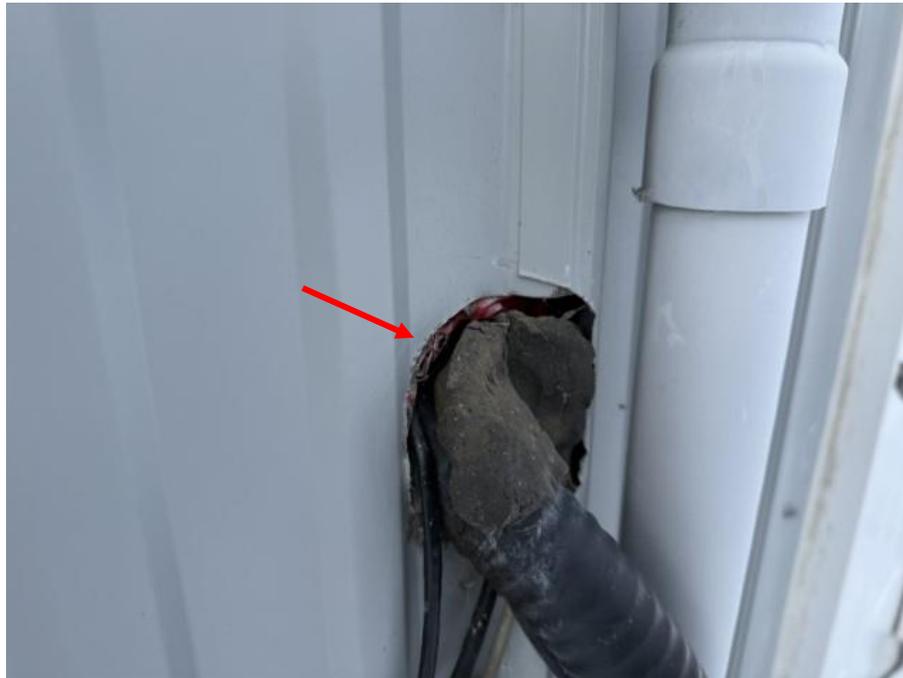
Photo 5: Recreation Hall – Unsealed Exterior Penetration

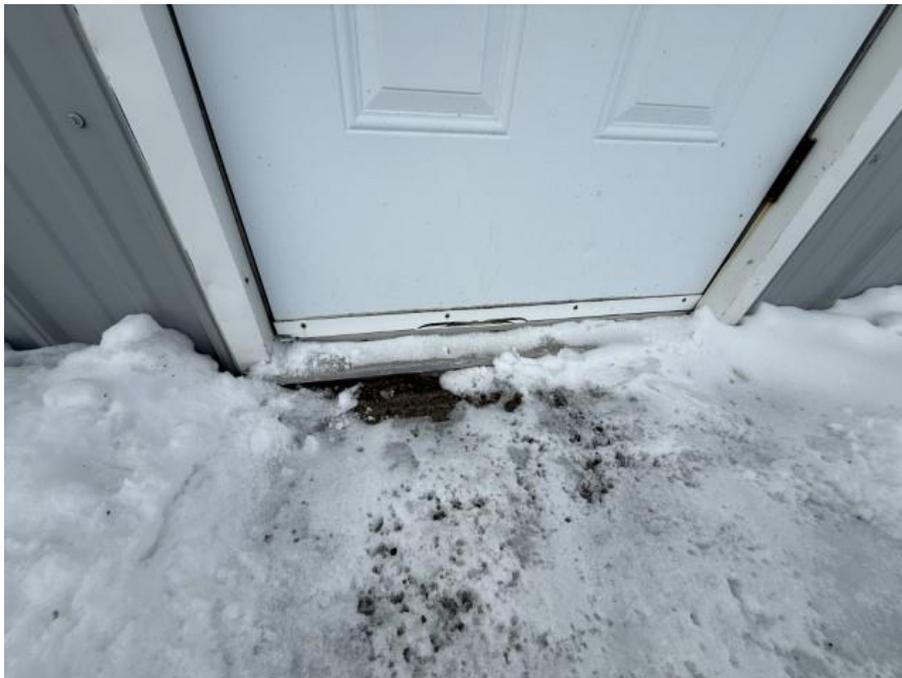
Photo 8: Recreation Hall –Door and Surround Typical Damage

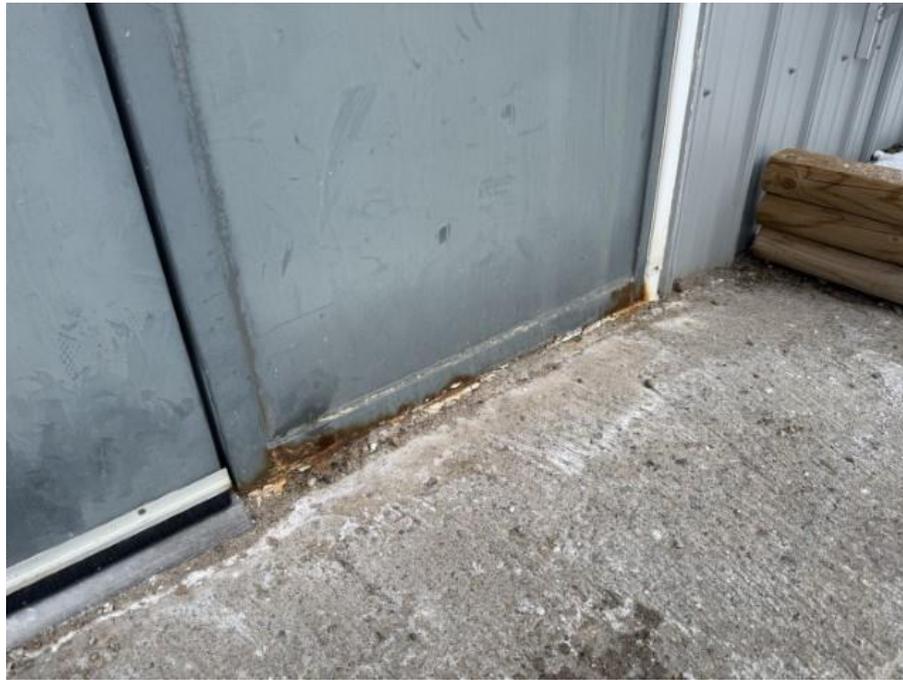
Photo 9: Recreation Hall – Door Base Corrosion

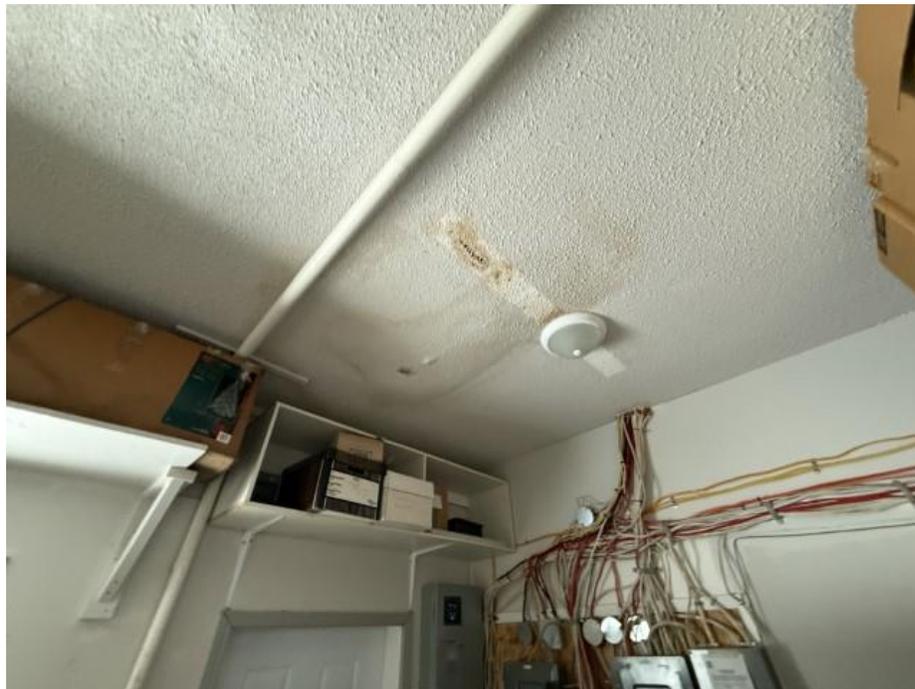
- Repetitive localized roof leaks have been noted within the Recreation Centre building during the springtime snow melt in two locations over the last approximately 3 years. No repairs have been undertaken to resolve.

Photo 10: Recreation Hall – Evidence of Roof Leaks

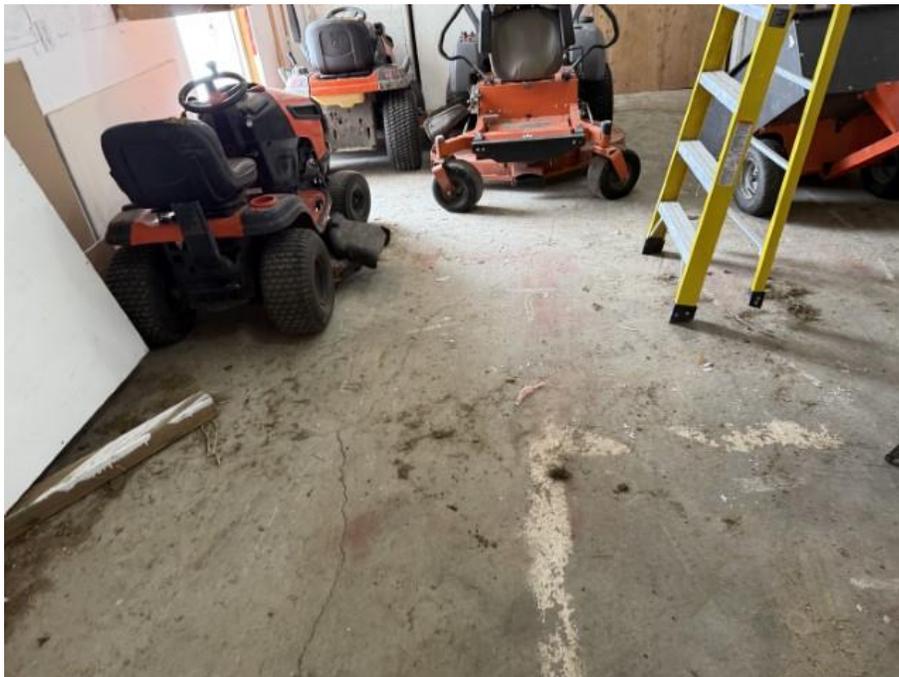
Photo 2: Changing/Storage Building – Overview of Slab Cracking

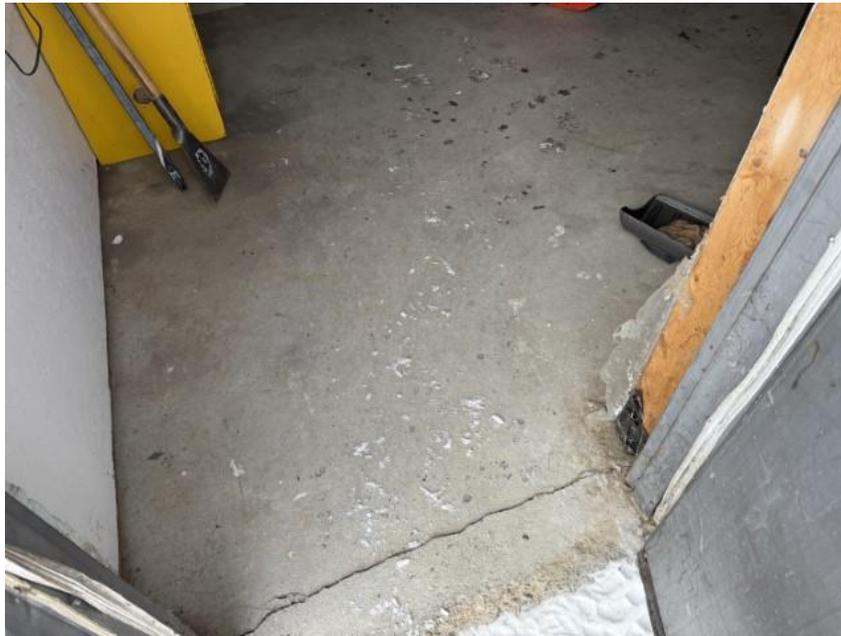
Photo 3: Changing/Storage Building – Cracking at Foundation-Slab

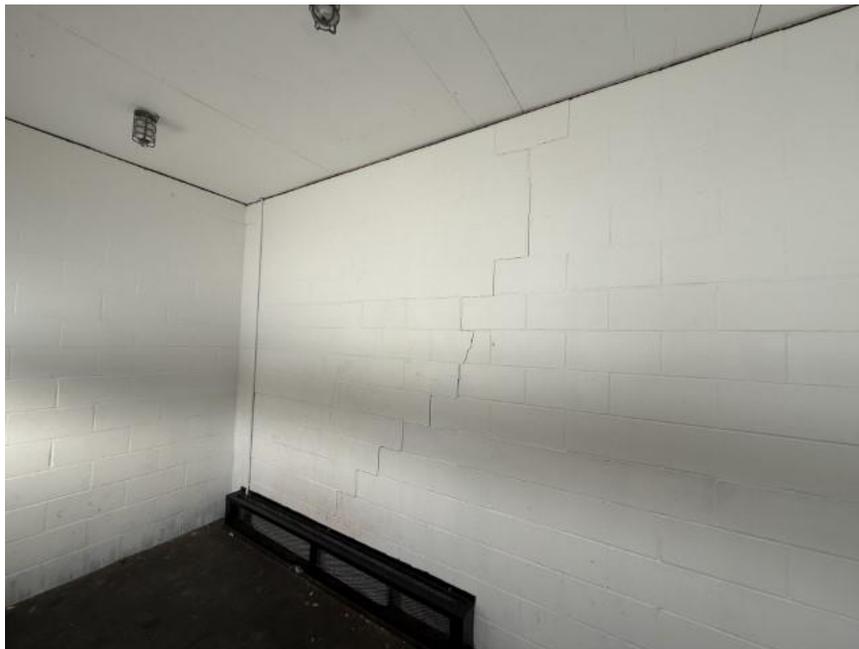
- It was reported that there is an underground tank which collects biowaste from the change room building washrooms. There are notable open joints and step cracking in the concrete masonry unit (CMU) block walls above this area. Staff note that the width of these cracks and openings varies significantly throughout the year.

Photo 4: Changing/Storage Building – Typical Step Cracking and Cracked CMU

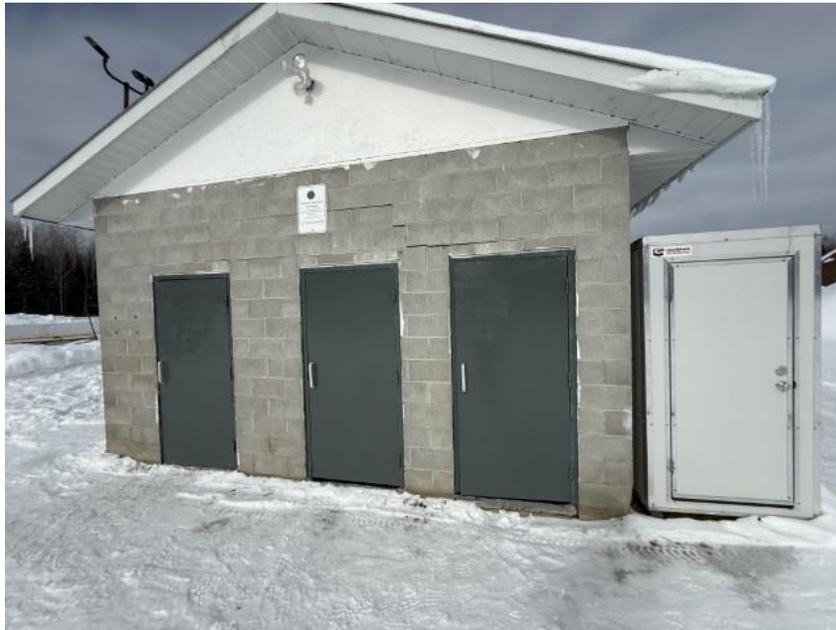
Photo 5: Changing/Storage Building – Doors and Overhead Step Cracking
