THE TOWNSHIP OF CALVIN

BRIDGE MANAGEMENT STUDY REPORT (FINAL)

6 BRIDGES

NOVEMBER 2023

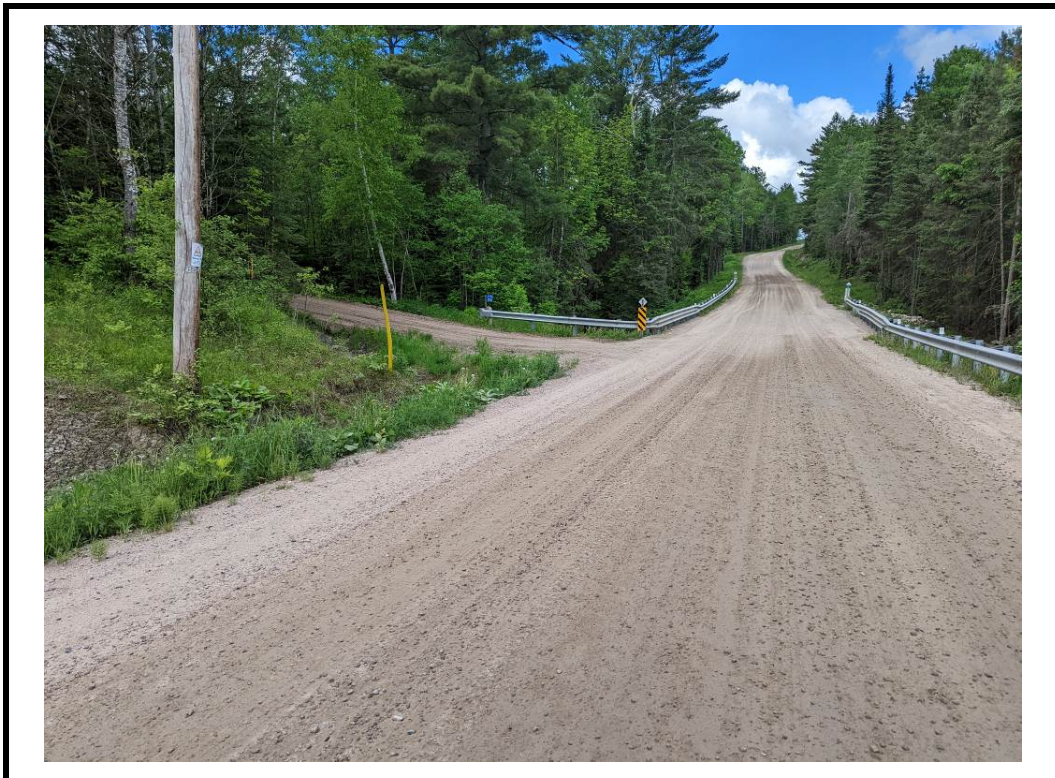
Photo 8 Tire rutting noted on east approach wearing surface

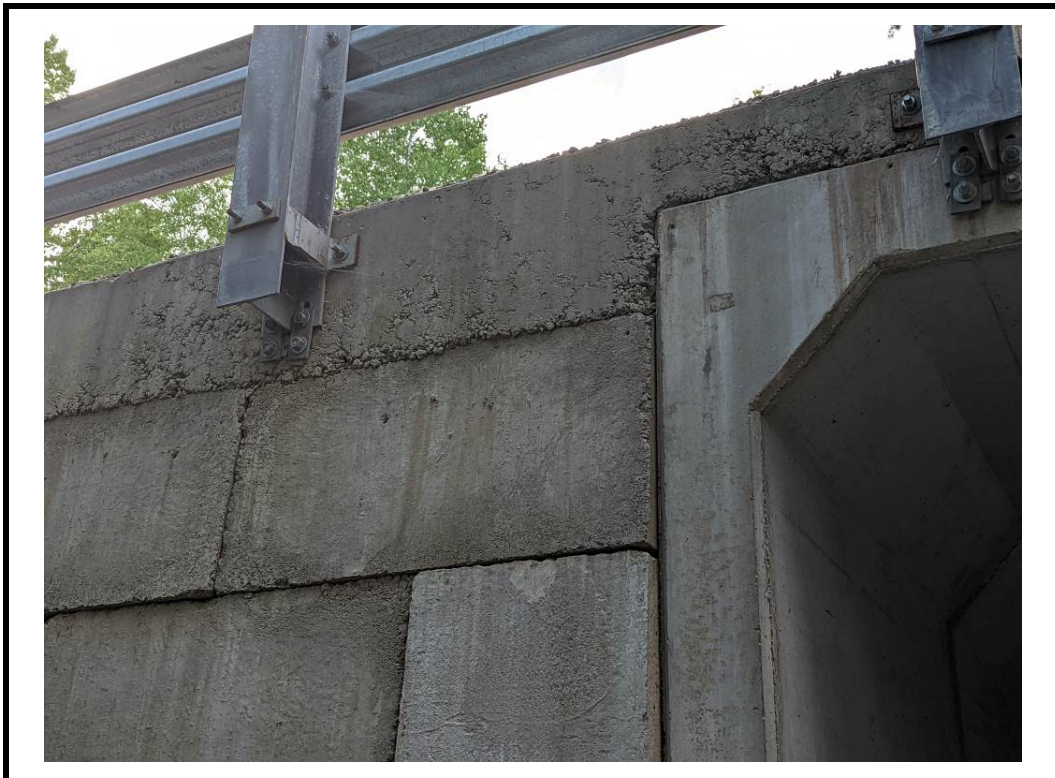
Photo 10 Light honeycombing noted on exterior deck soffit at northeast corner

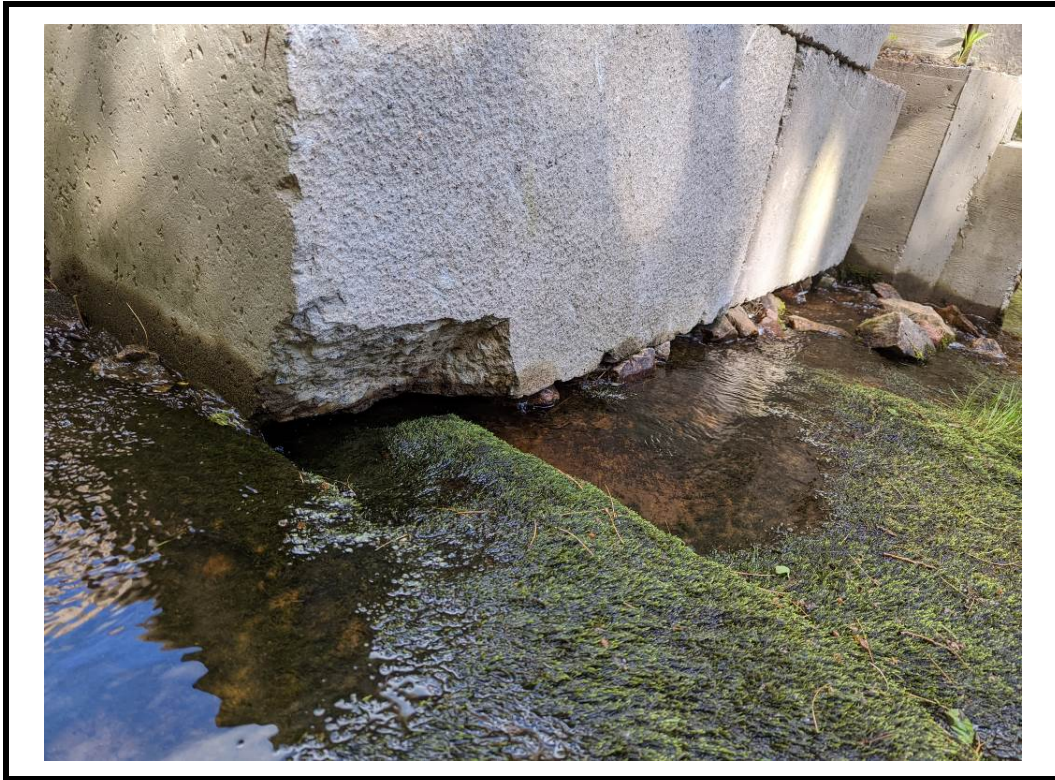
Photo 11 Some undermining and water flowing at southeast wall

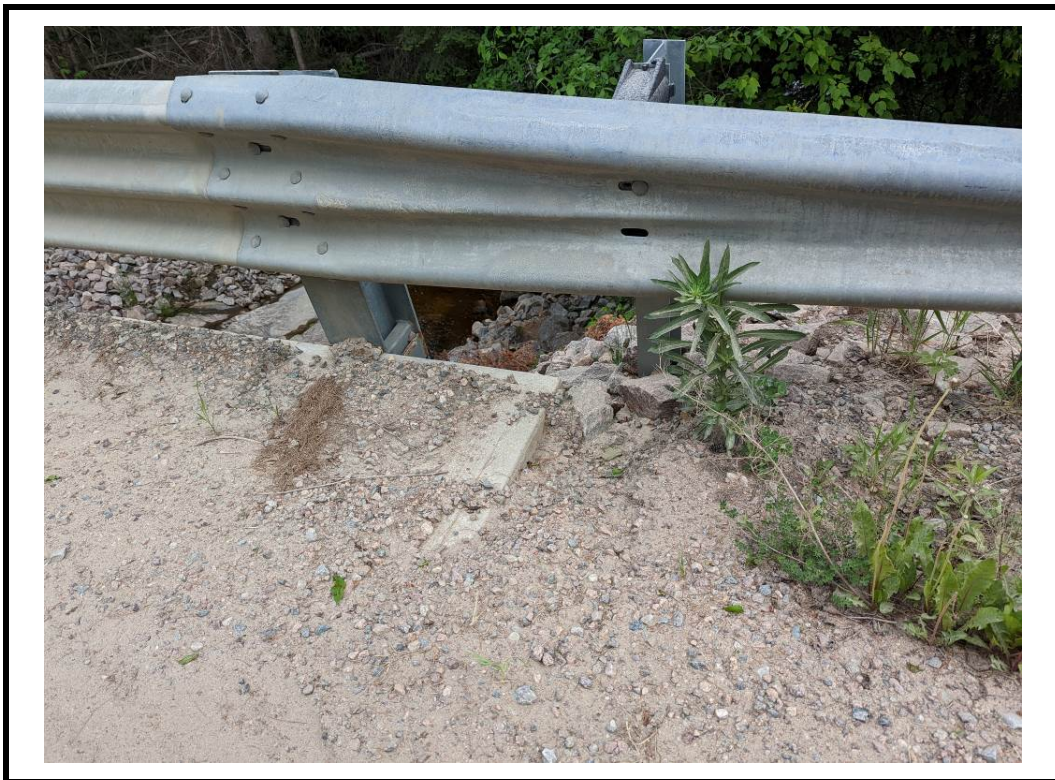
Photo 14 Some loose gravel noted at the edge of deck

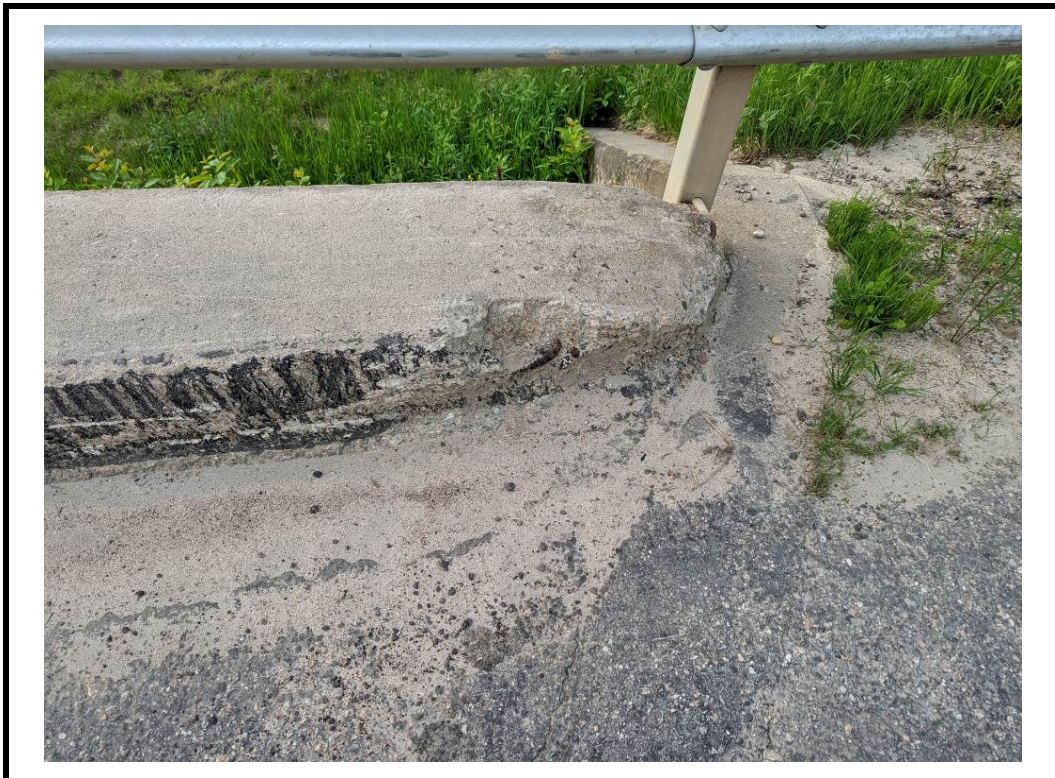
Photo 8 Small Spall with exposed corroded reinforcement noted on curb at northwest corner

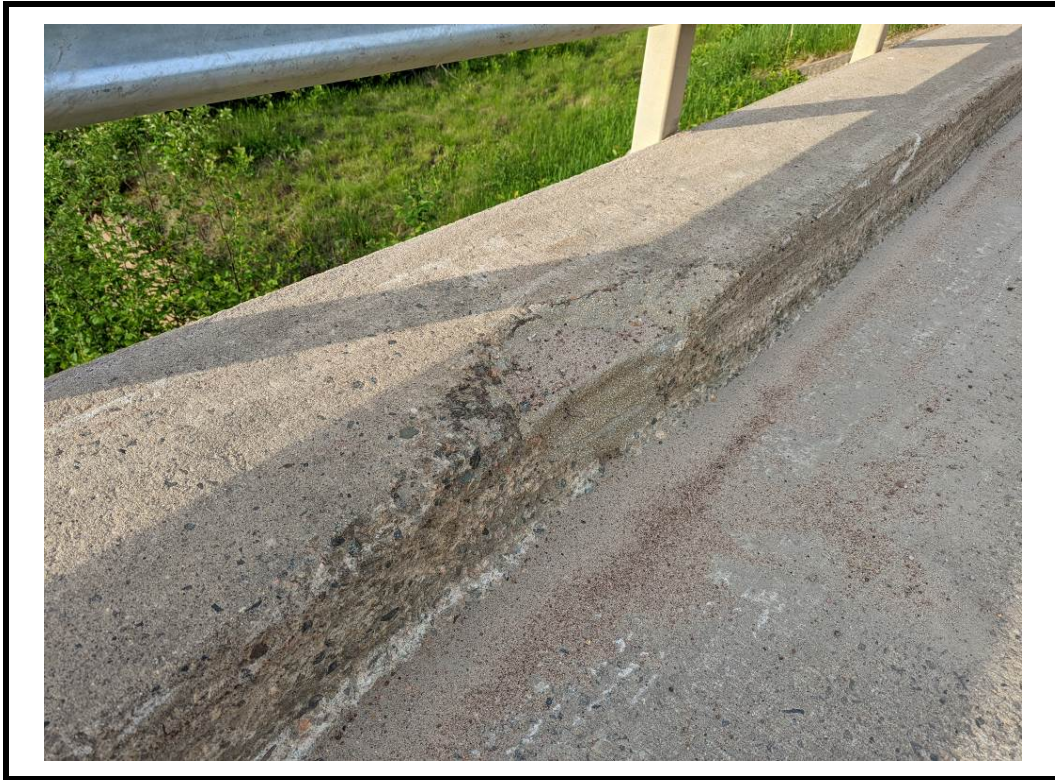
Photo 9 Scaling and abrasions noted on south curb

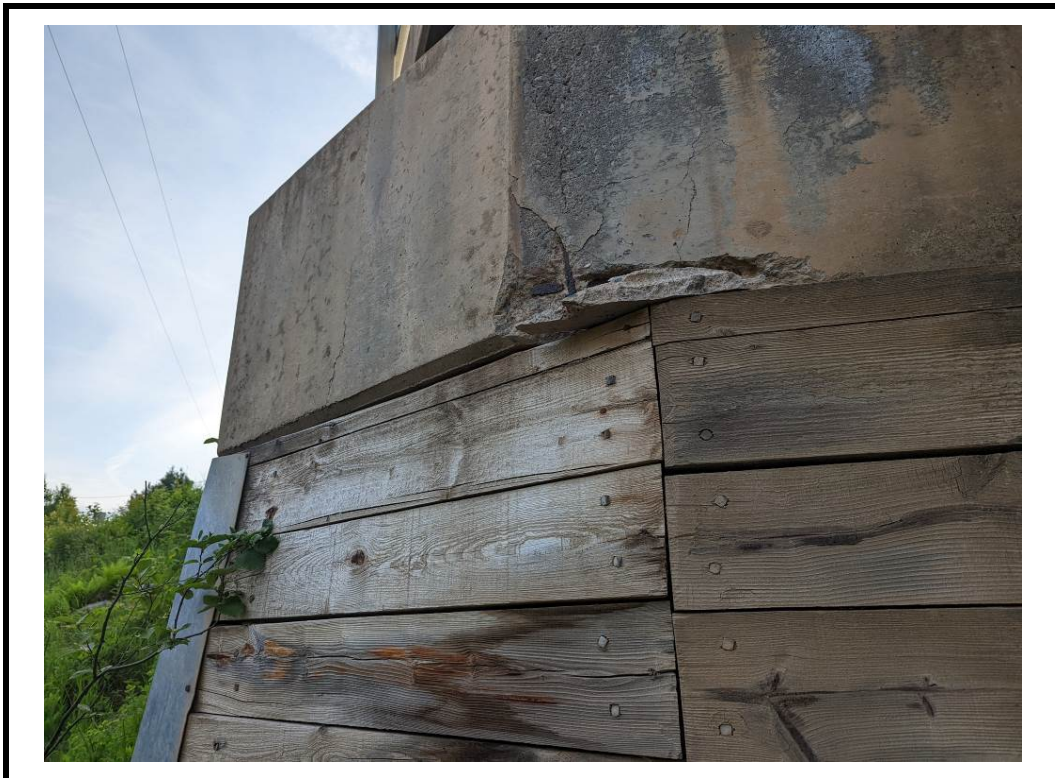
Photo 10 Spall with exposed corroded reinforcement noted on west pier cap

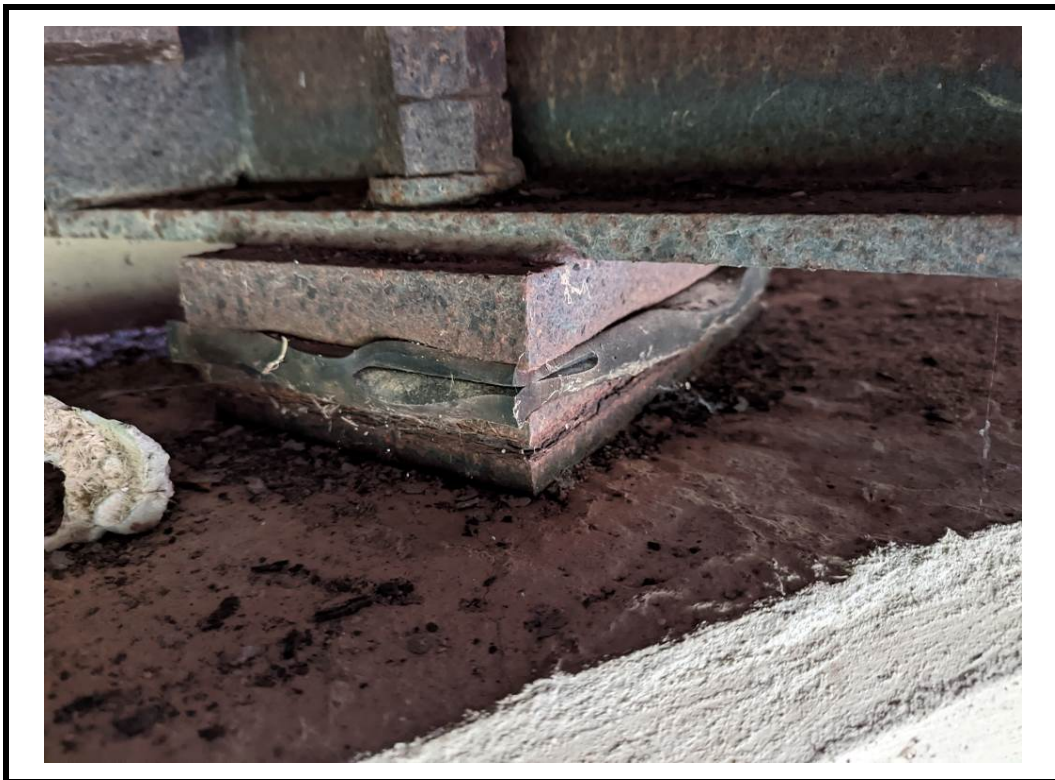
Photo 12 Bulging abutment bearing and corrosion on bearing plate at southwest corner

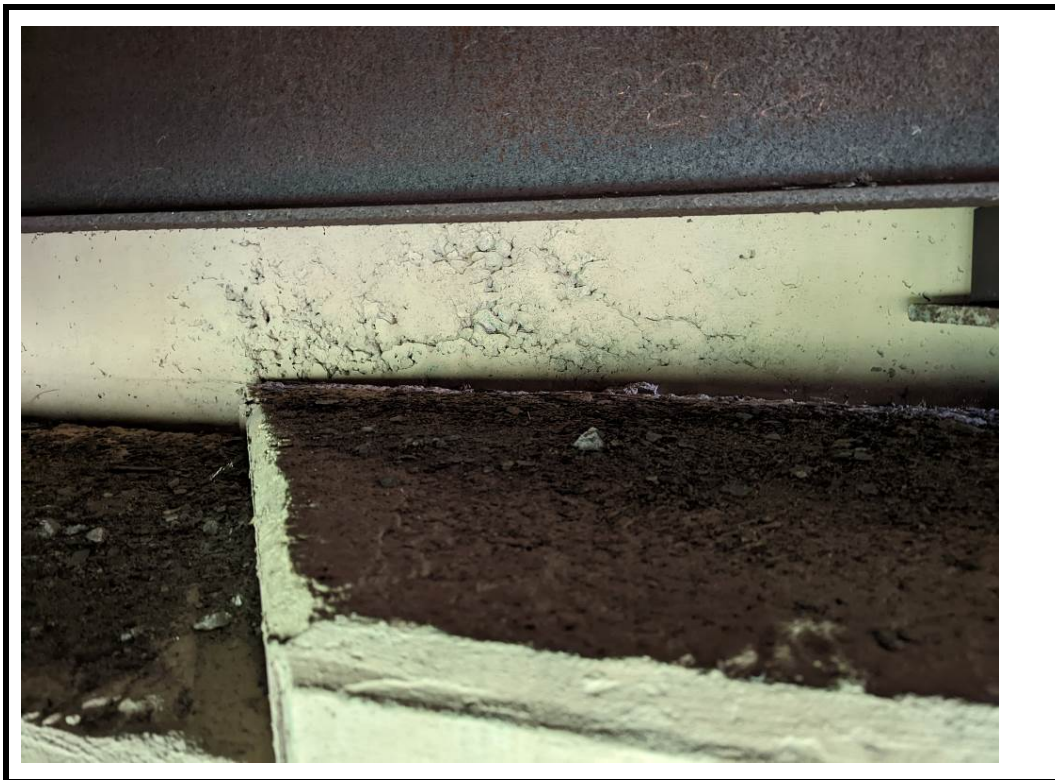
Photo 16 Light honeycombing noted on west ballast wall

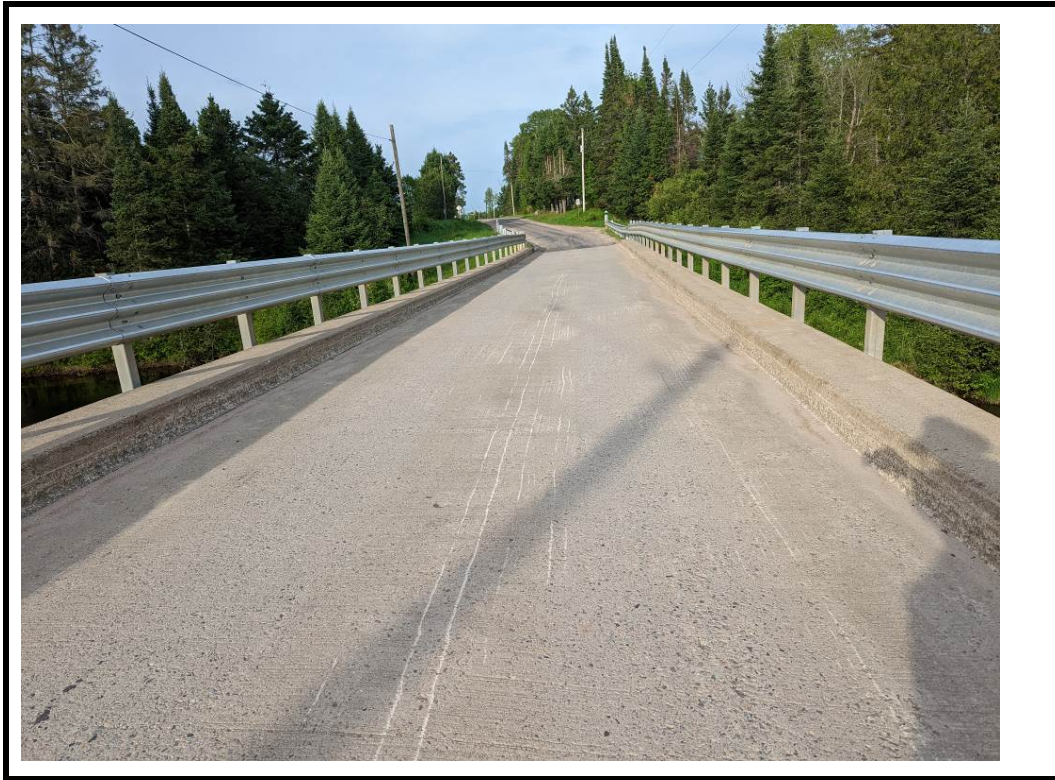
Photo 17 Light scaling and minor abrasion noted throughout exposed deck top

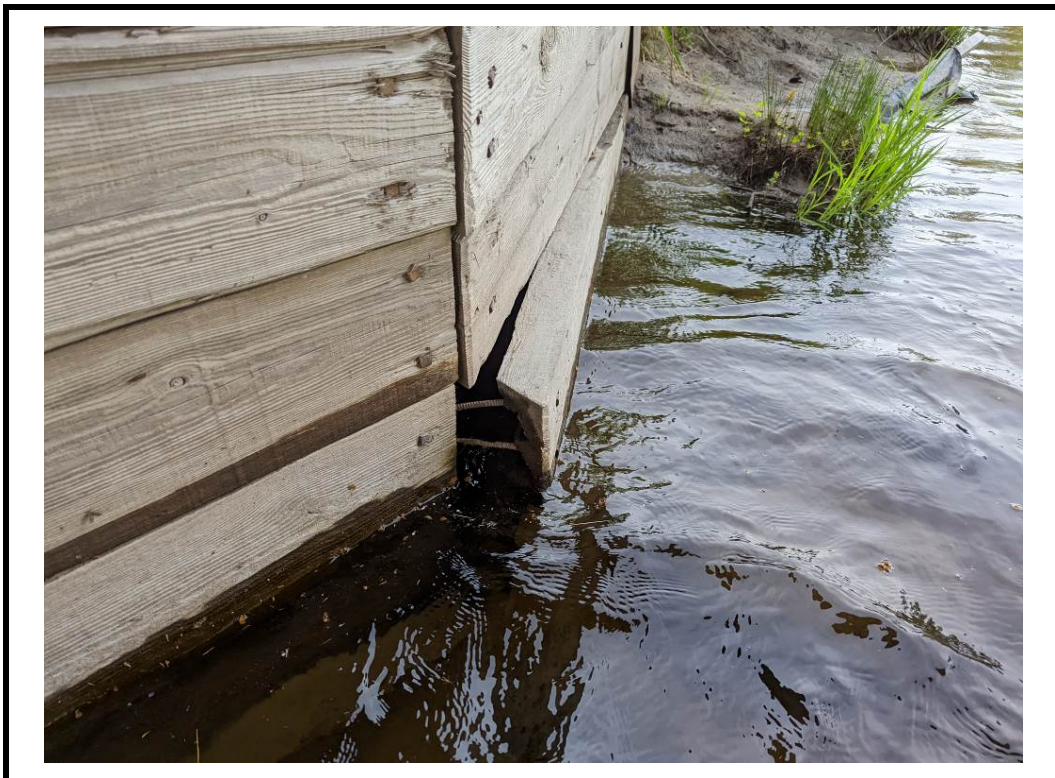
Photo 18 Some separation and weathering of timber crib noted throughout pier shaft

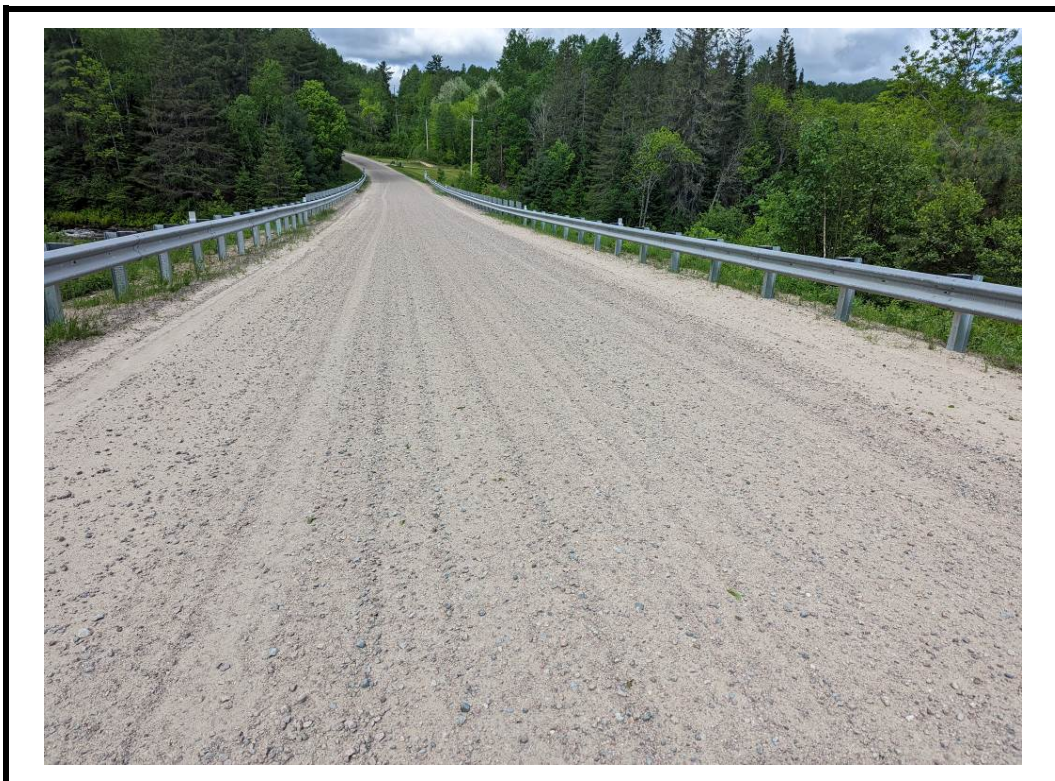
Photo 8 Light tire rutting and loose gravel noted throughout approach wearing surface

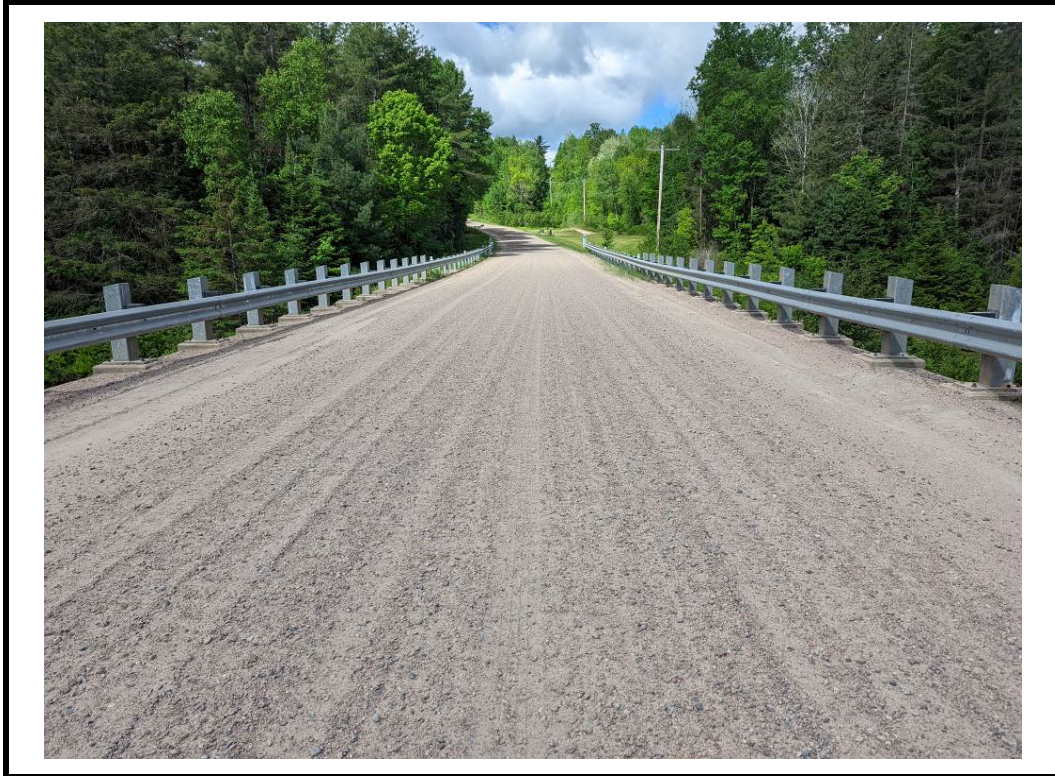
Photo 9 Typical deck wearing surface with loose gravel noted throughout

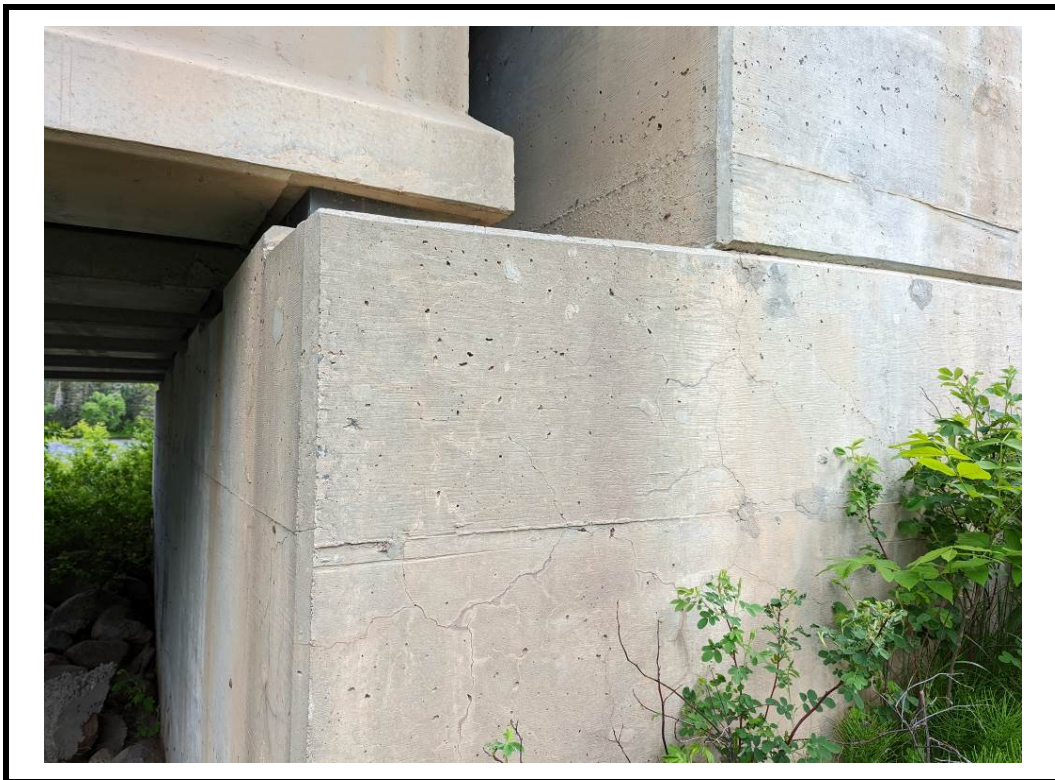
Photo 12 Cracks and stains noted on southeast wingwall

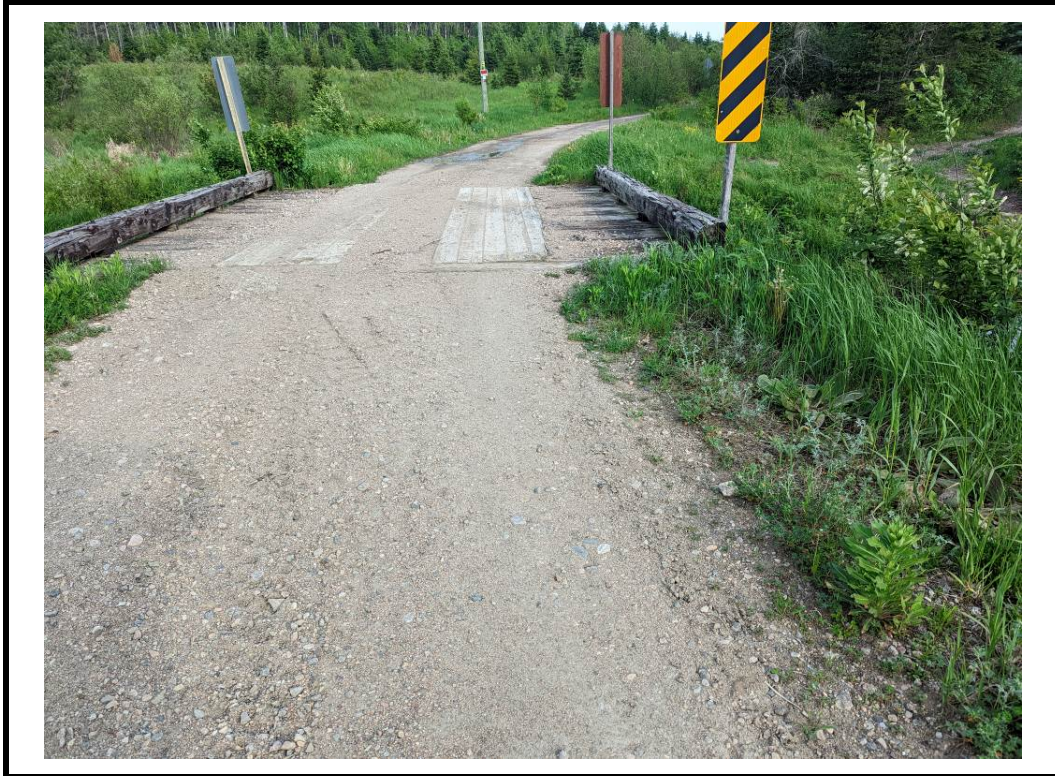
Photo 7 Damaged hazard sign on NW corner of barrier

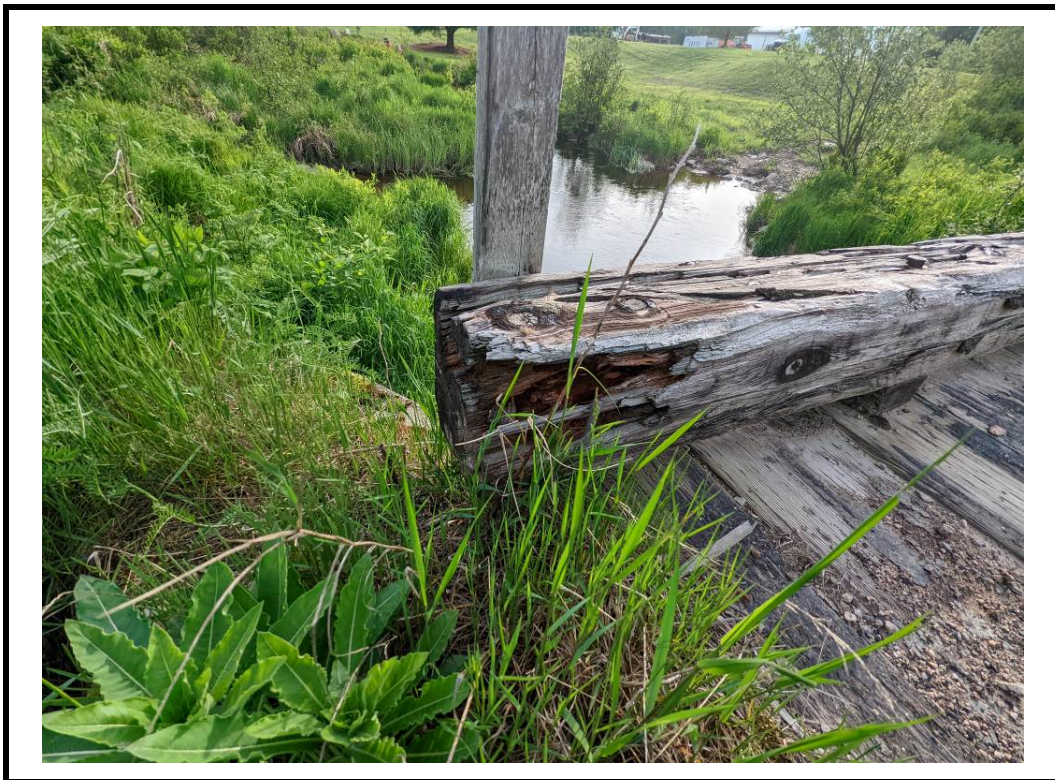
Photo 8 Splits, checks and rot on northwest timber curb

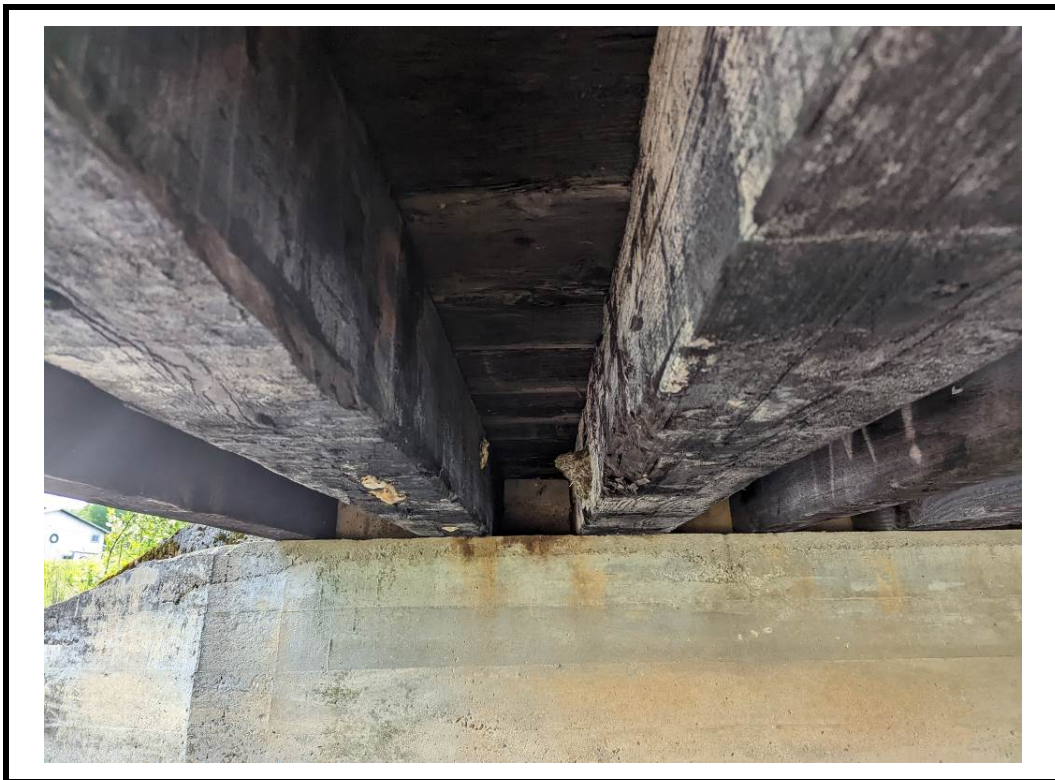
Photo 10 Weathering on timber girders

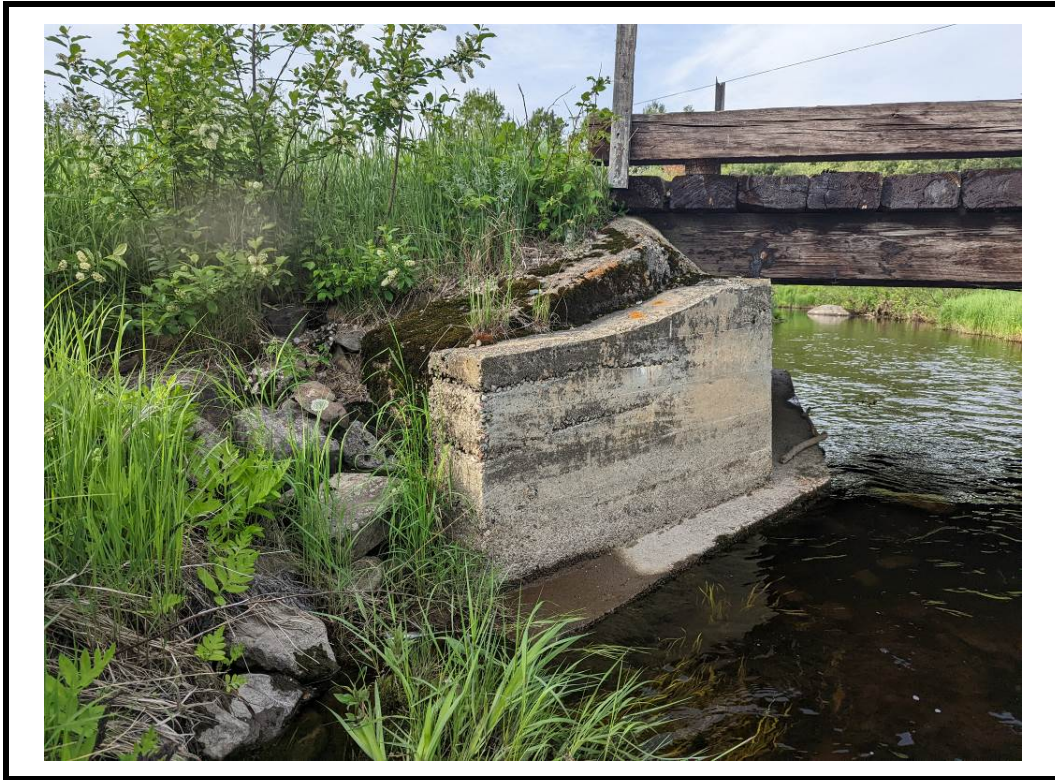
Photo 11 Moderate scaling noted on NW wingwall

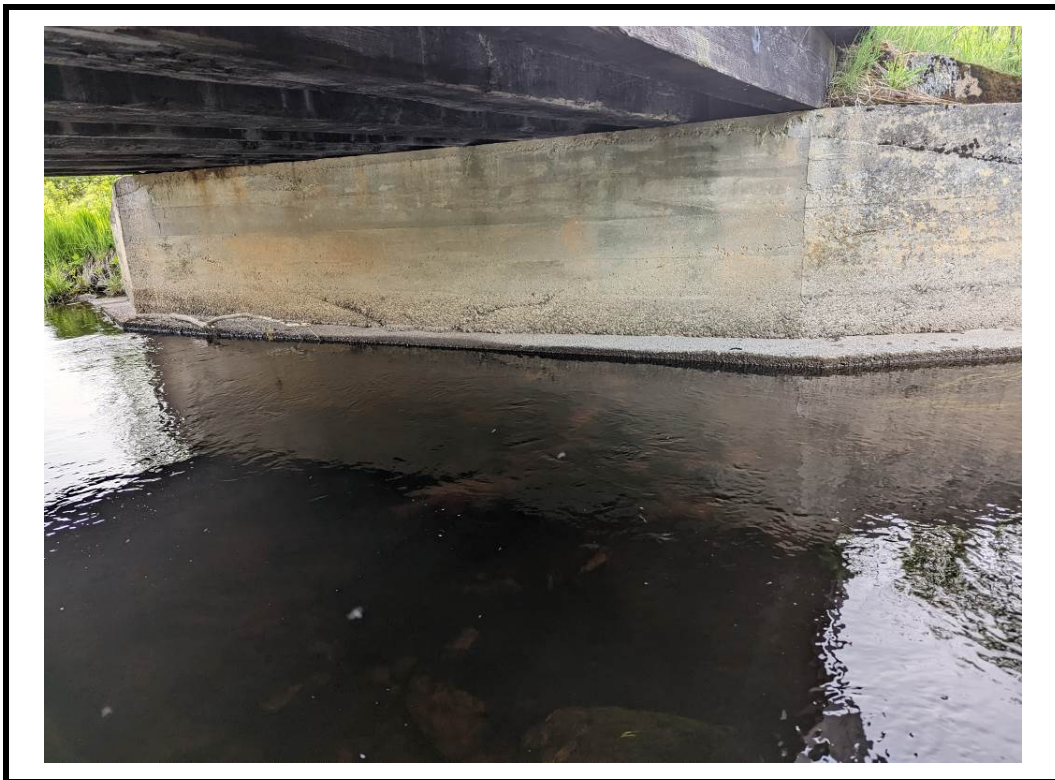
Photo 12 Moderate scaling on base of north abutment wall

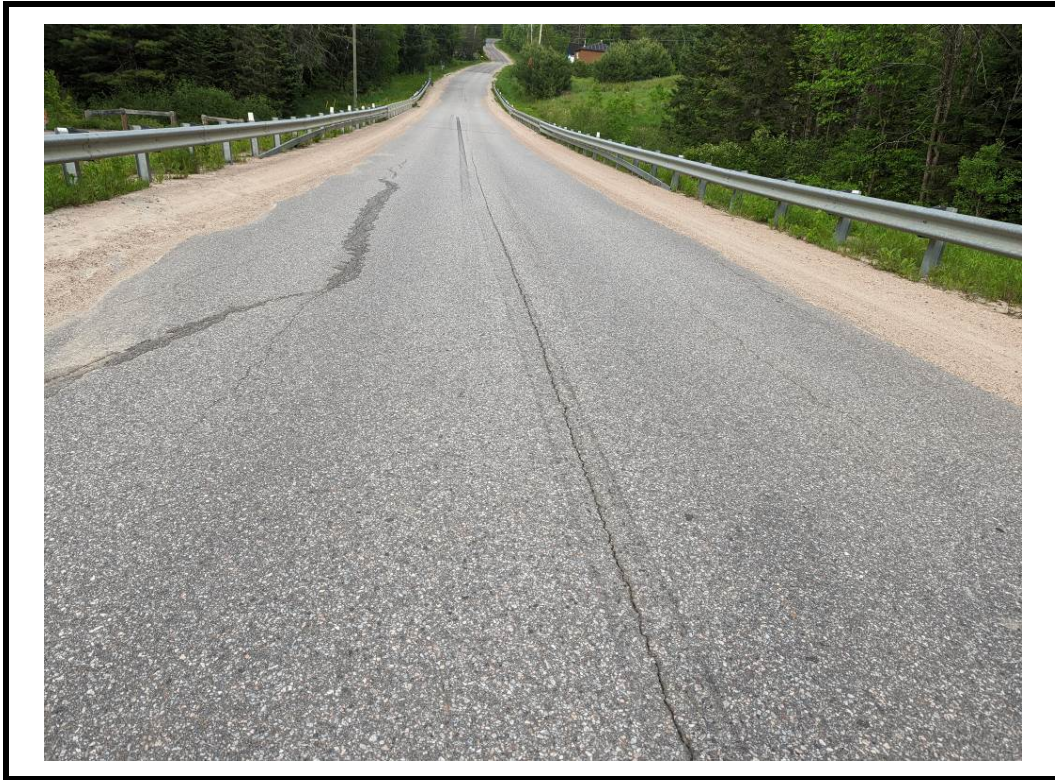
Photo 7 Wide transverse and longitudinal cracks on west approach wearing surface

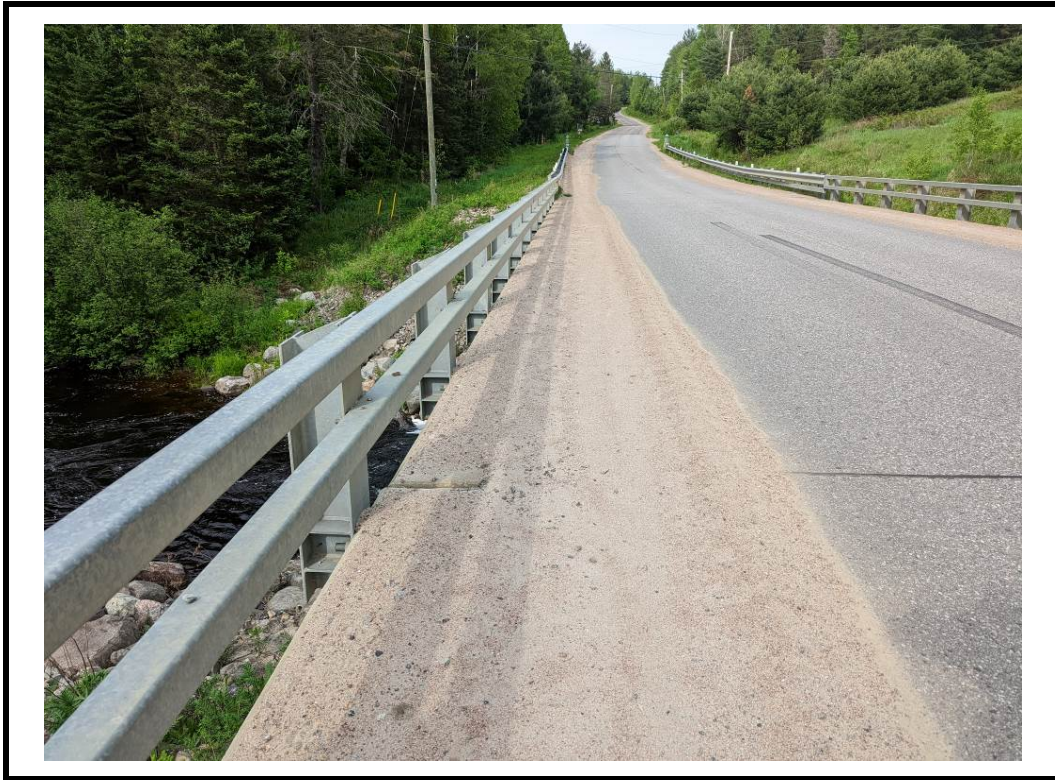
Photo 11 Sand accumulation noted on both side of deck wearing surface

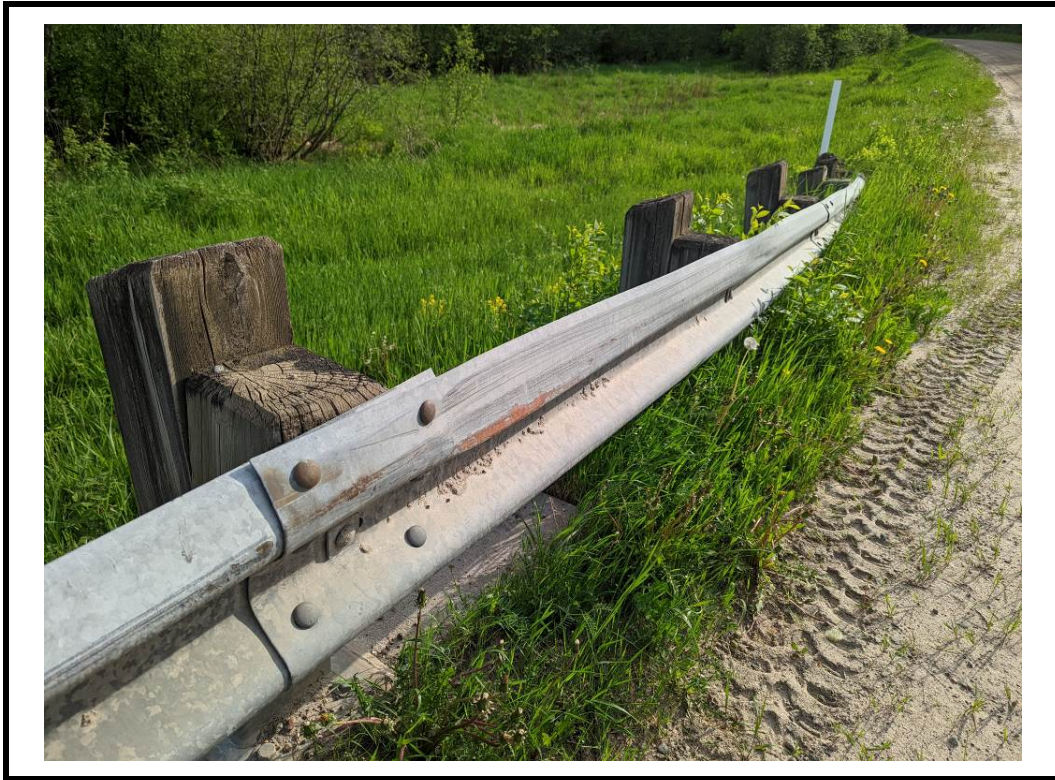
Photo 7 Substandard end treatment with damage northwest approach barrier

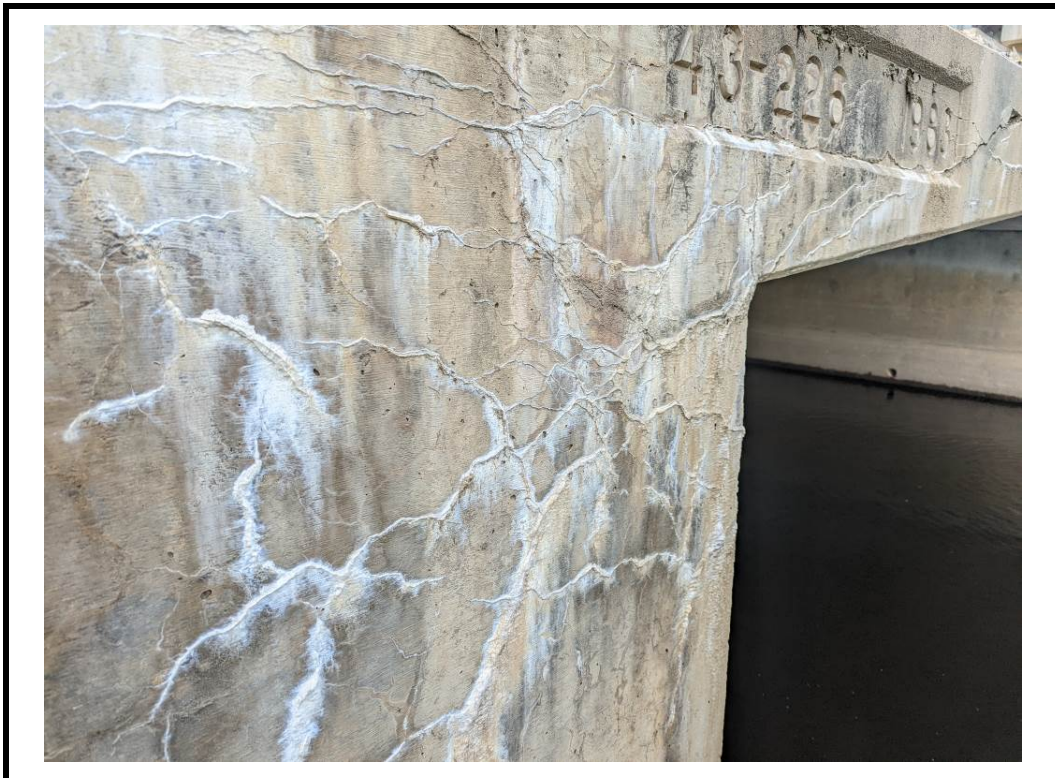
Photo 8 Narrow crack with efflorescence and rust stains on southwest wingwall

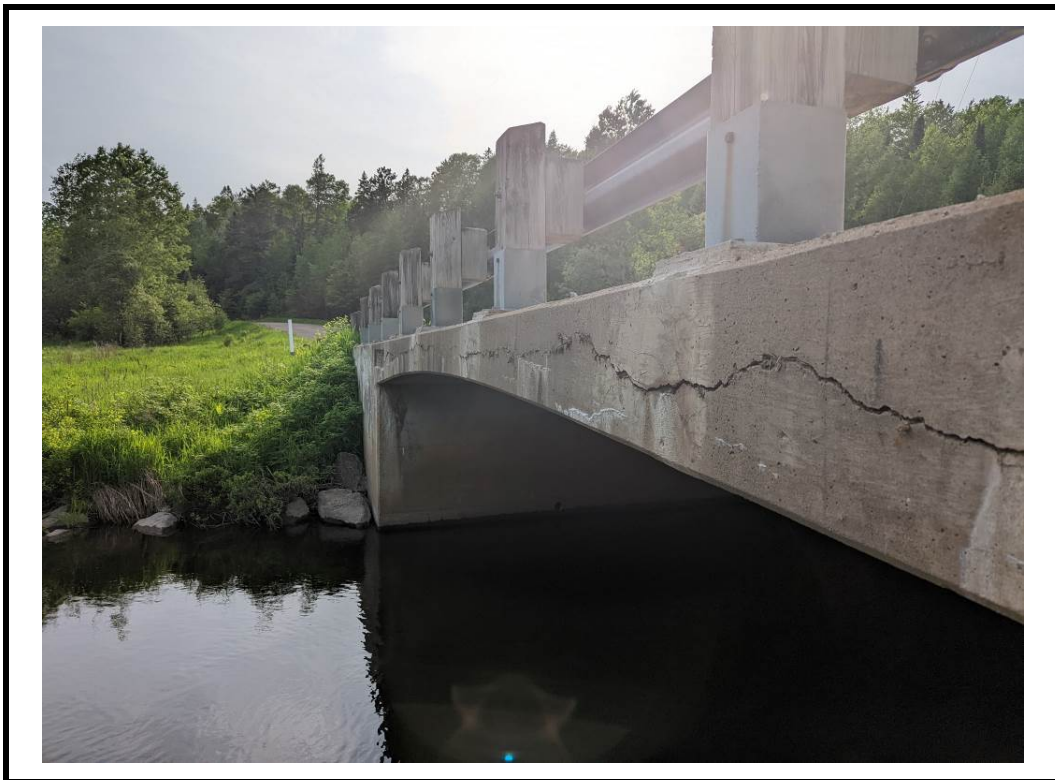
Photo 10 Wide horizontal cracks with concrete delamination noted on soffit exterior

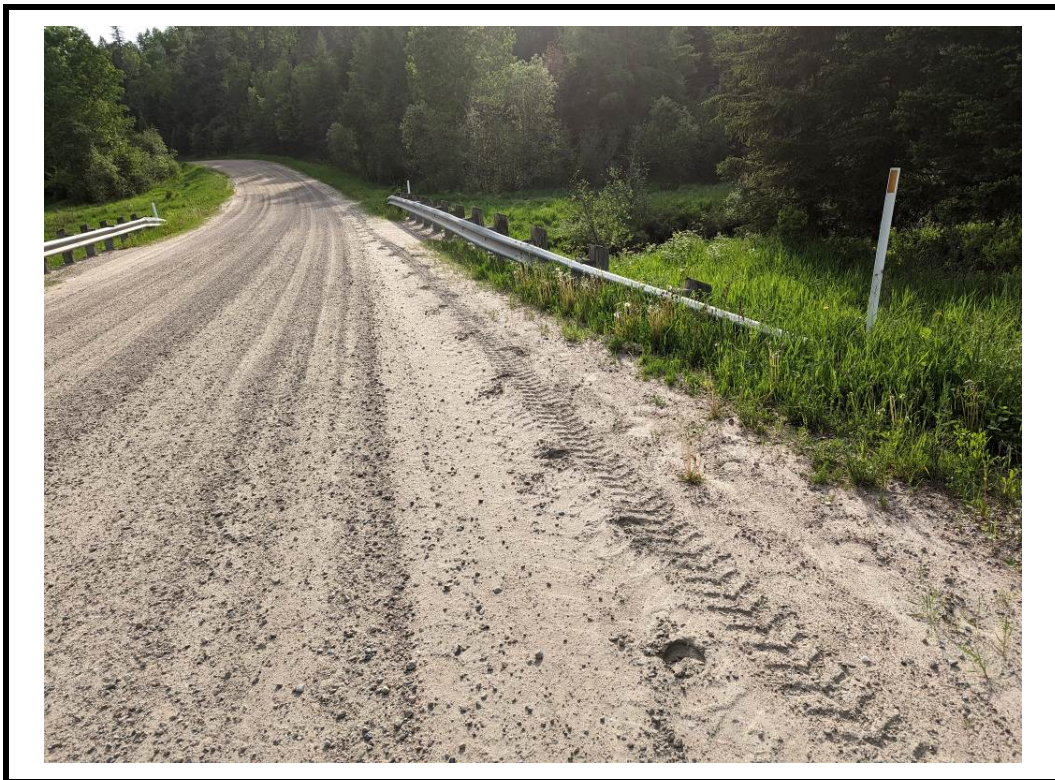
Photo 12 Moderate vegetation grown in front of approach guiderail
