THE TOWNSHIP OF CALVIN

BRIDGE MANAGEMENT STUDY REPORT (FINAL)

6 BRIDGES

NOVEMBER 2023

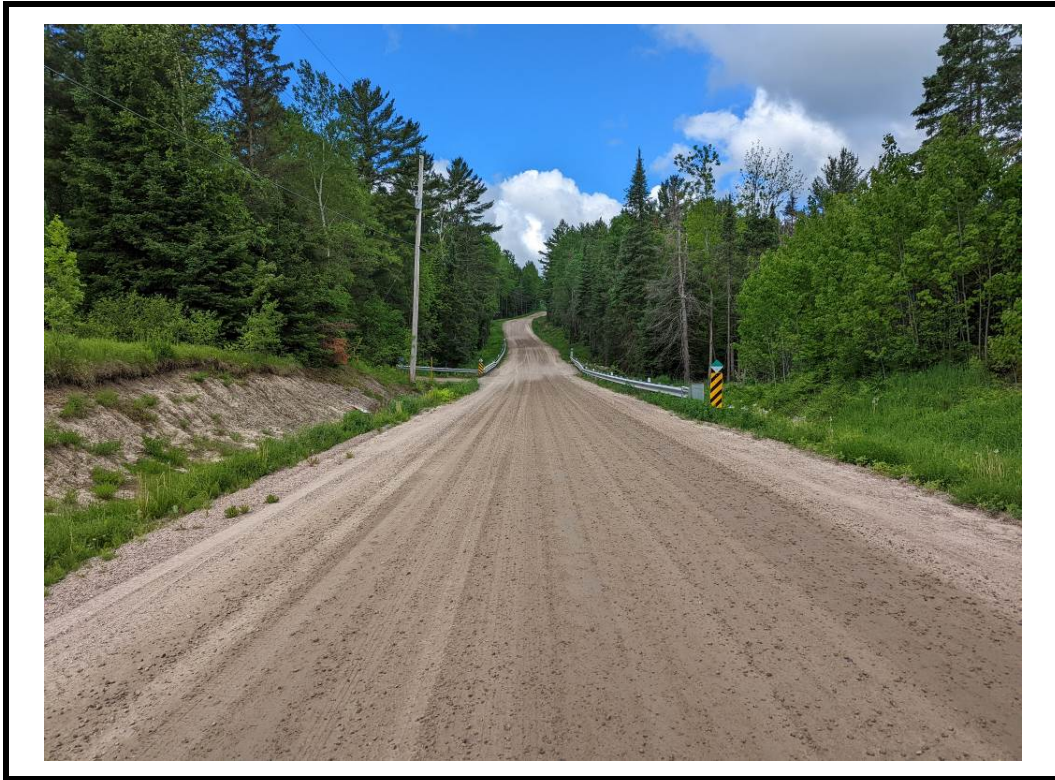
Photo 1 Structure from east approach

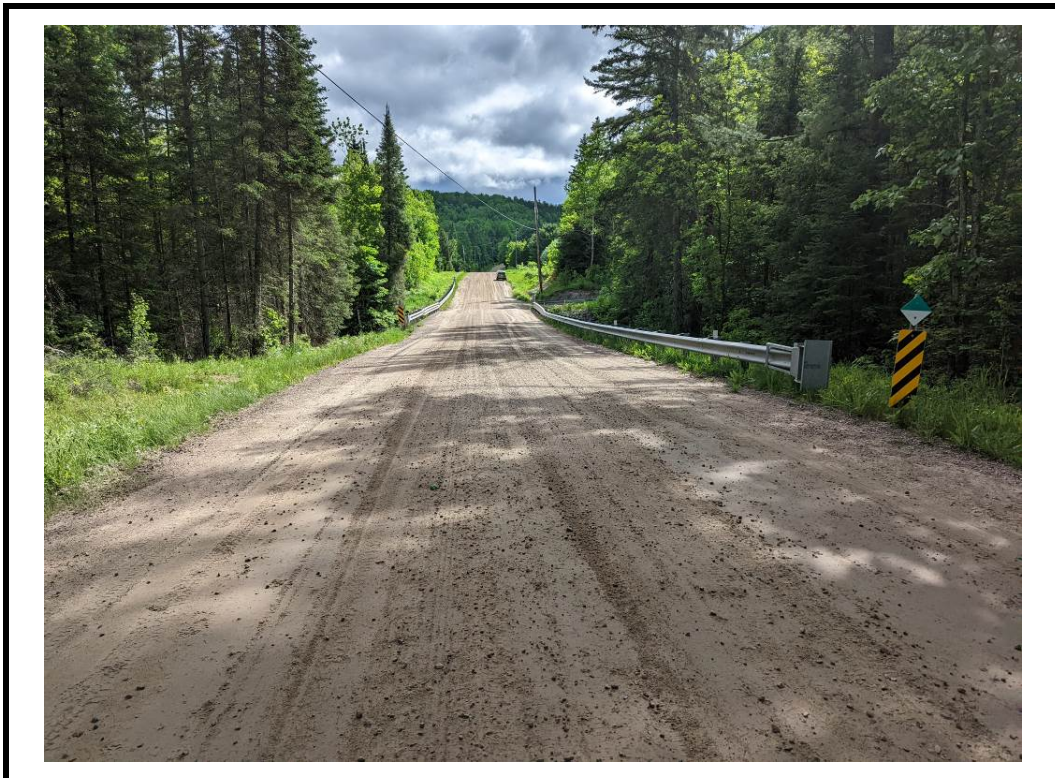
Photo 2 Structure from west approach

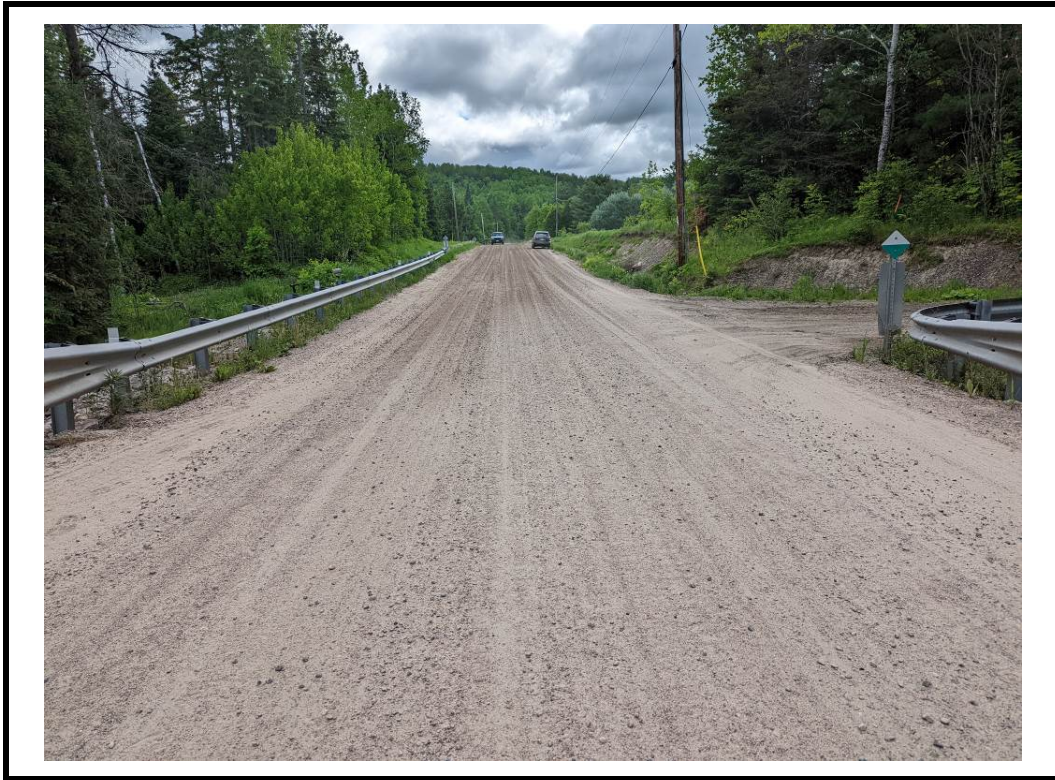
Photo 3 East approach from centre of structure

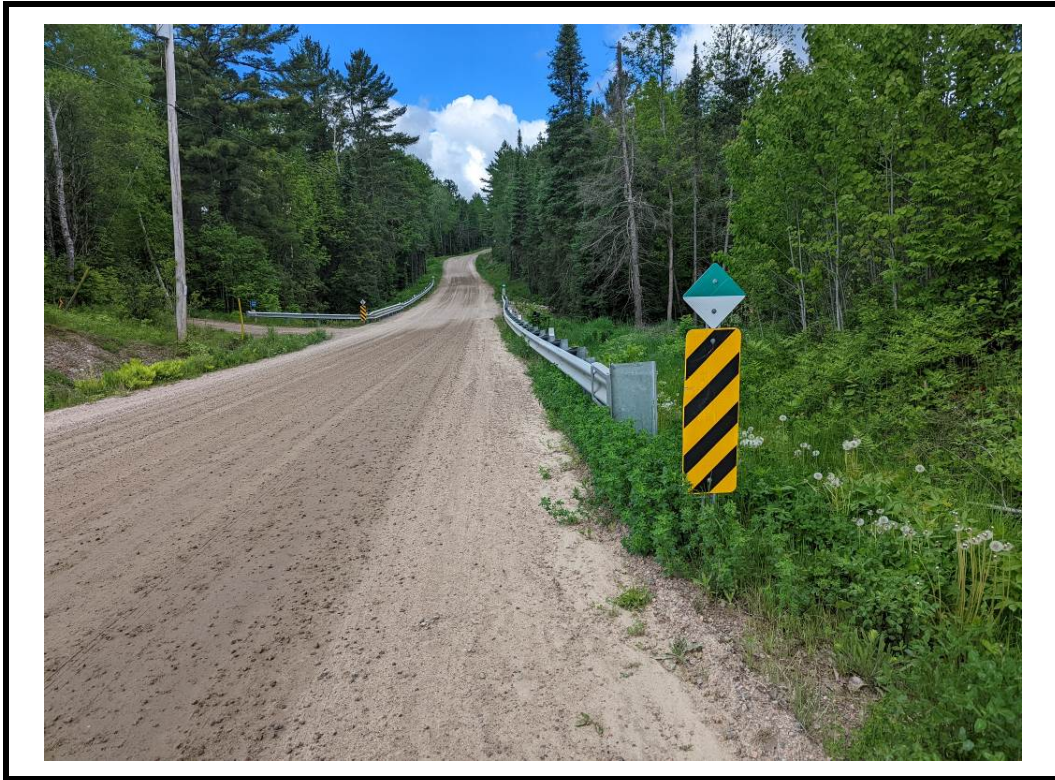
Photo 7 Northeast approach end treatment

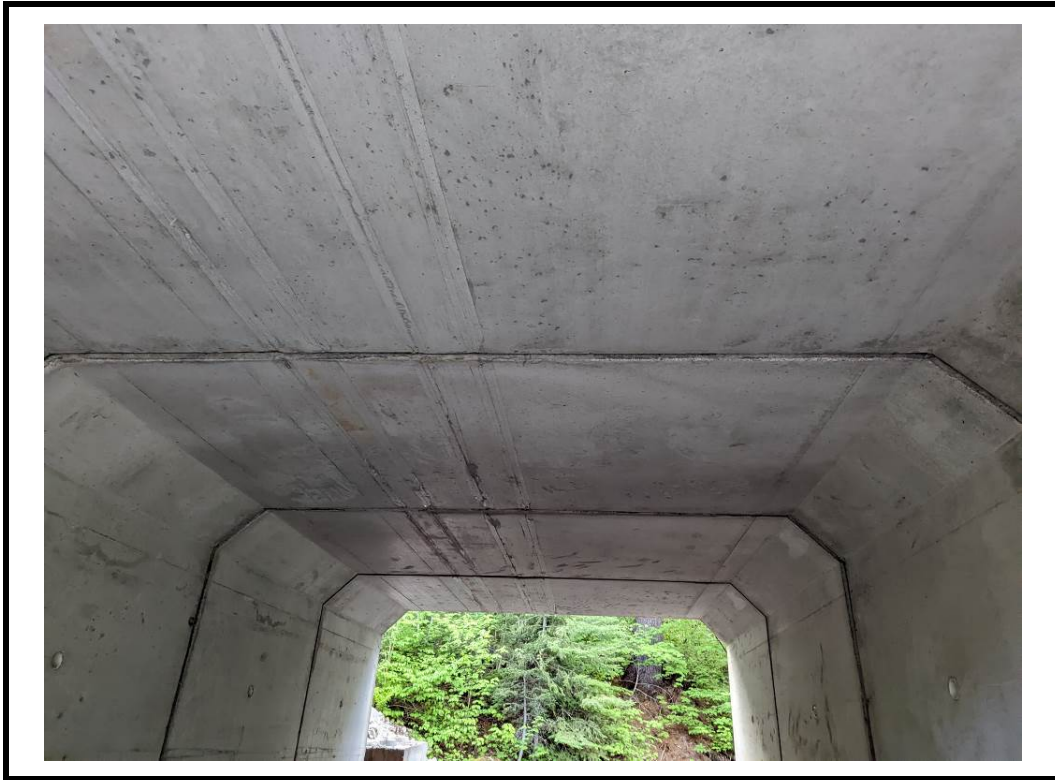
Photo 9 Culvert barrel soffit

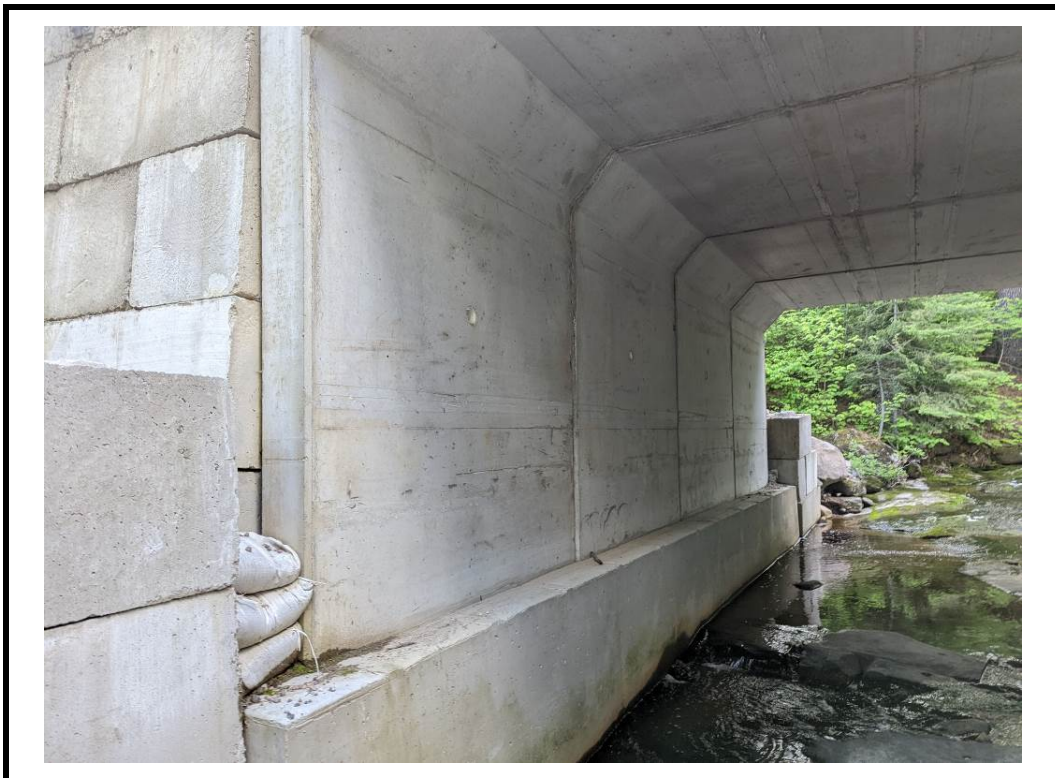
Photo 12 East abutment wall

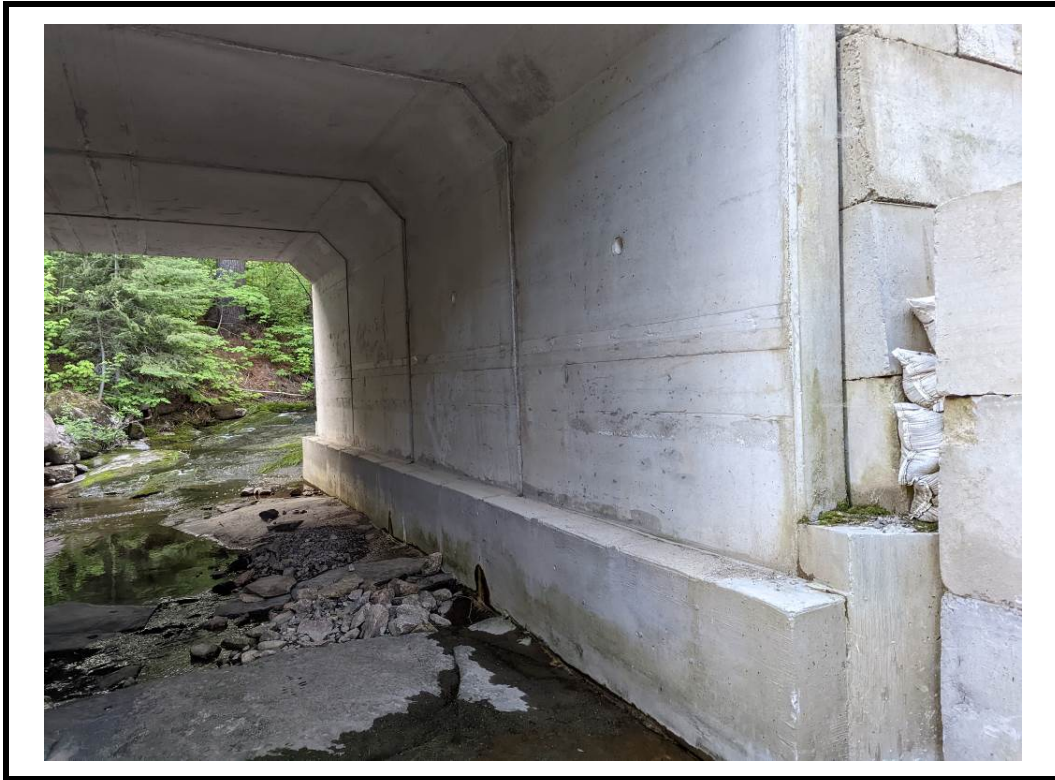
Photo 13 West abutment wall

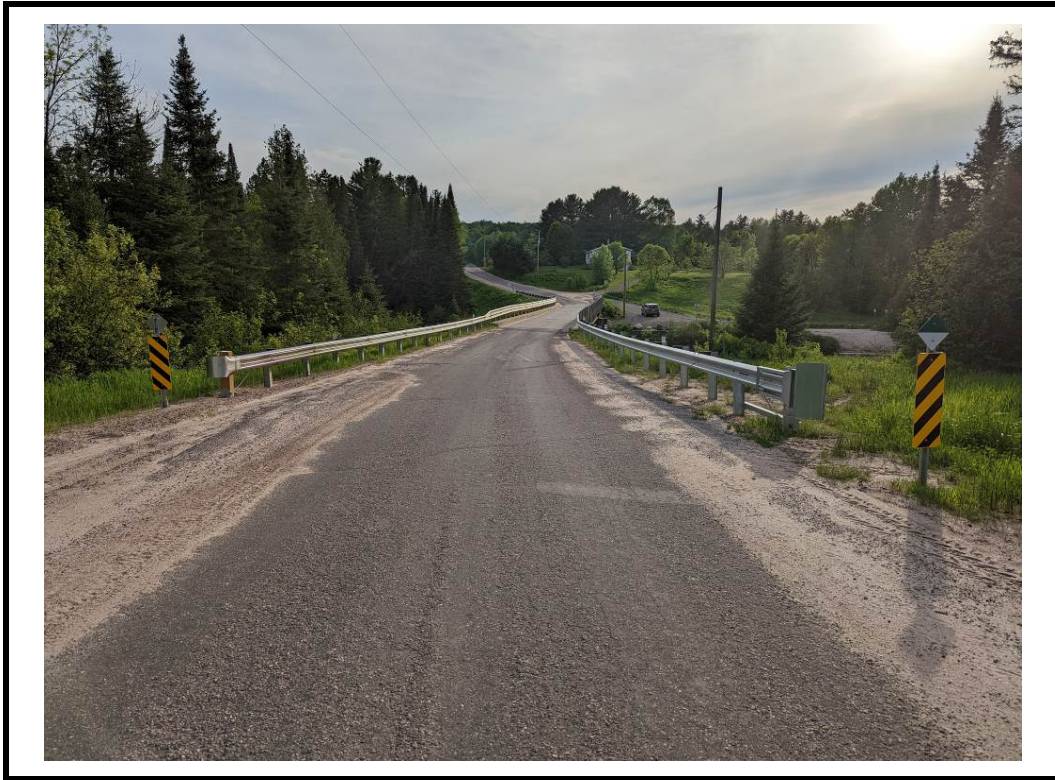
Photo 1 Structure from east approach

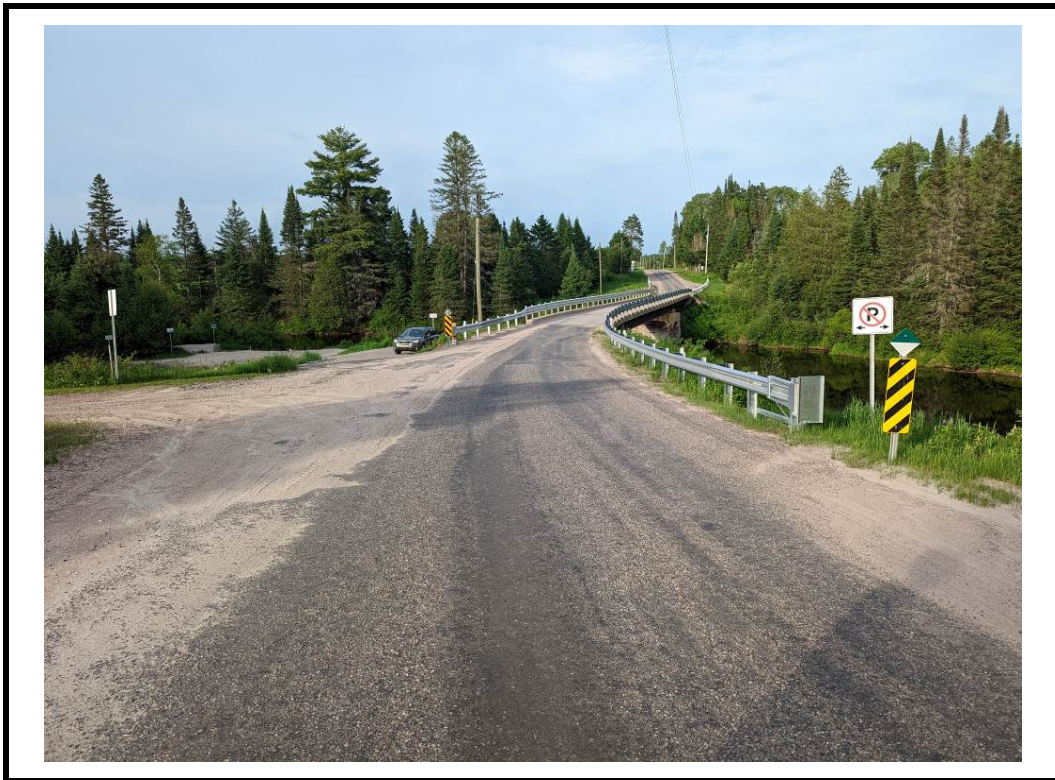
Photo 2 Structure from west approach

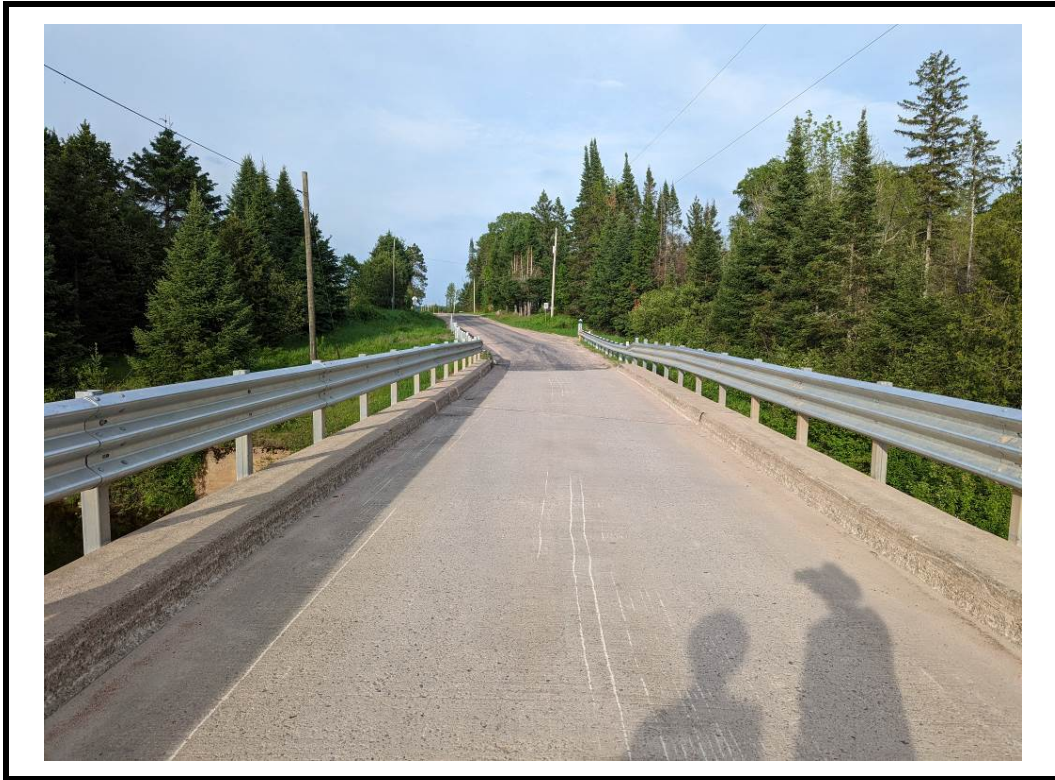
Photo 3 East approach from centre of structure

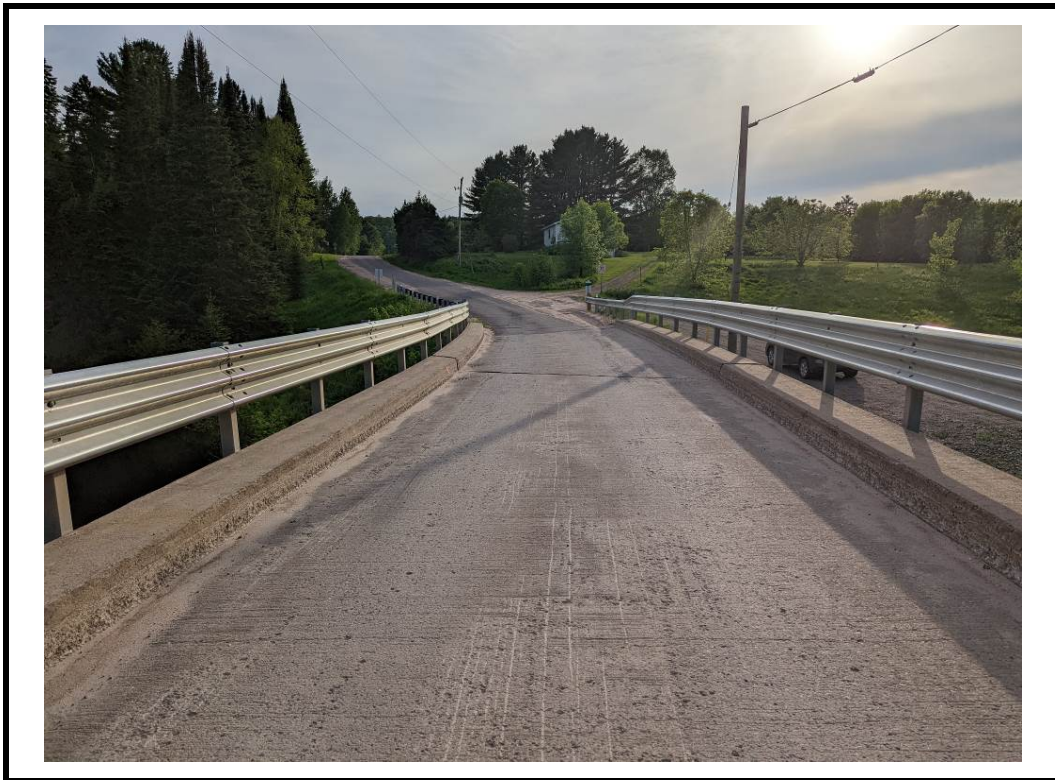
Photo 4 West approach from centre of structure

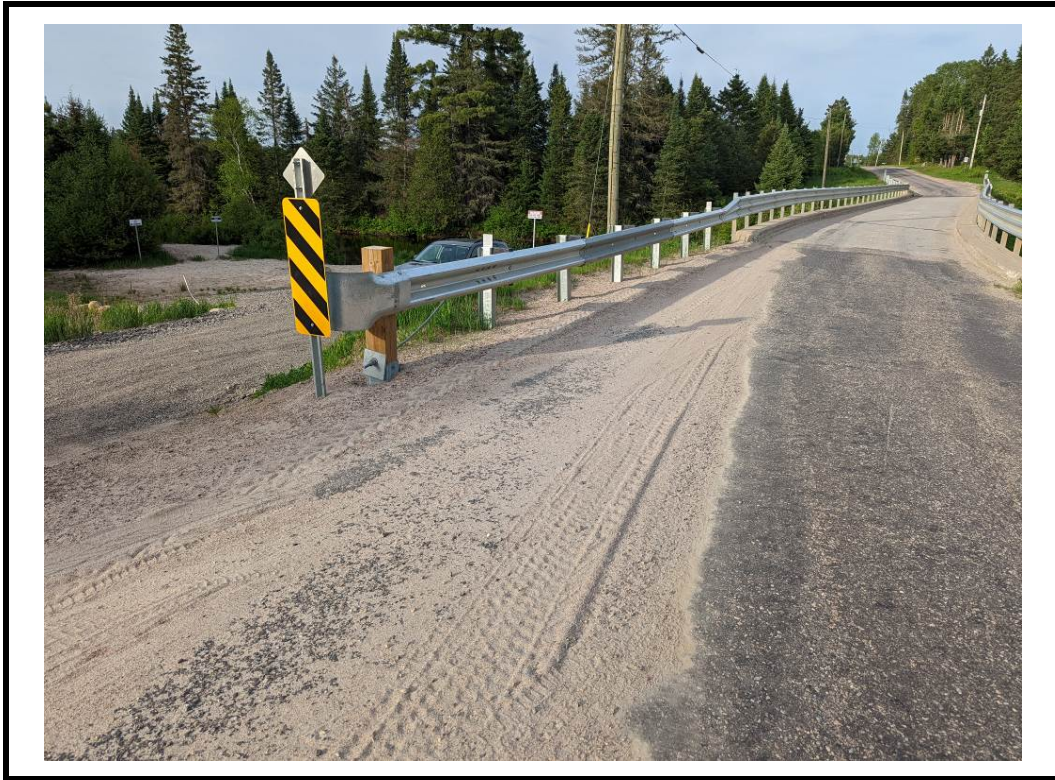
Photo 7 Typical approach barrier at northwest corner

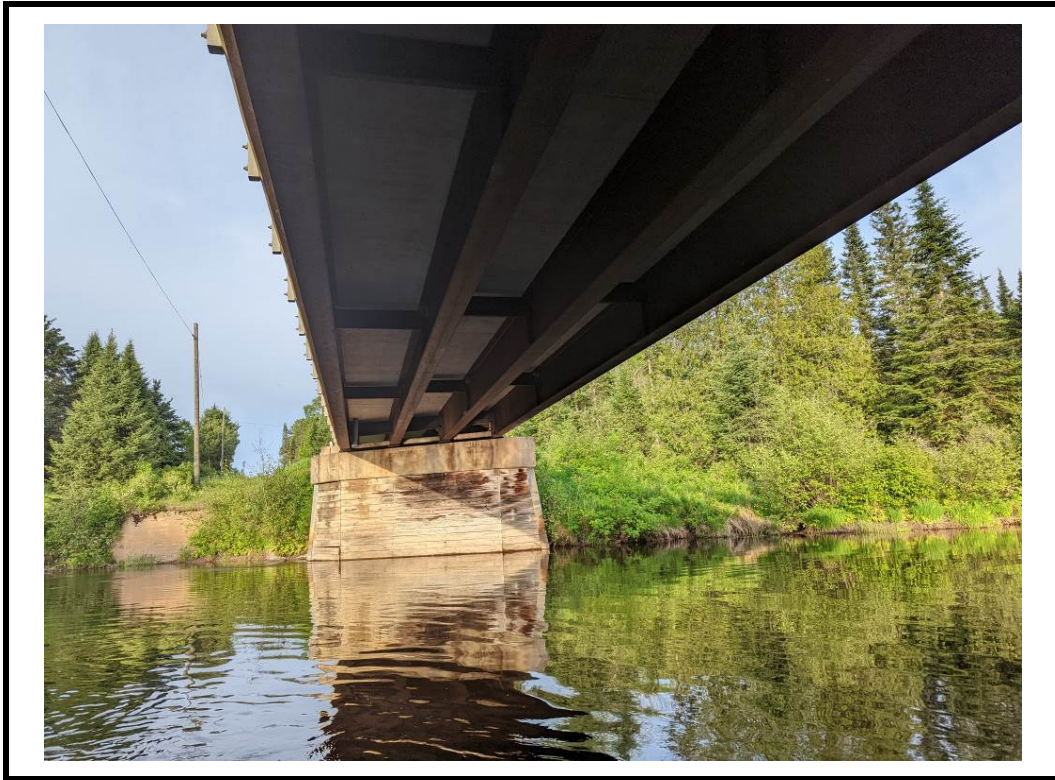
Photo 11 Middle span underside

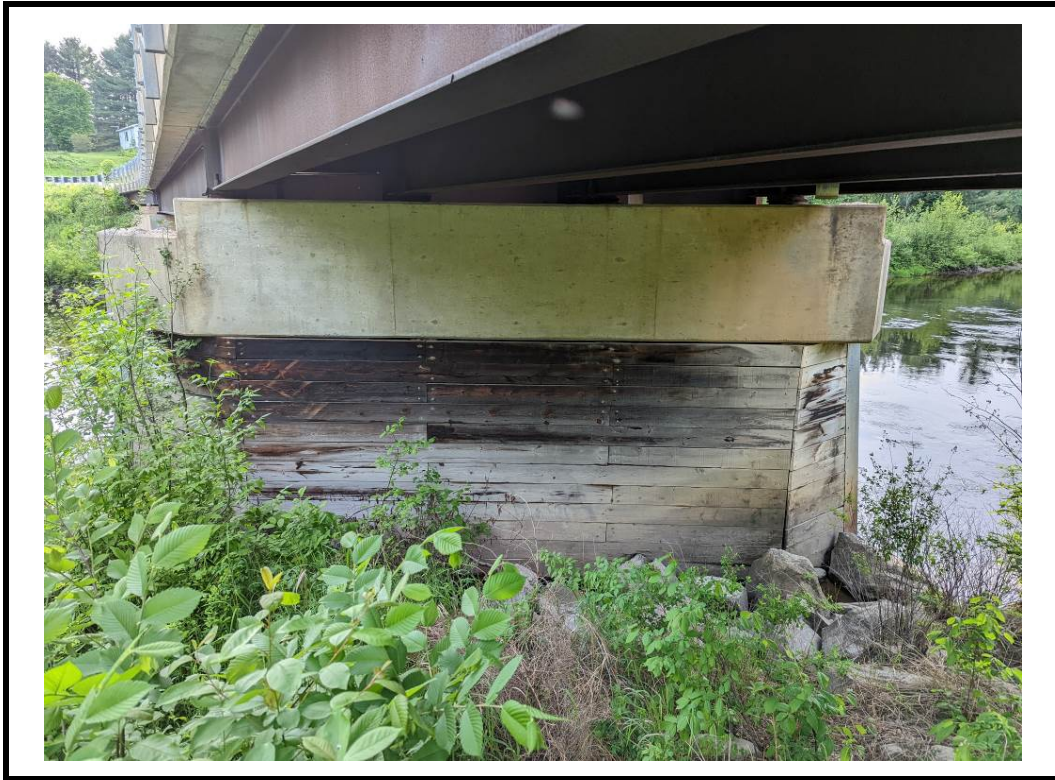
Photo 13 East pier and pier cap

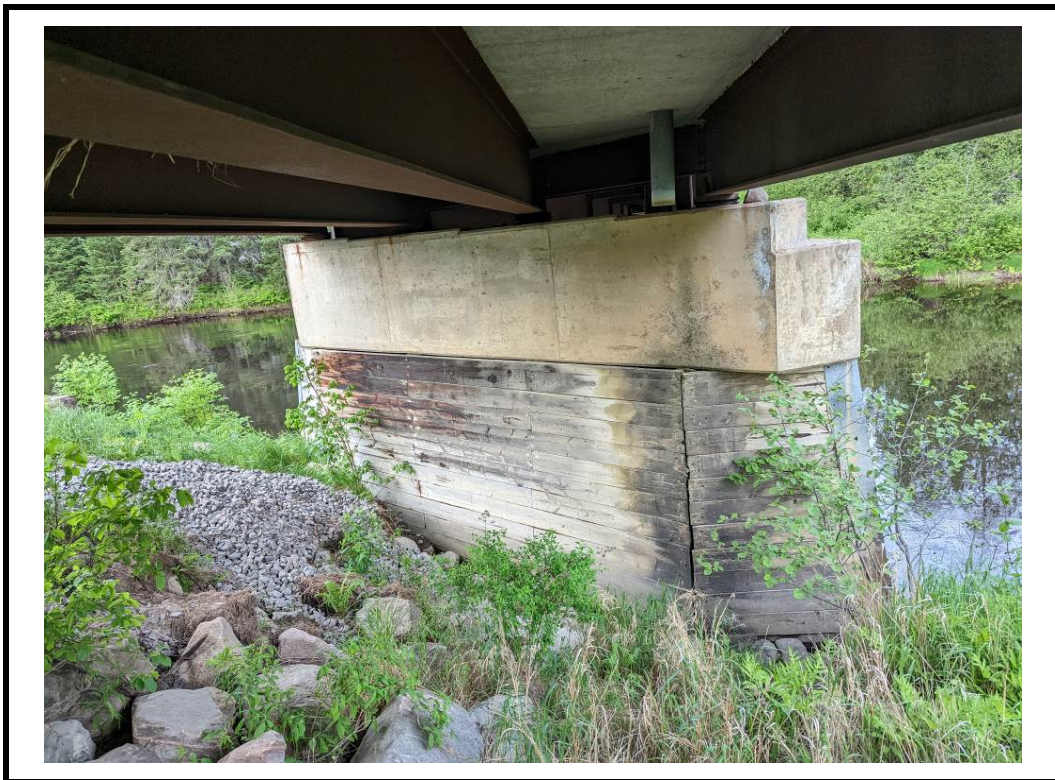
Photo 14 West pier and pier cap

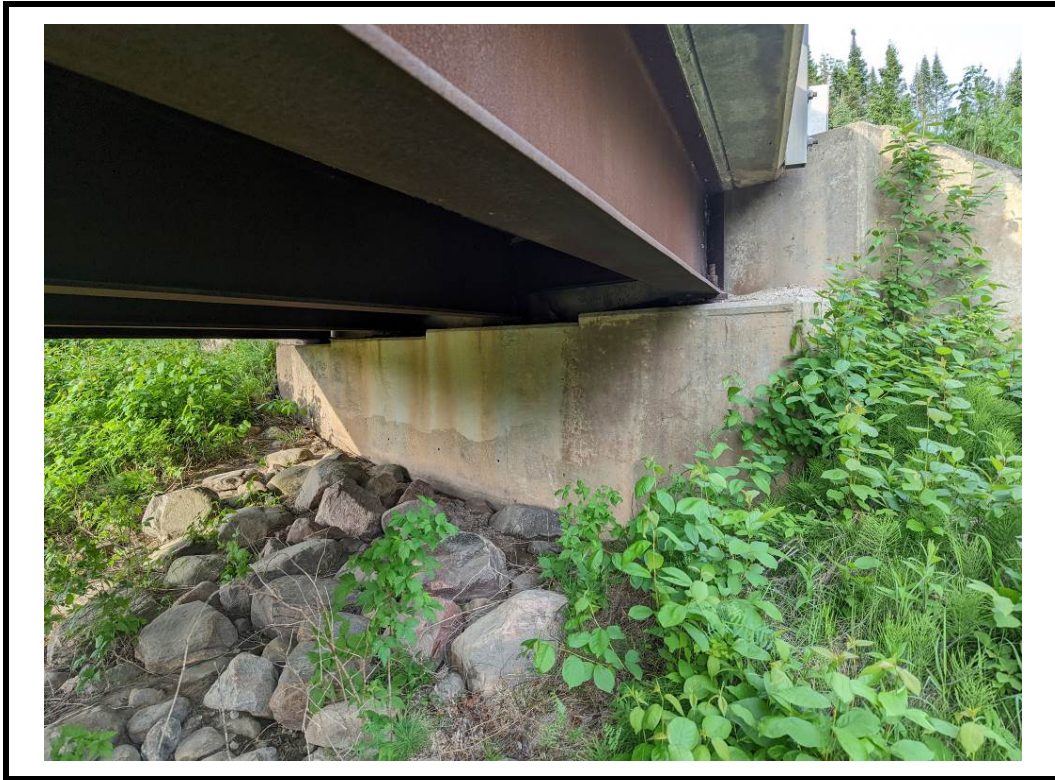
Photo 15 East abutment wall

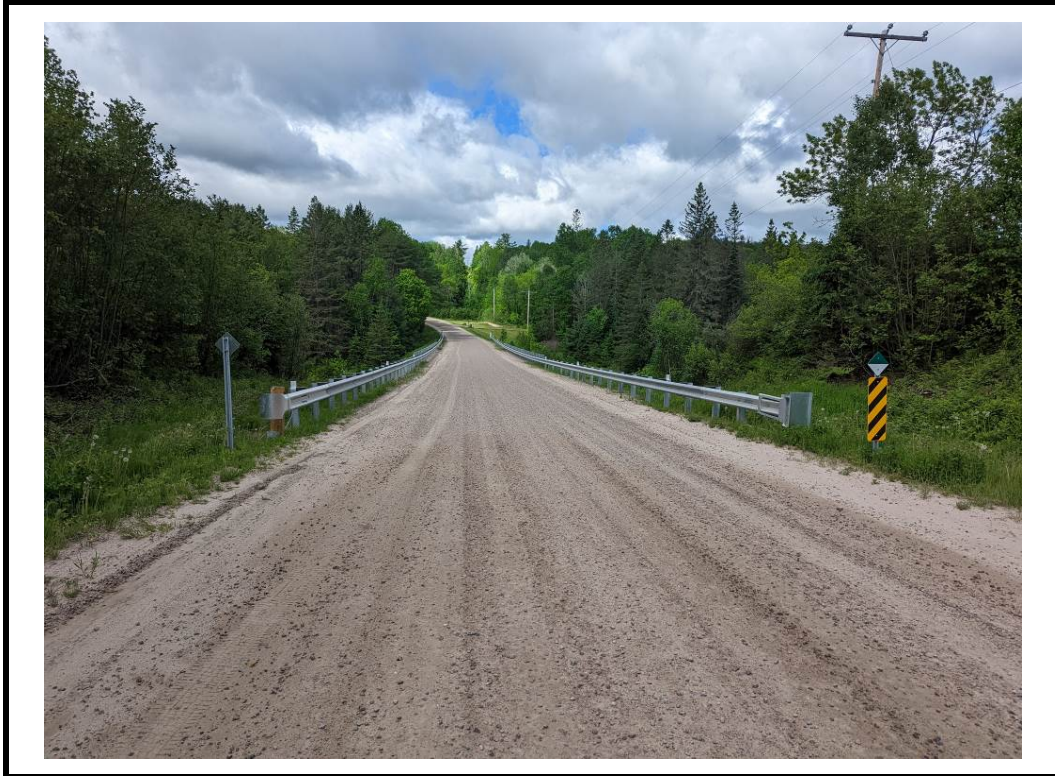
Photo 1 Structure from east approach

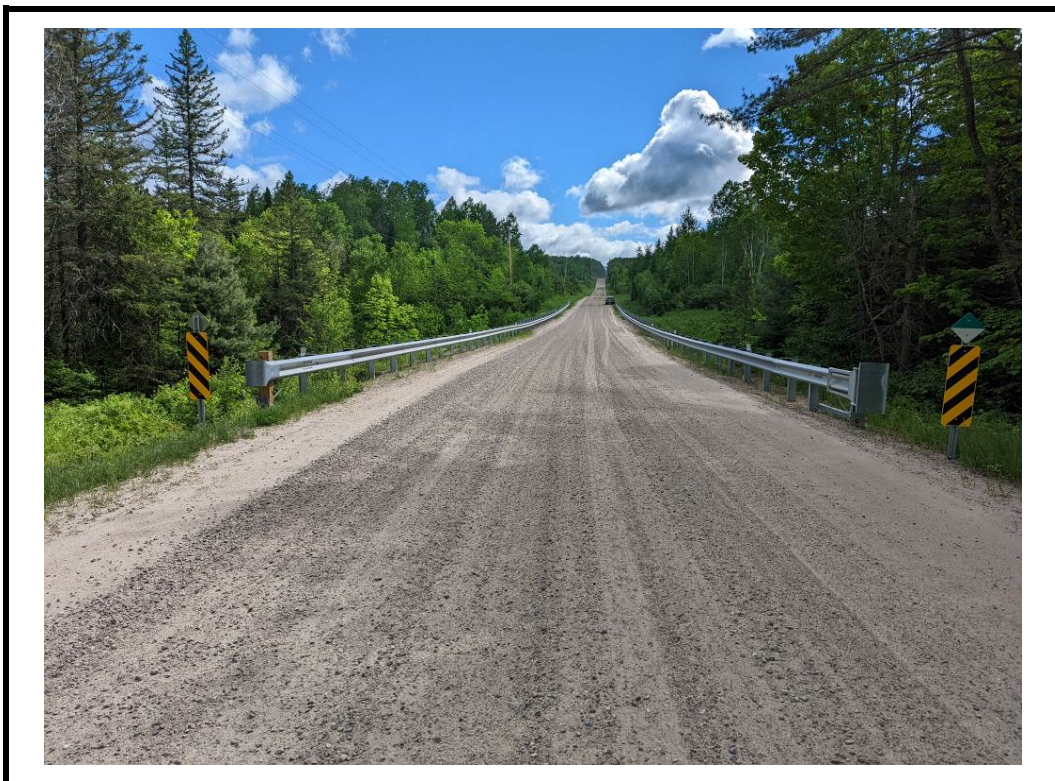
Photo 2 Structure from west approach

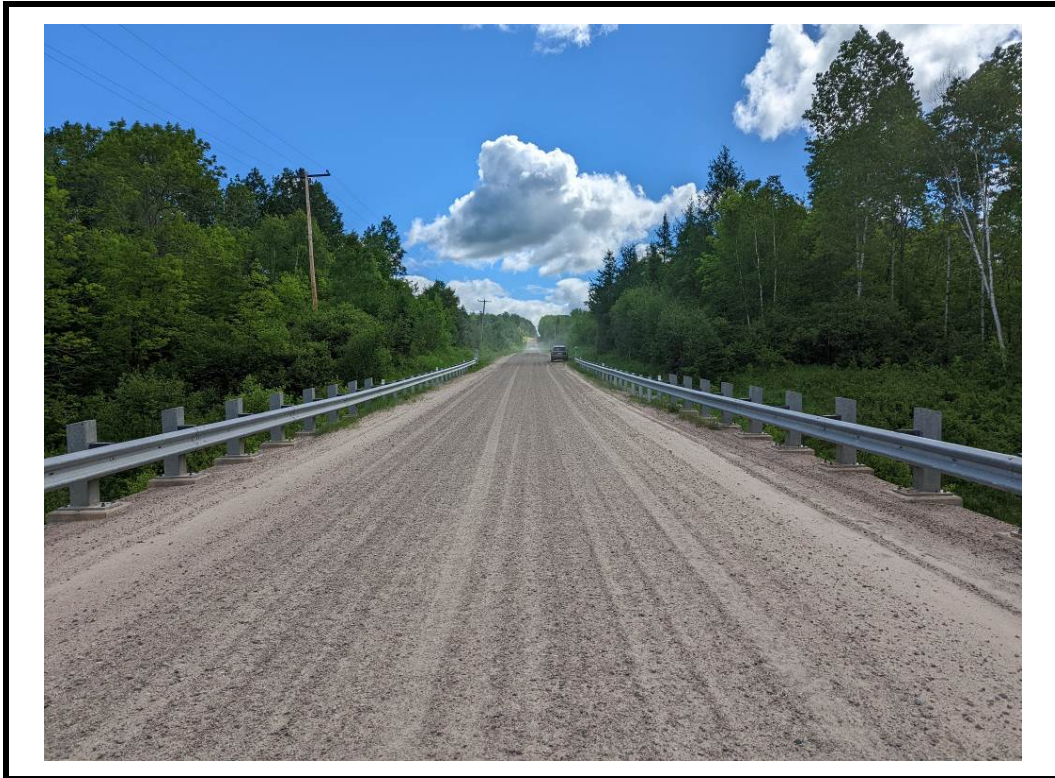
Photo 3 East approach from centre of structure

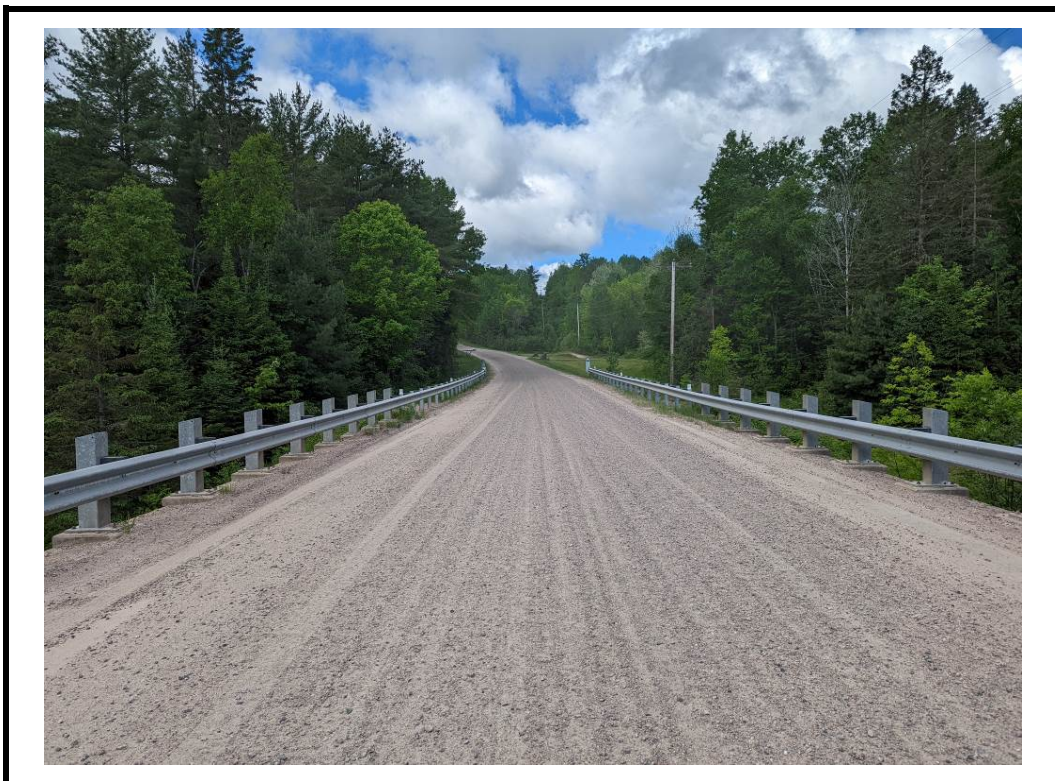
Photo 4 West approach from centre of structure

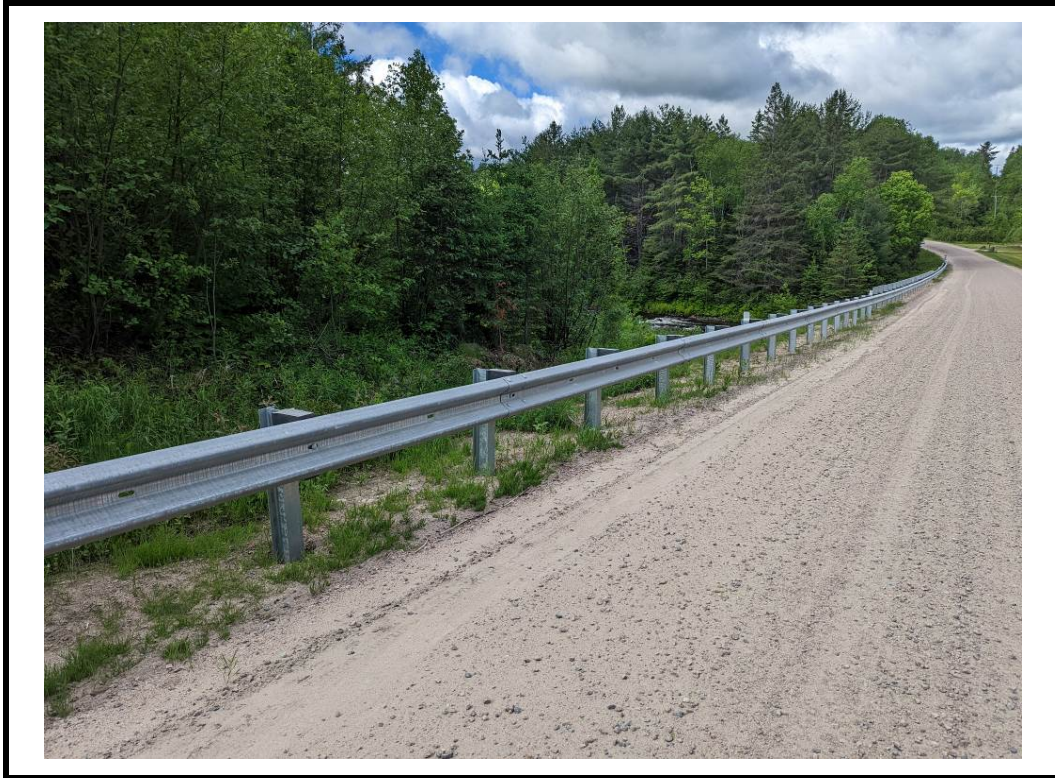
Photo 7 Typical approach barrier at southeast corner

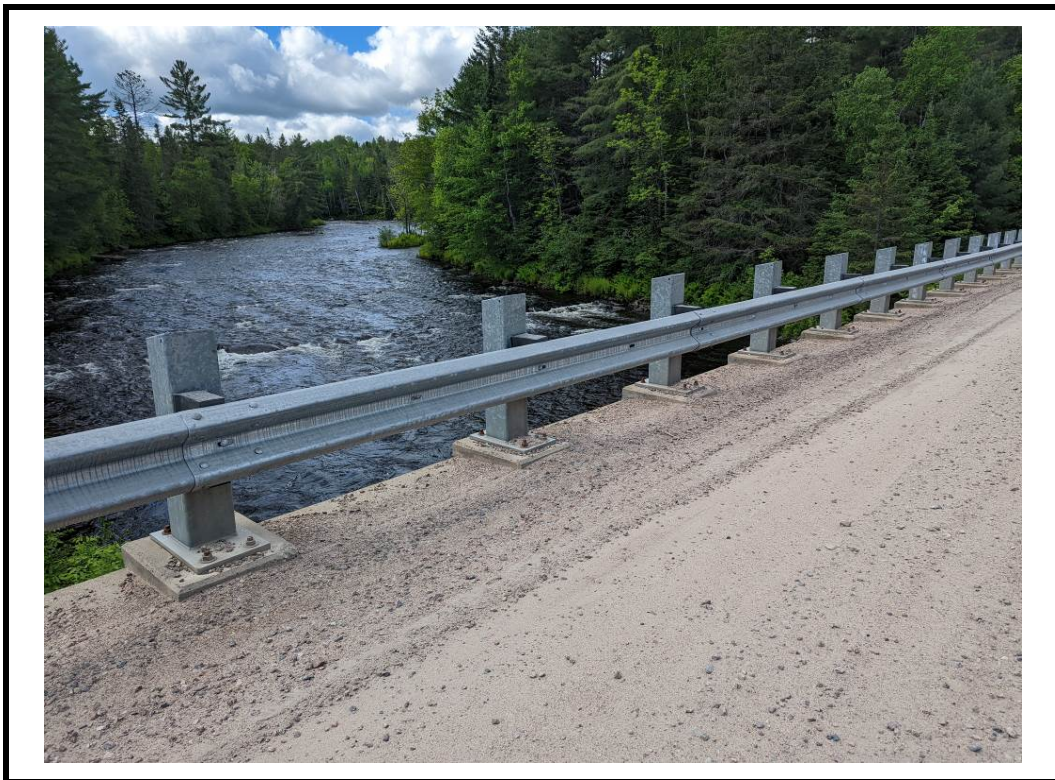
Photo 10 Typical deck barrier at south side of structure

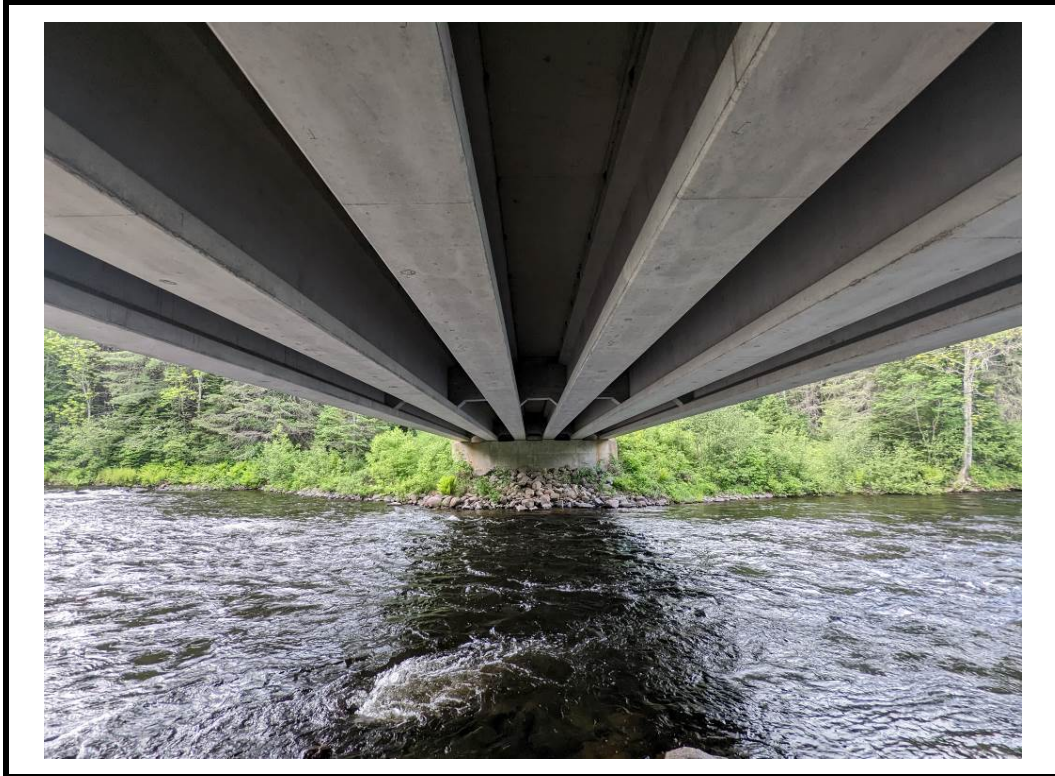
Photo 11 Underside of Structure

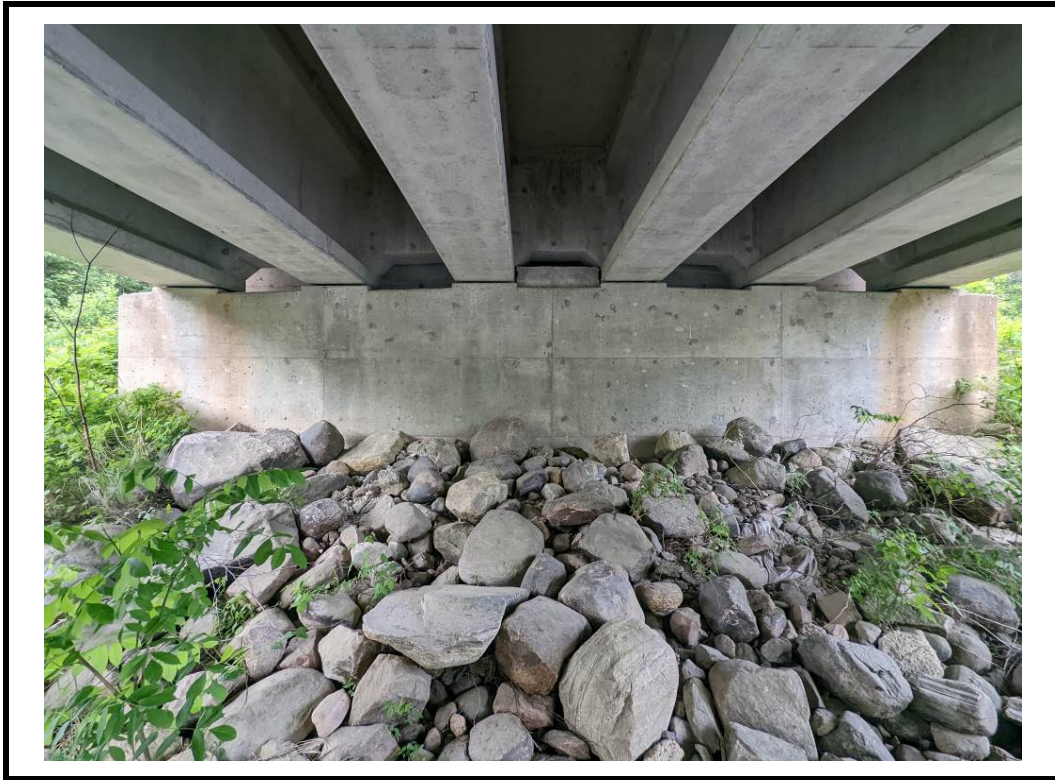
Photo 13 East abutment wall

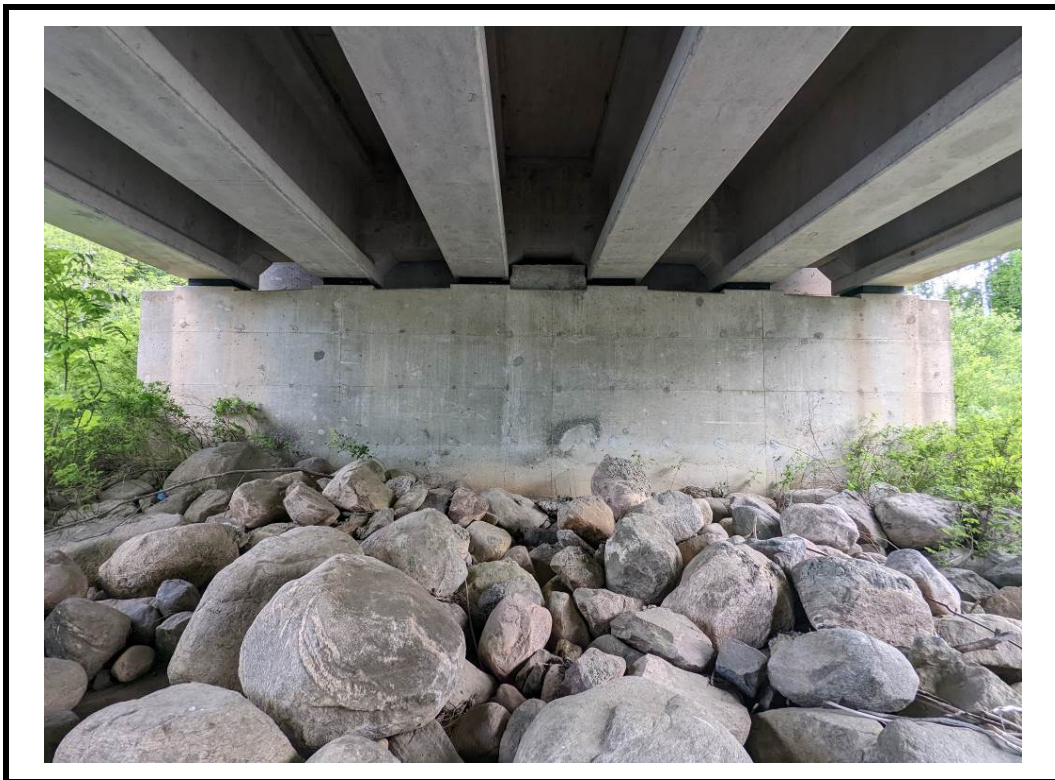
Photo 14 West abutment wall

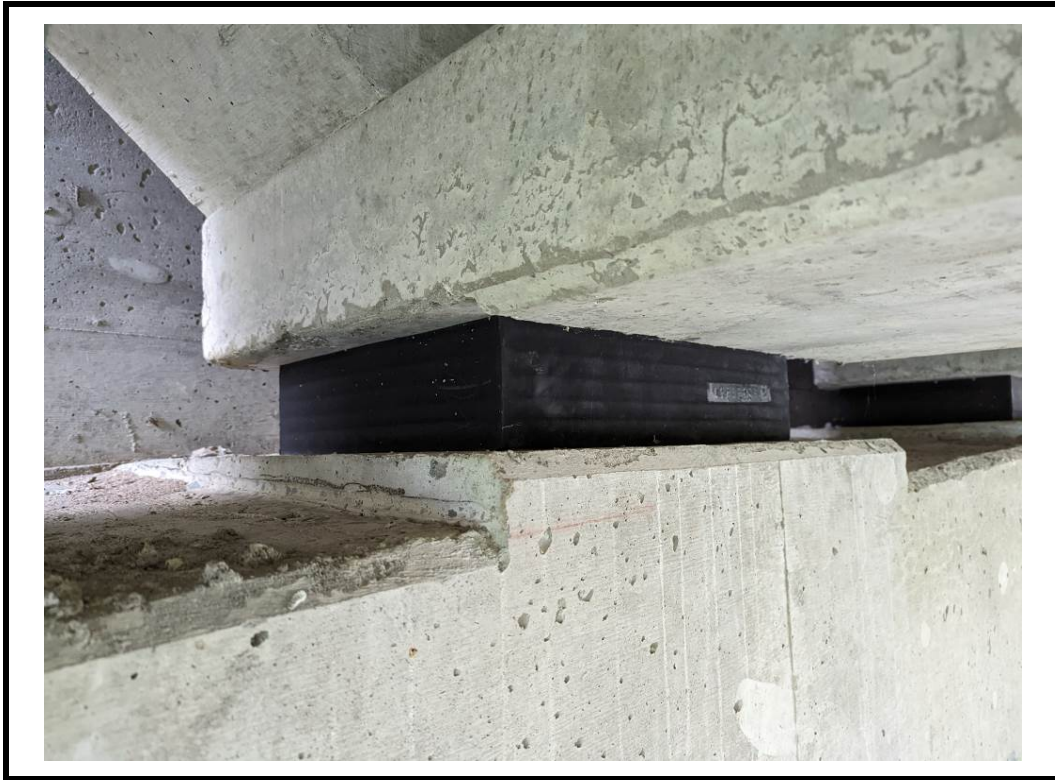
Photo 15 Typical bearing at east abutment wall

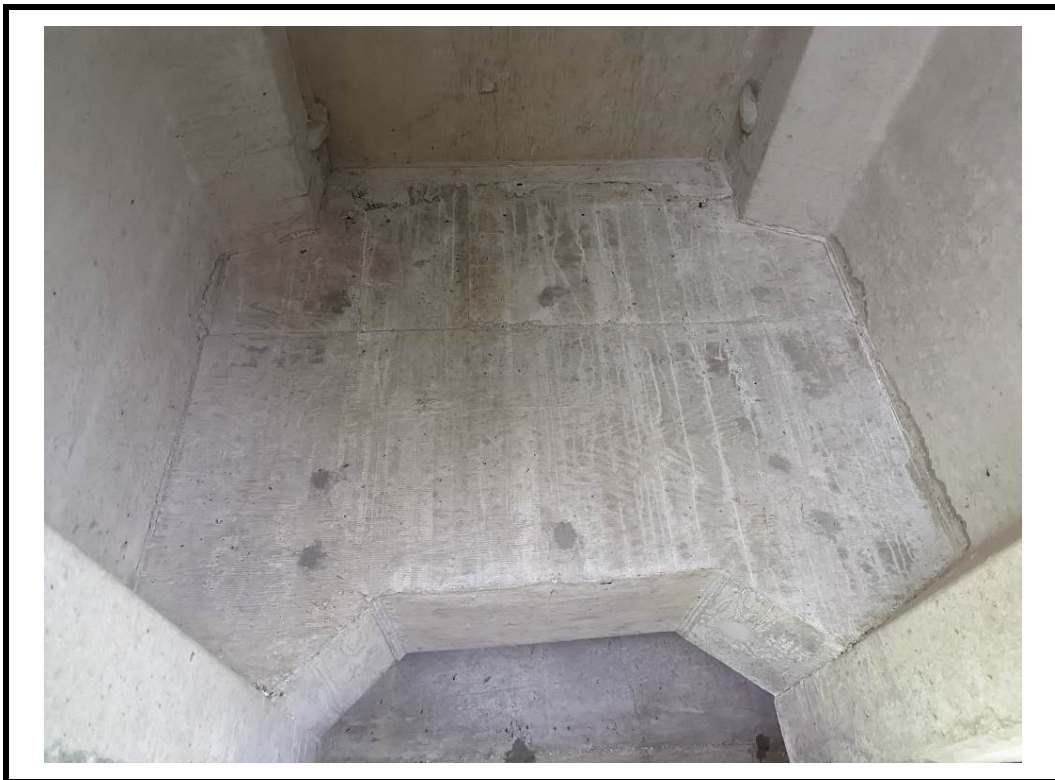
Photo 16 Typical view of diaphragm at west

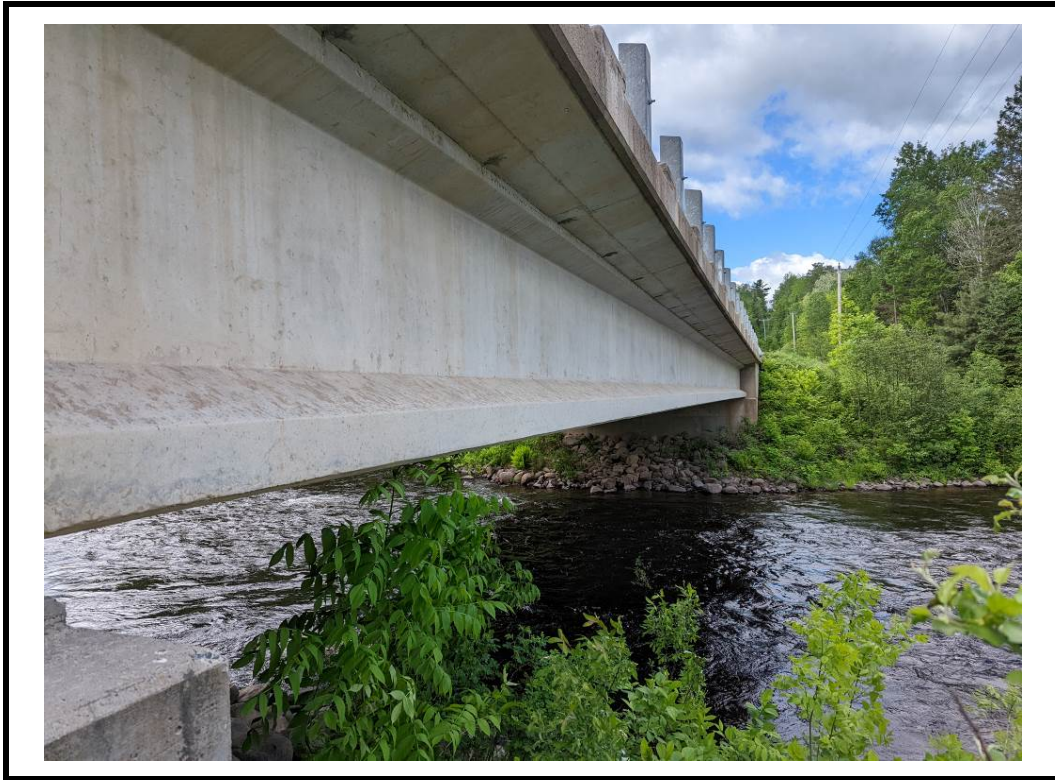
Photo 17 Typical view of exterior girder at north side
