THE TOWNSHIP OF CALVIN

BRIDGE MANAGEMENT STUDY REPORT (FINAL)

6 BRIDGES

NOVEMBER 2023

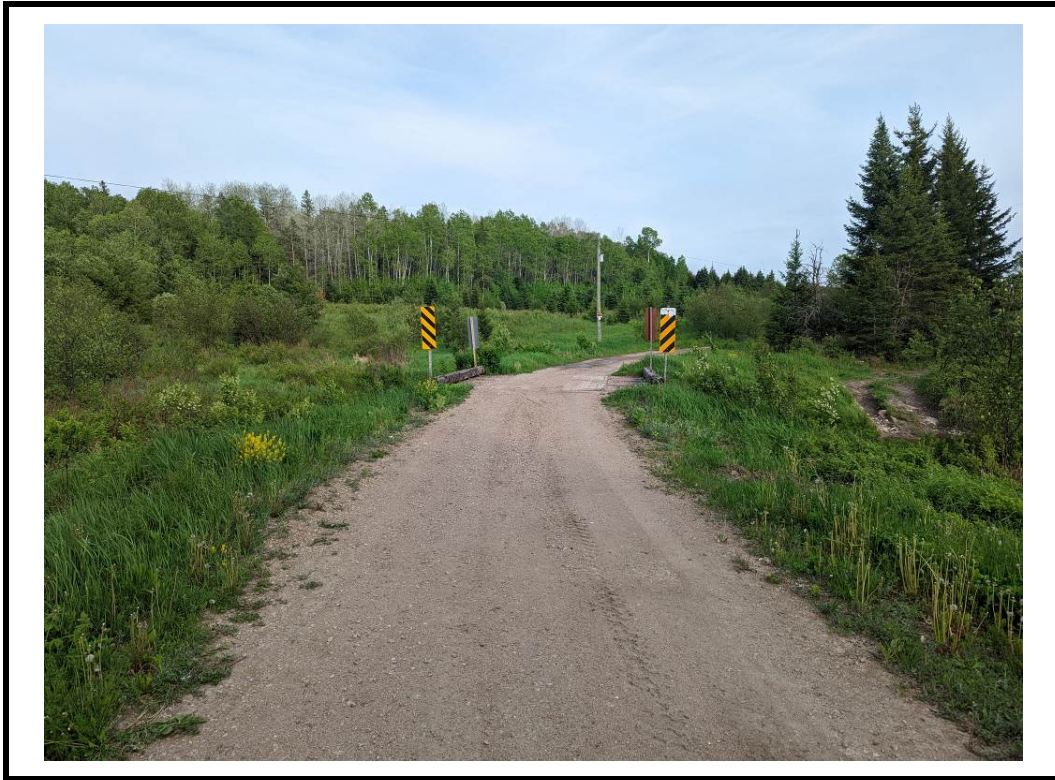
Photo 1 Structure from north approach

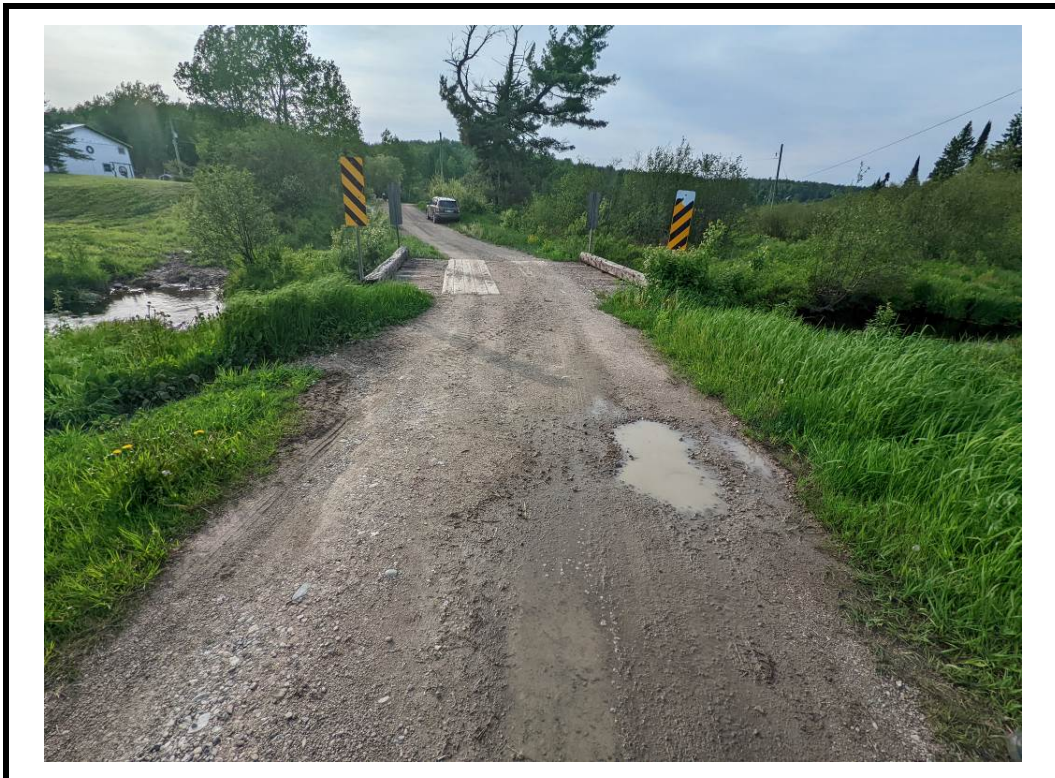
Photo 2 Structure from south approach

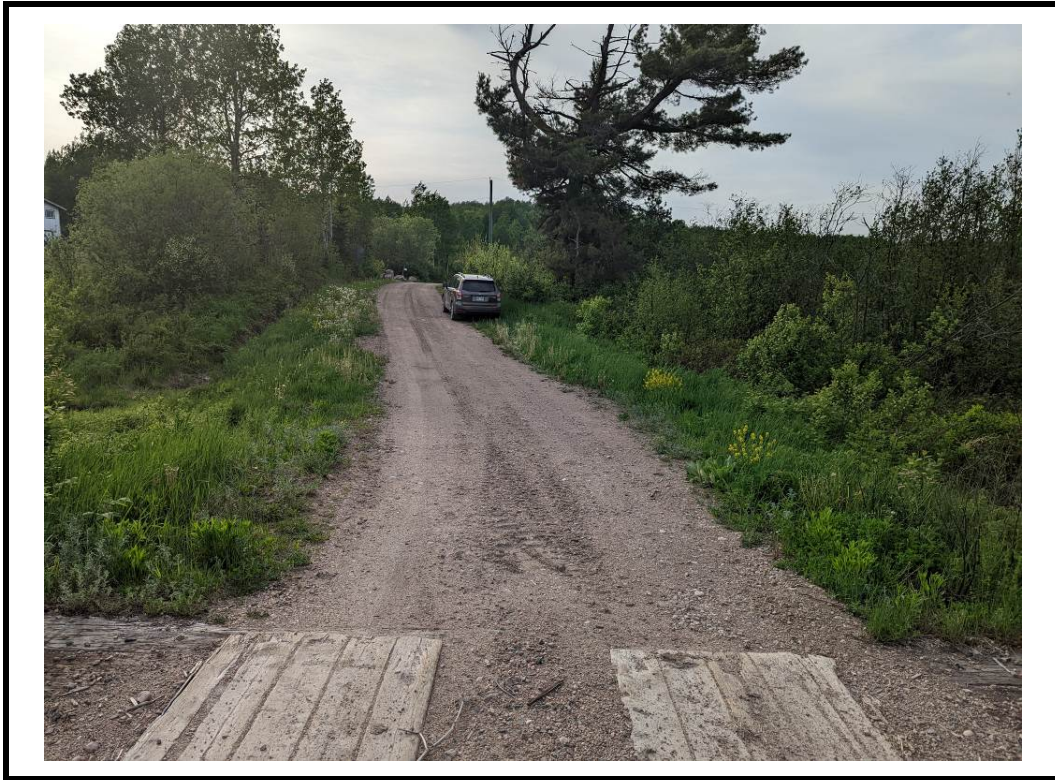
Photo 3 North approach from centre of structure

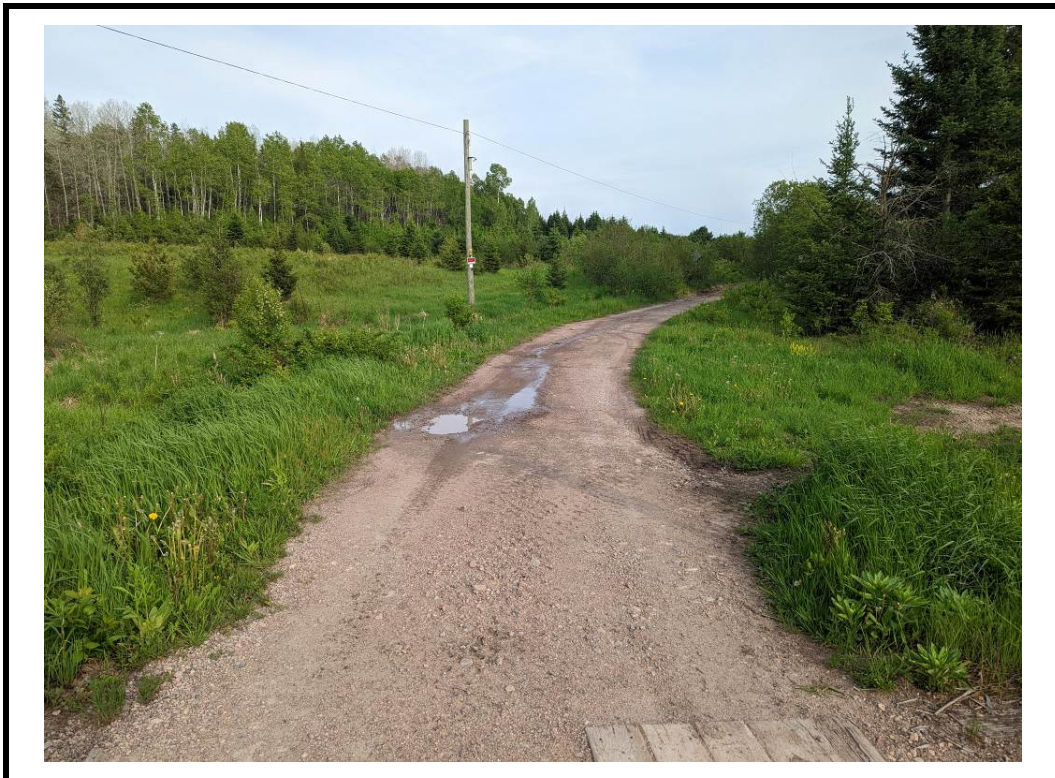
Photo 4 South approach from centre of structure

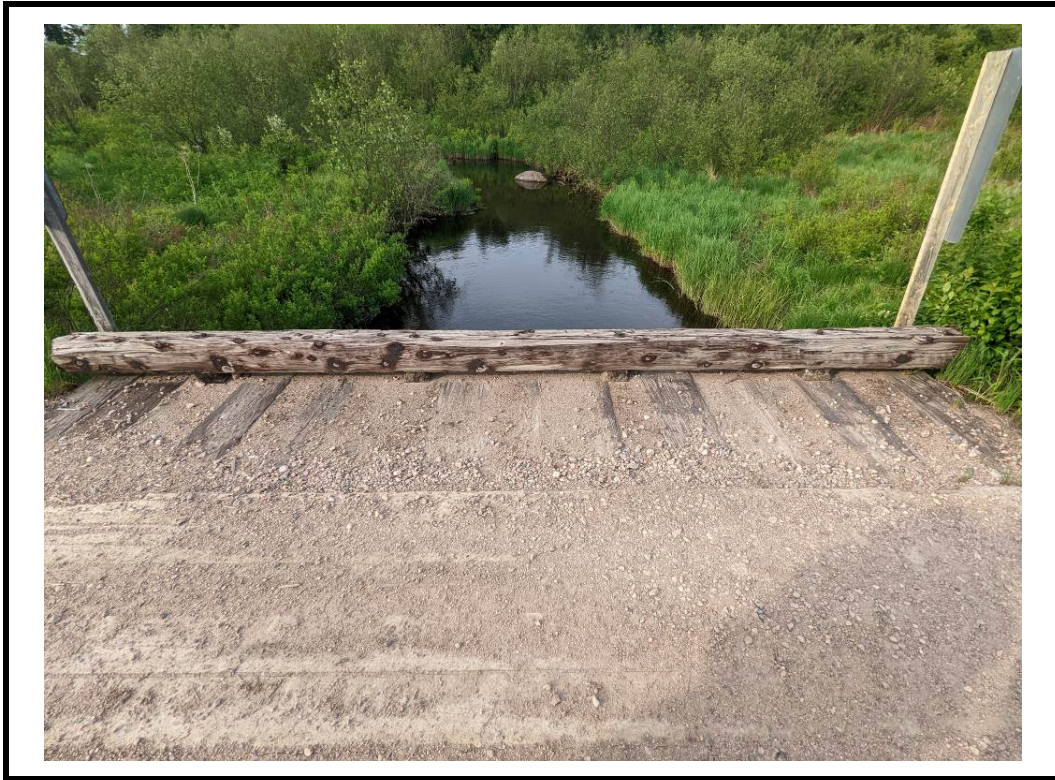
Photo 9 Deck wearing surface

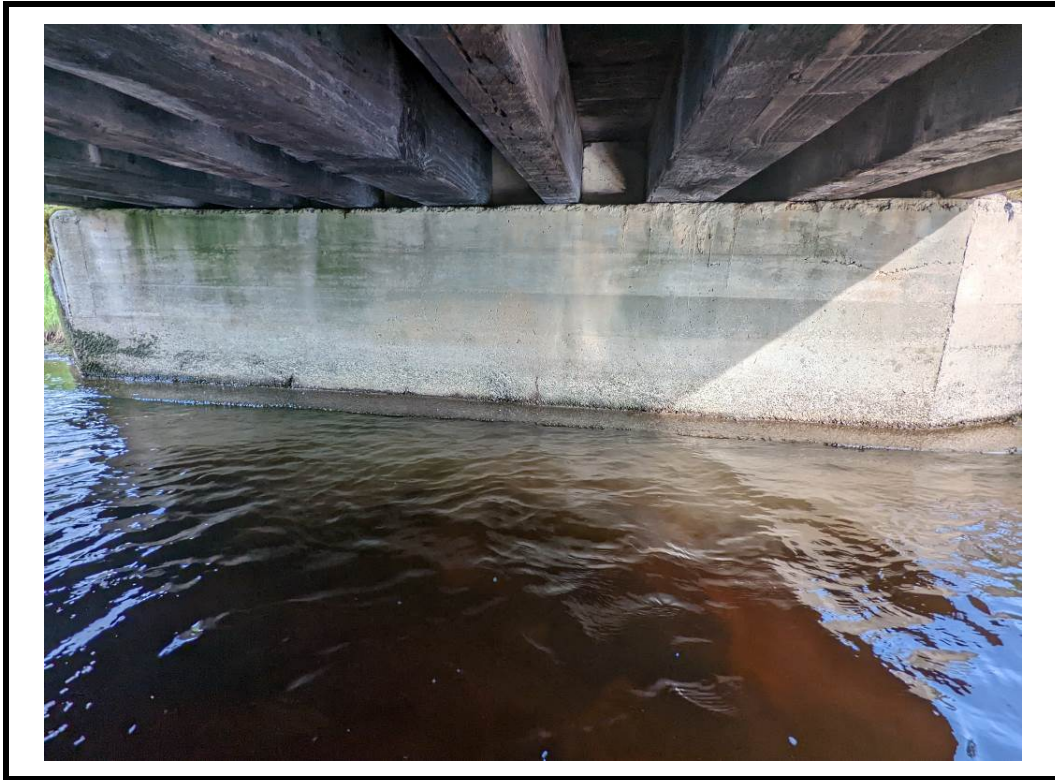
Photo 13 South abutment wall

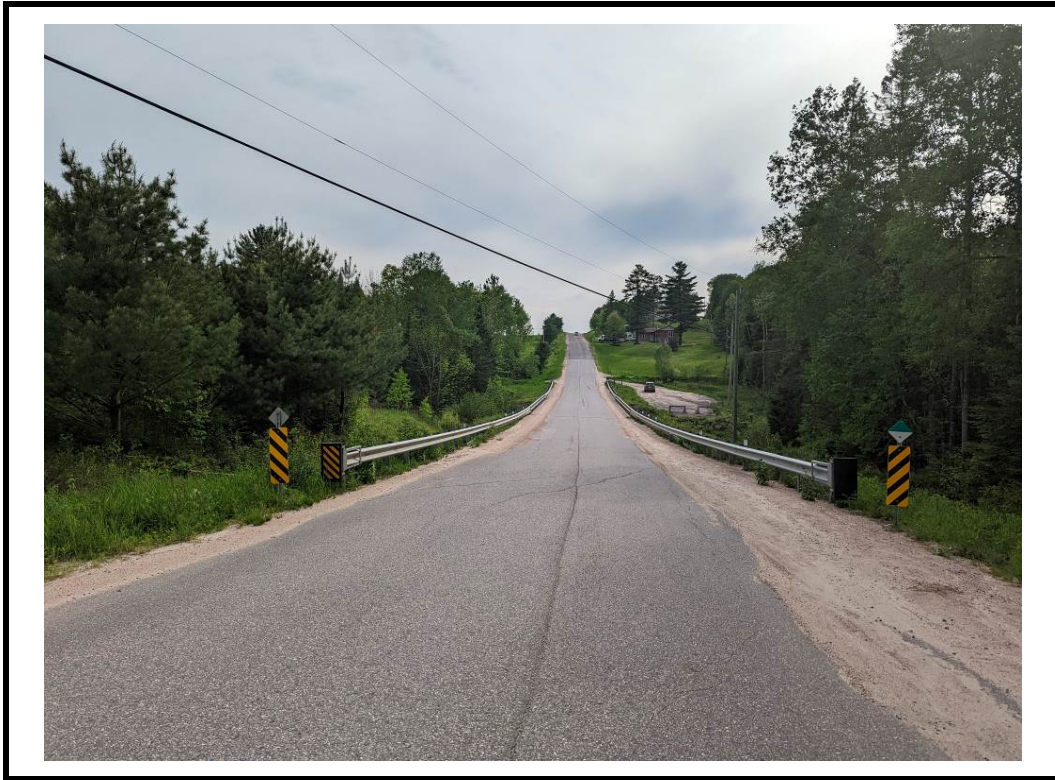
Photo 1 Structure from east approach

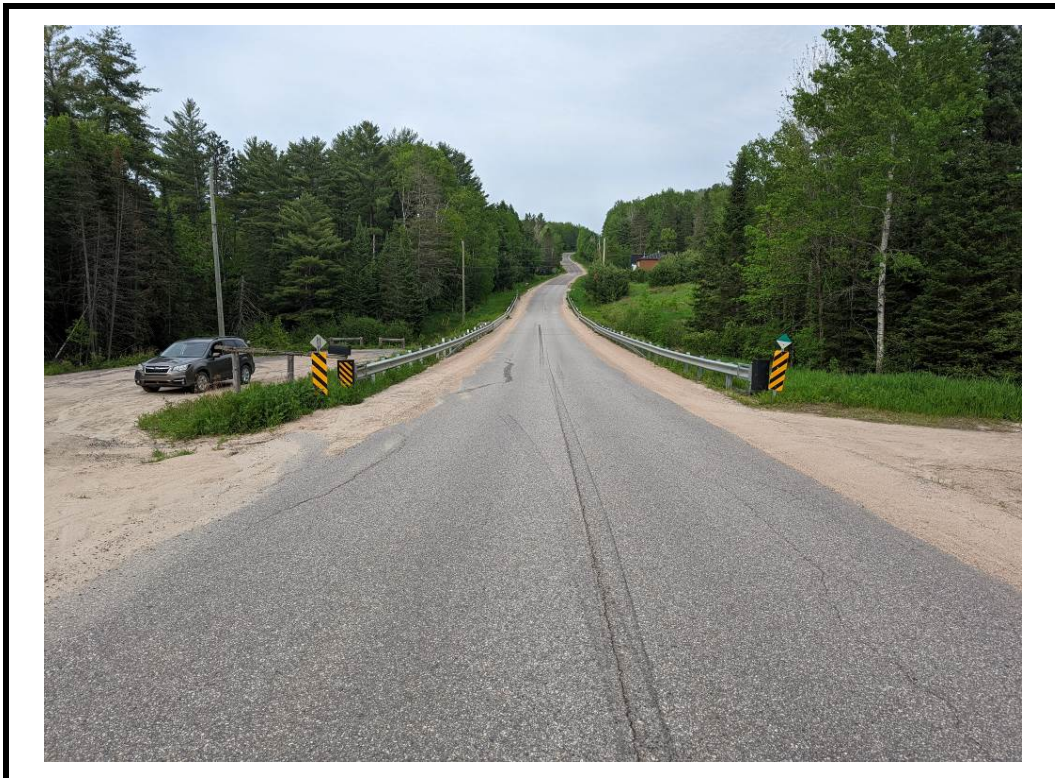
Photo 2 Structure from west approach

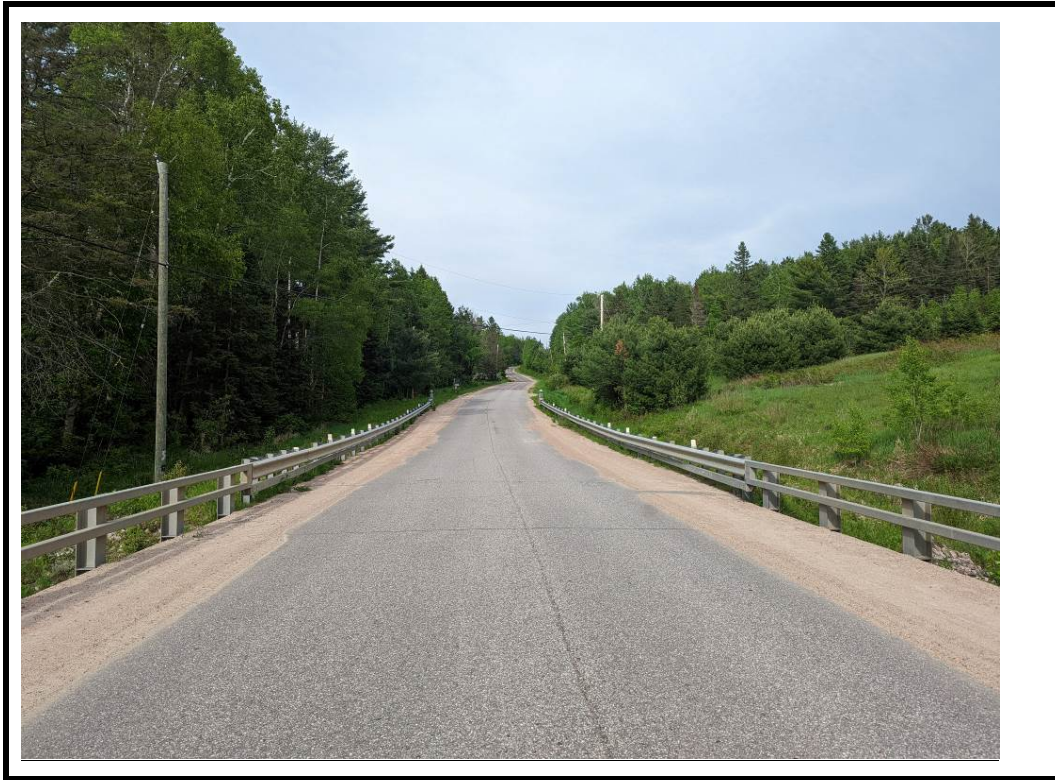
Photo 3 East approach from centre of structure

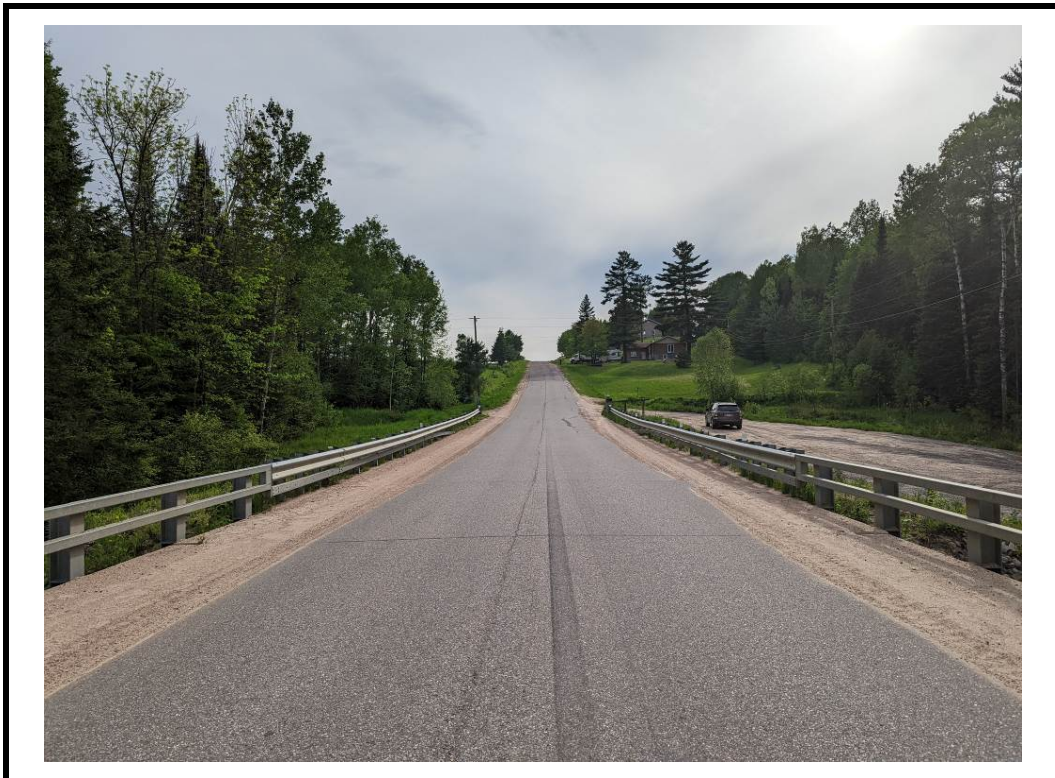
Photo 4 West approach from centre of structure

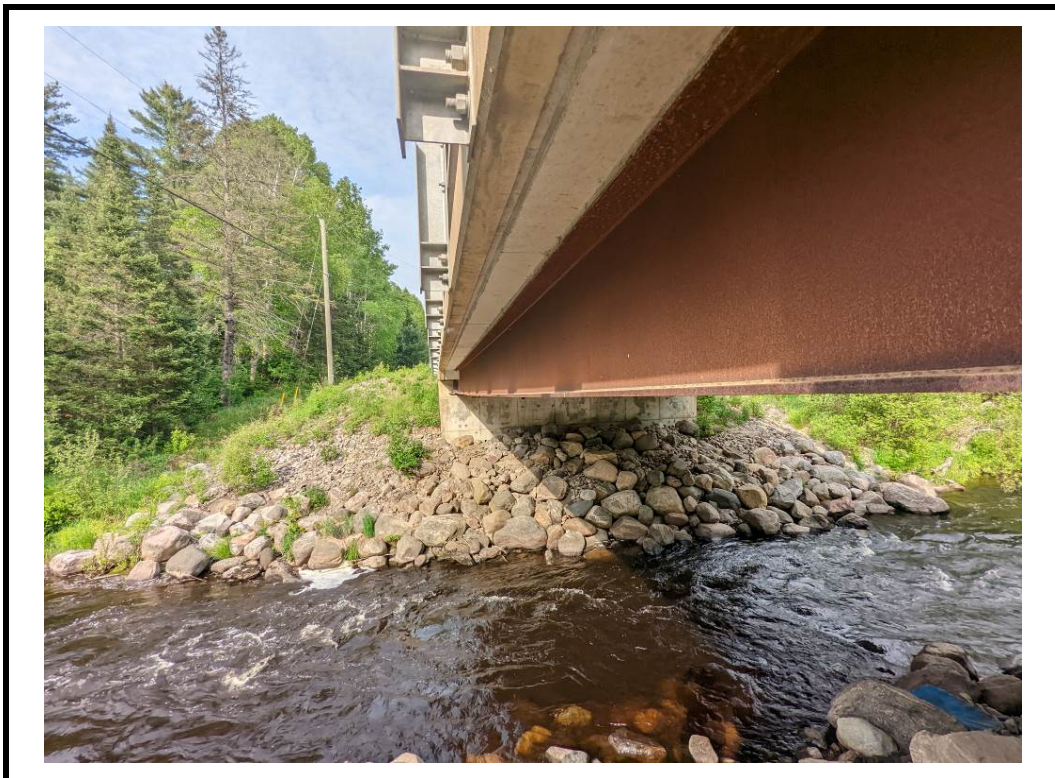
Photo 8 Typical end of steel girder at south side of structure

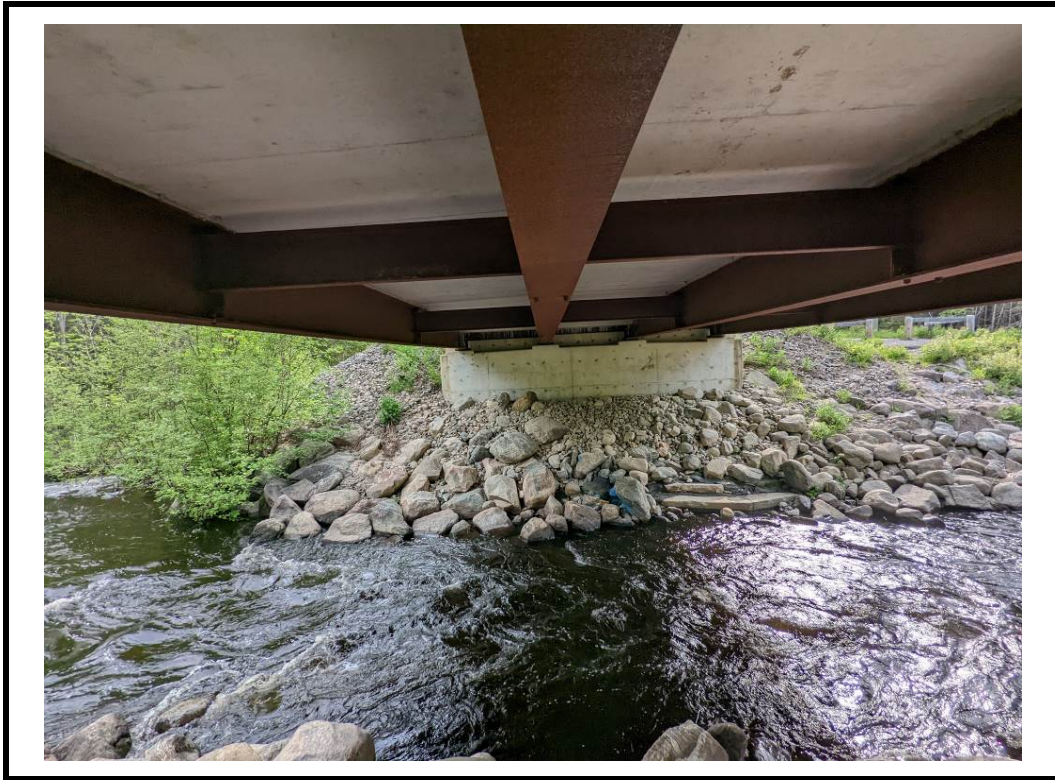
Photo 9 East underside of structure

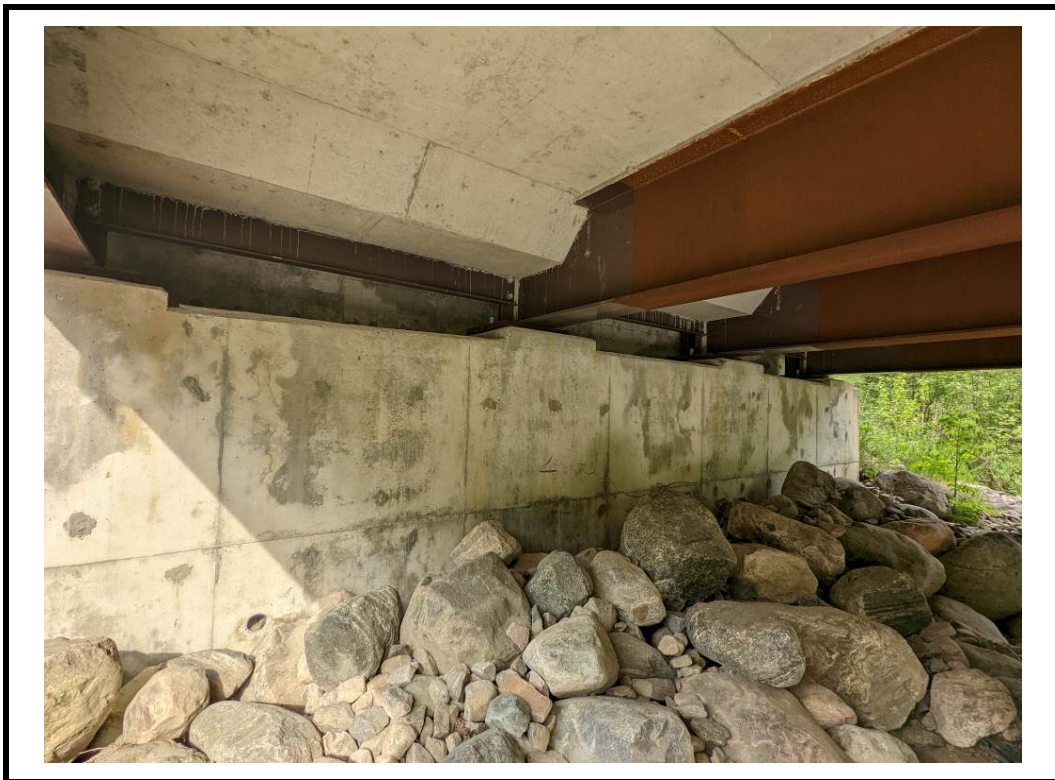
Photo 10 East abutment wall

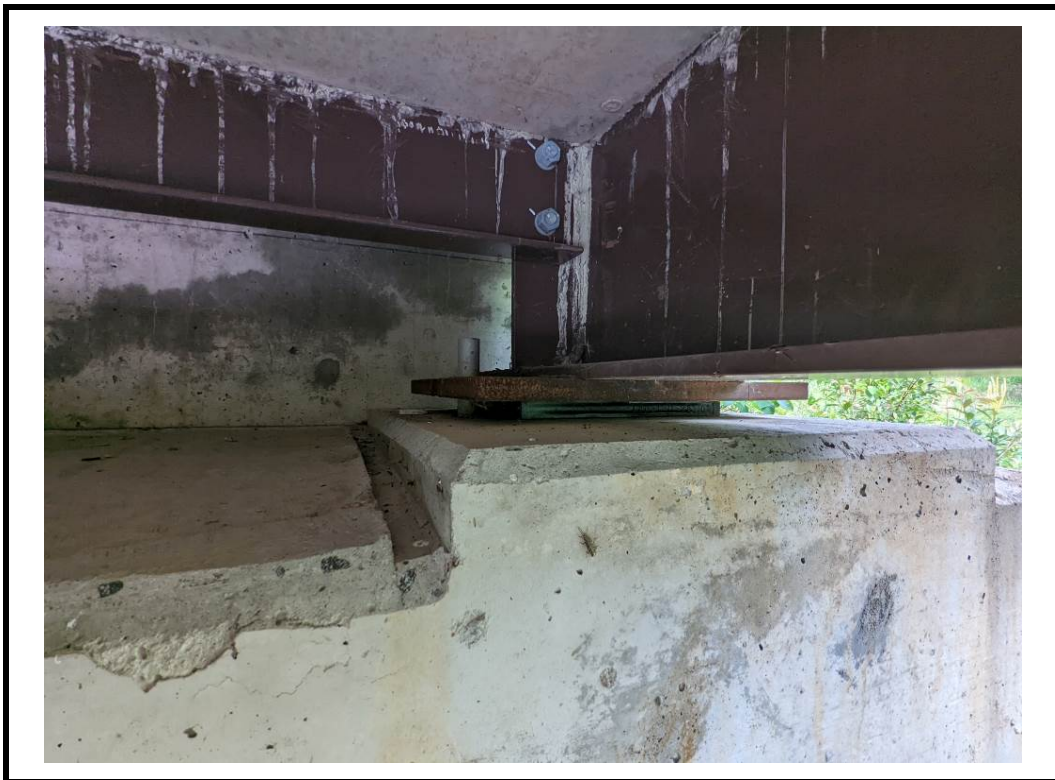
Photo 12 Typical bearing at southeast corner

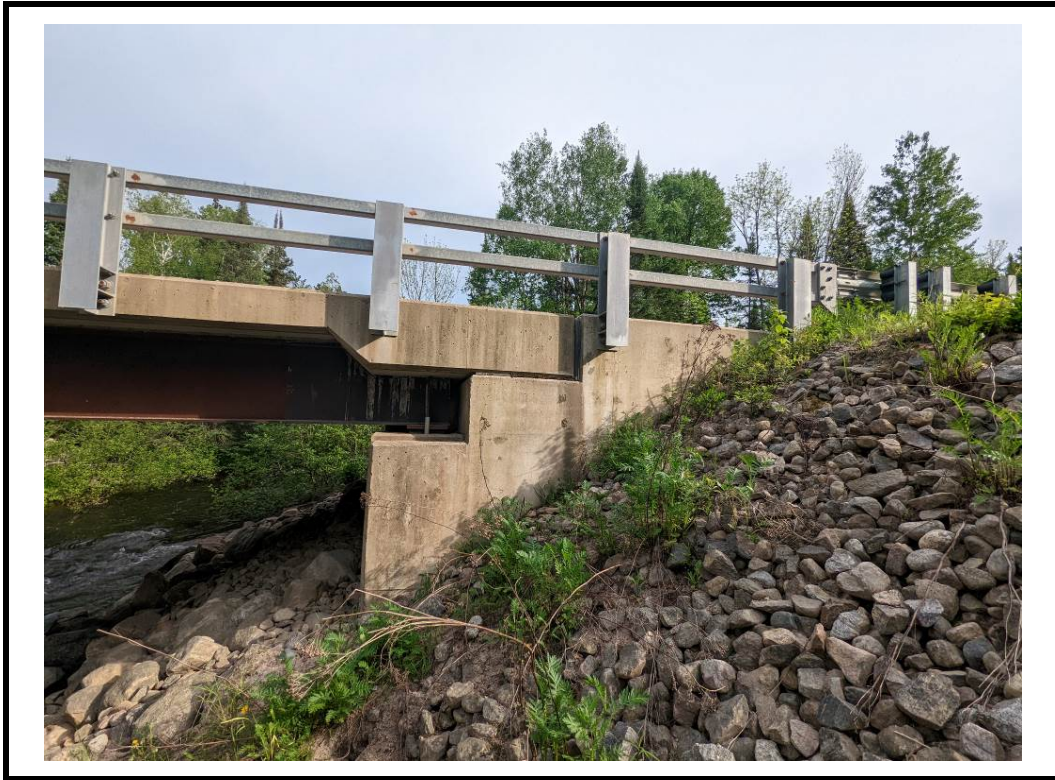
Photo 13 Typical southeast wingwall

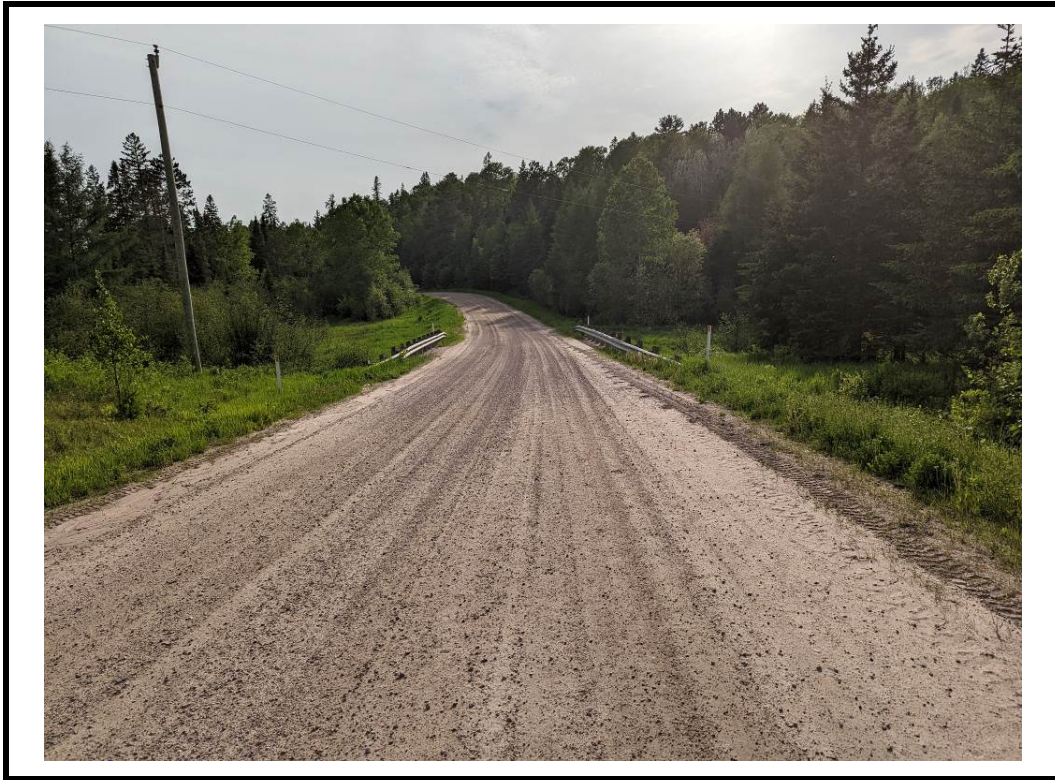
Photo 1 Structure from east approach

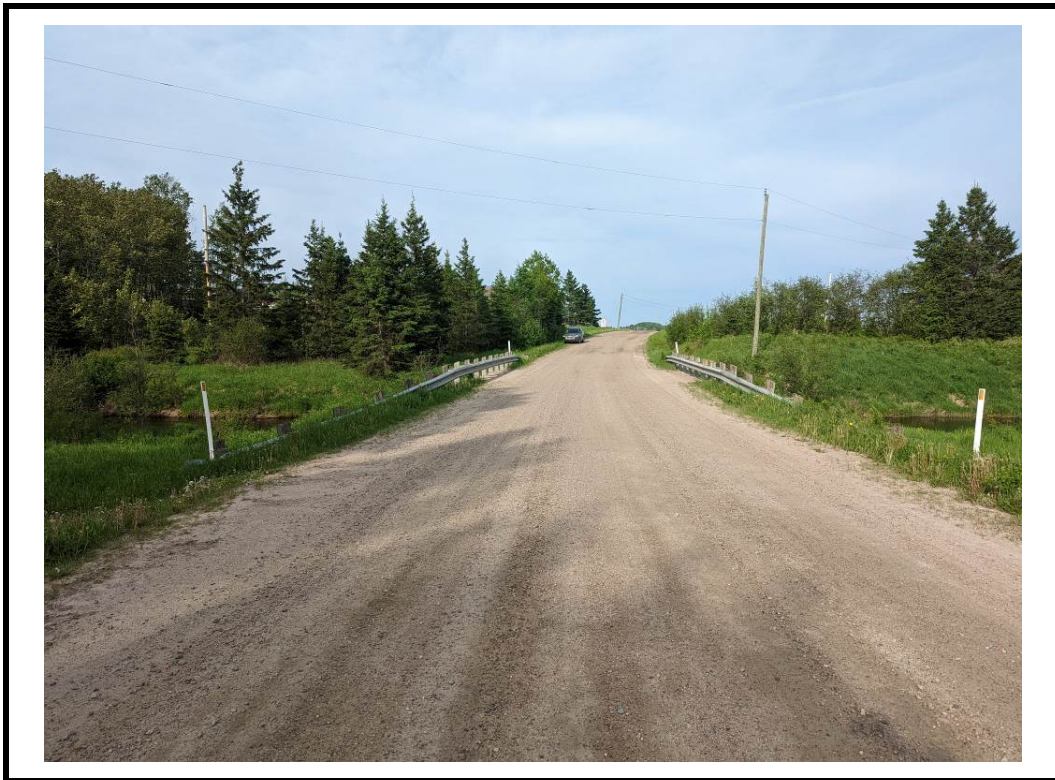
Photo 2 Structure from west approach

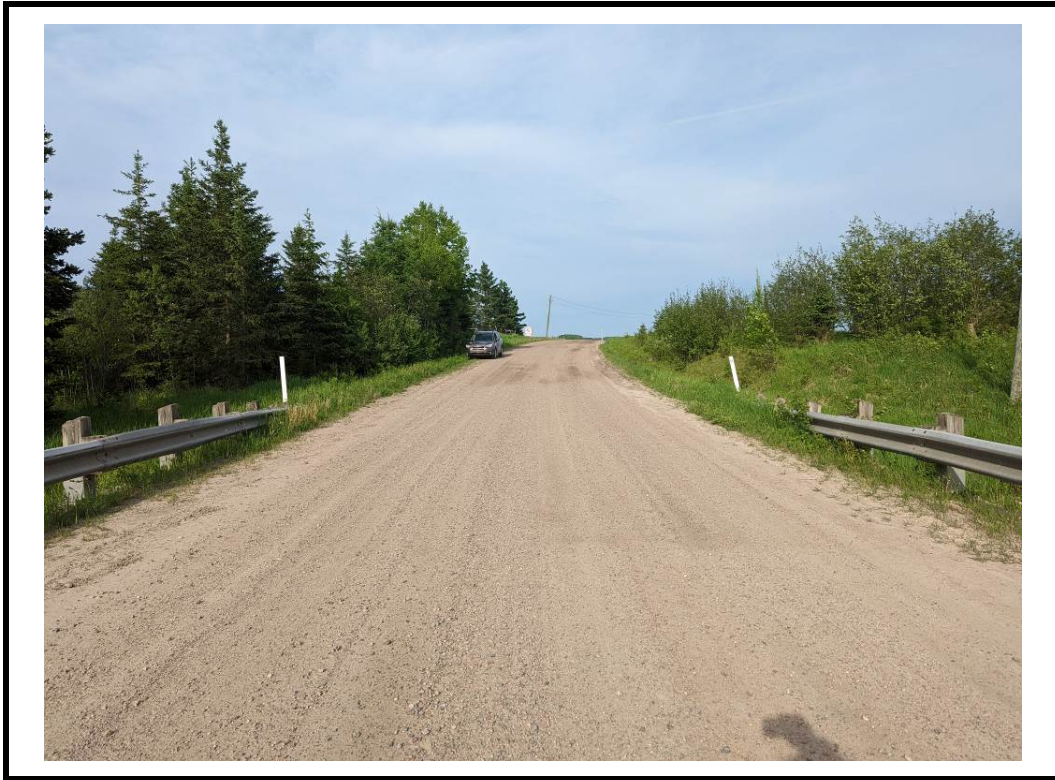
Photo 3 East approach from centre of structure

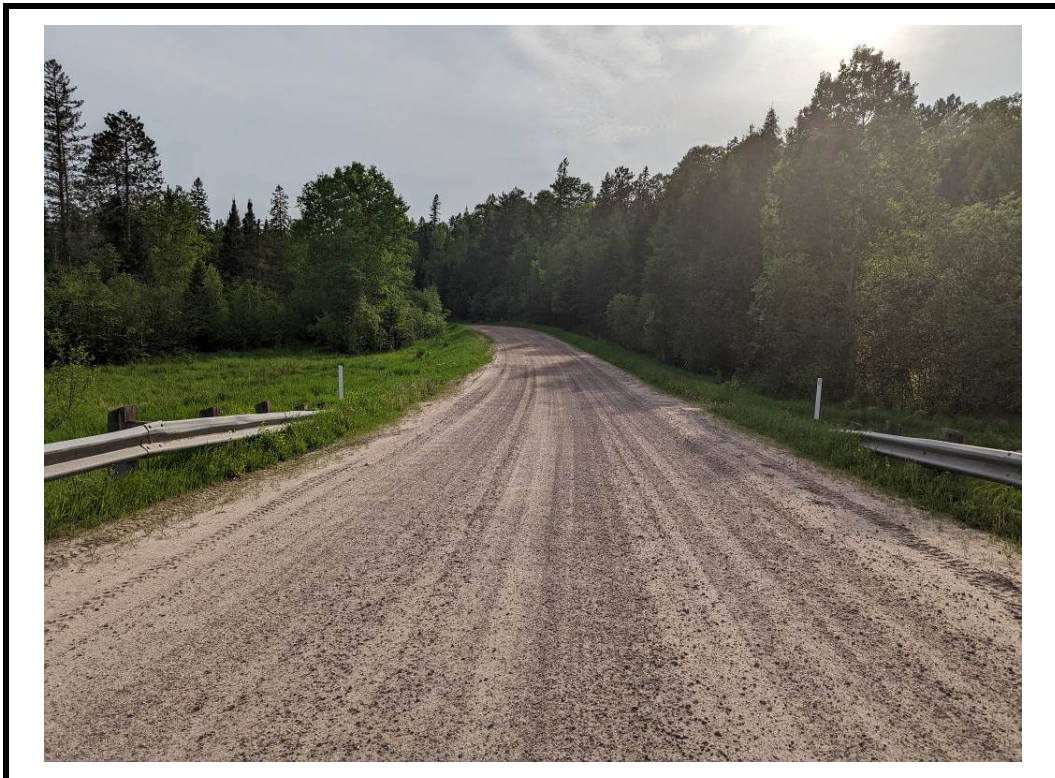
Photo 4 West approach from centre of structure

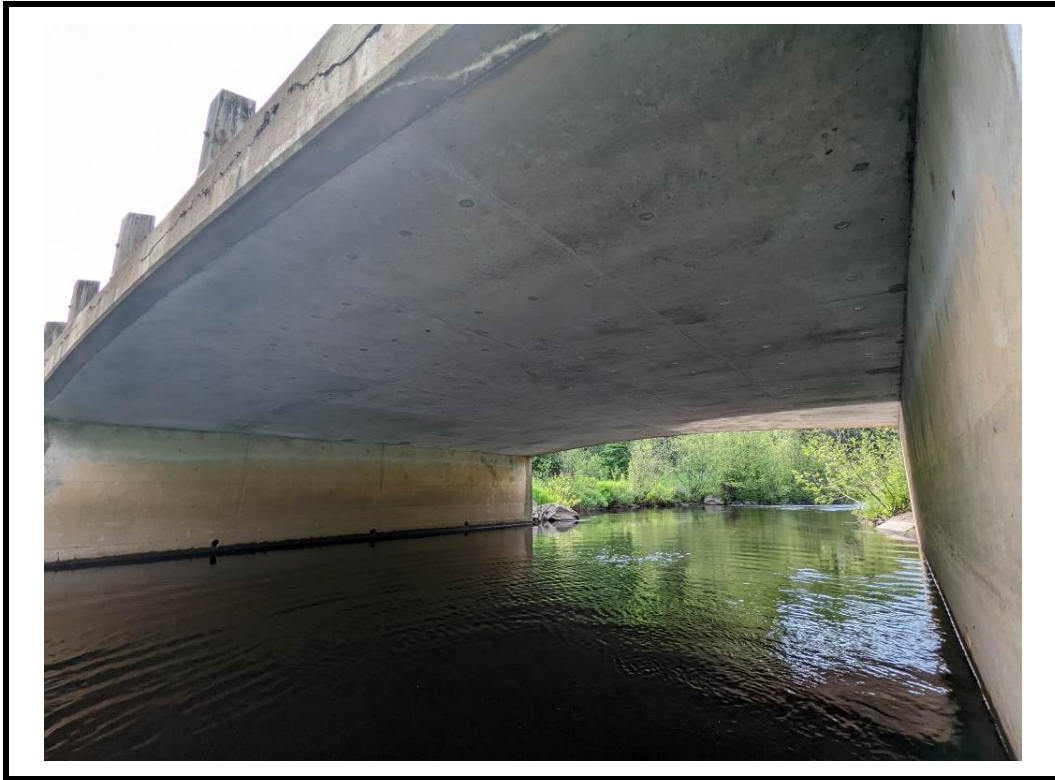
Photo 9 Underside of structure
