Municipality of Calvin

1355 & 1238 Peddlers Drive Facility and Building Condition Assessment – Draft V2

1355 & 1238 Peddlers Drive
Mattawa, Ontario

March 03, 2026
RJC No. KIN.143609.0001

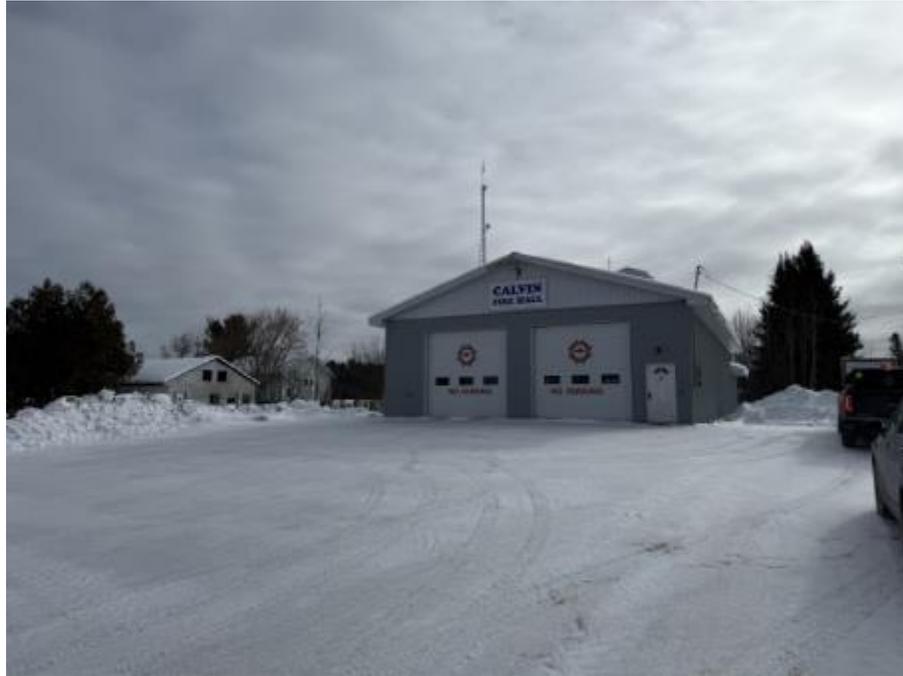
Photo 1: Fire Hall - Overview

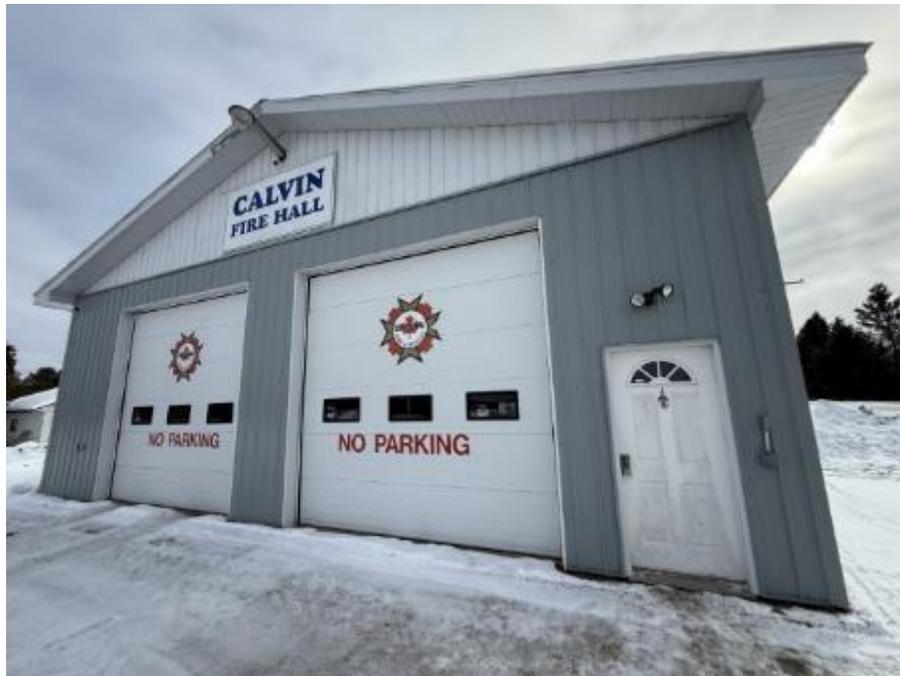
Photo 8: Fire Hall – Typical Garage and Man Doors

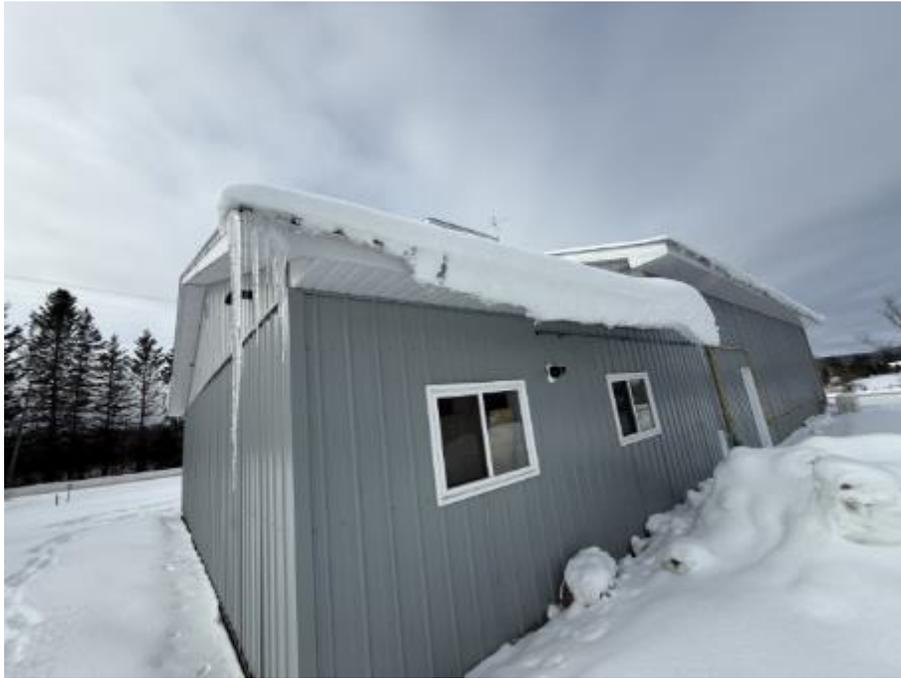
Photo 9: Fire Hall – Snow and Icicle Coverage

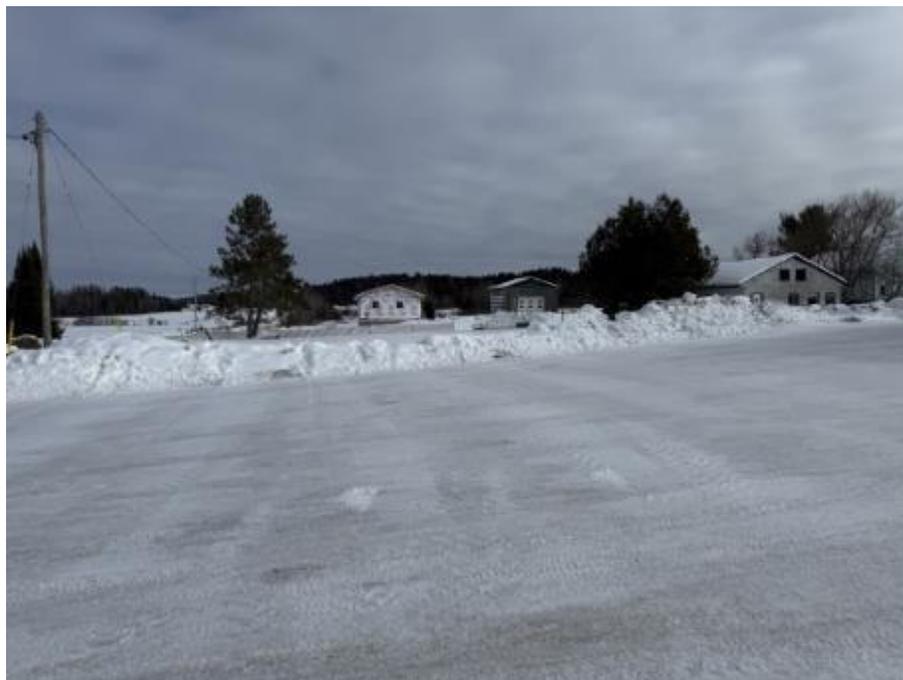
Photo 12: Fire Hall – Driveway and Parking Area

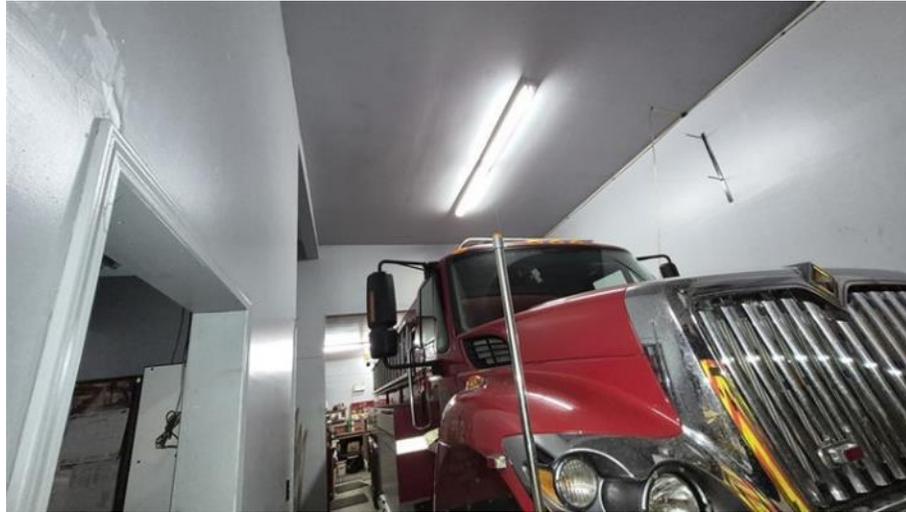
Photo 13: Fire Hall – Typical Existing Fluorescent Lighting

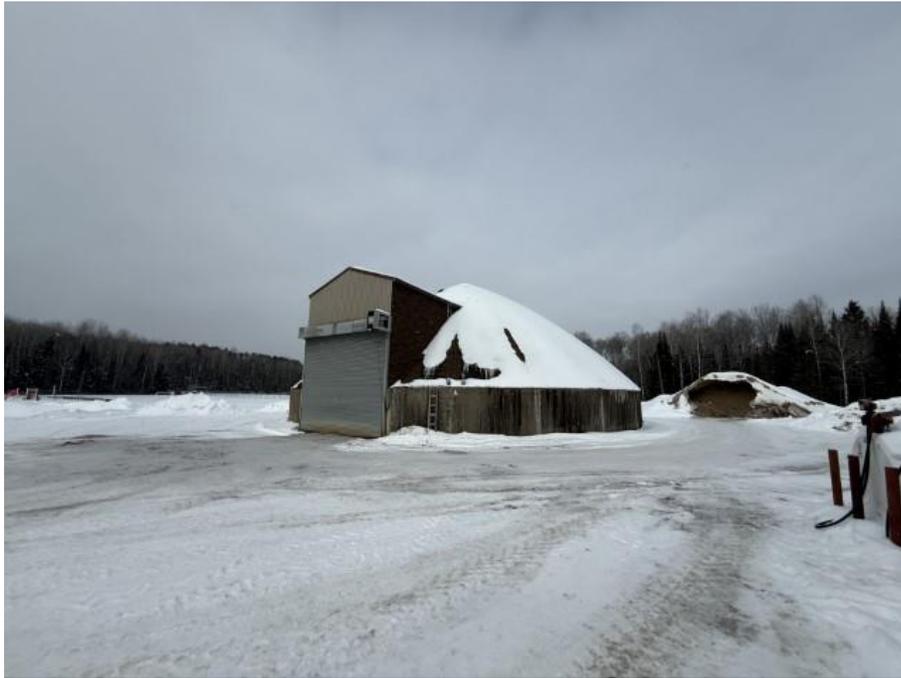
Photo 1: Sand Dome –Overview

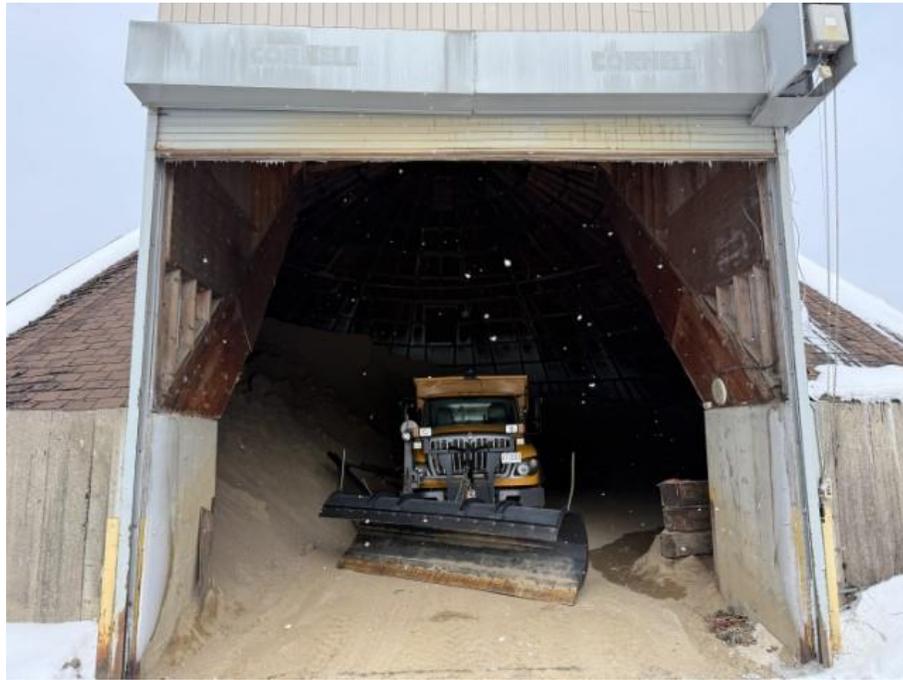
Photo 5: Sand Dome –Overhead Door

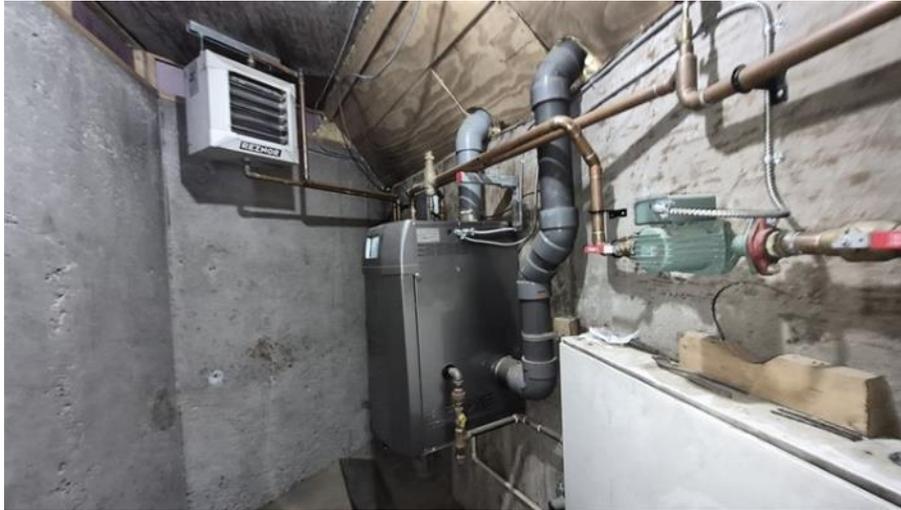
Photo 11: Sand Dome – Existing Heating Boiler and Mechanical Room Heater

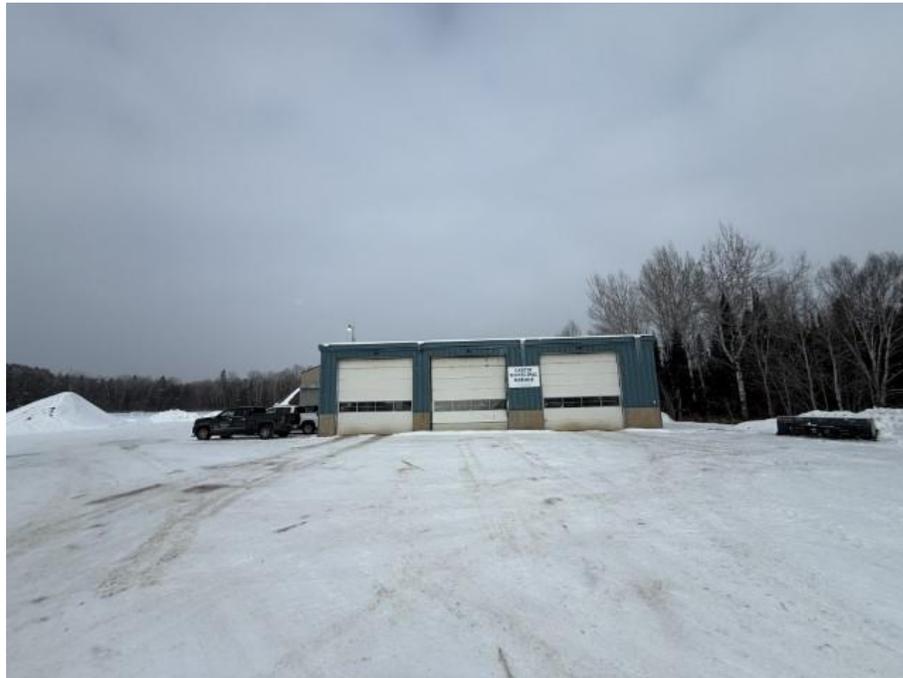
Photo 1: Municipal Garage – Overview of Building

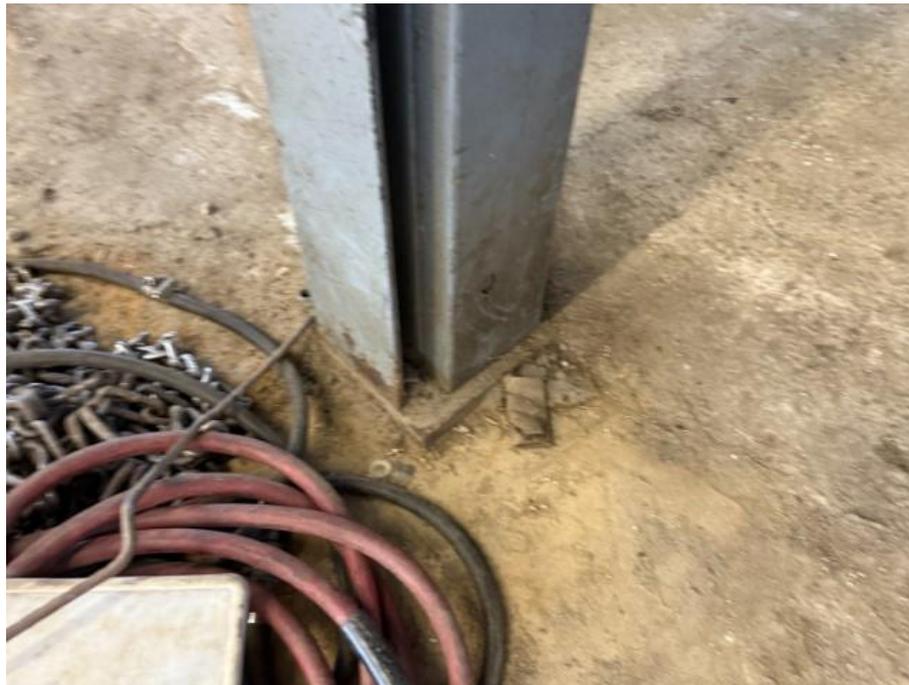
Photo 2: Municipal Garage – Typical Column Base

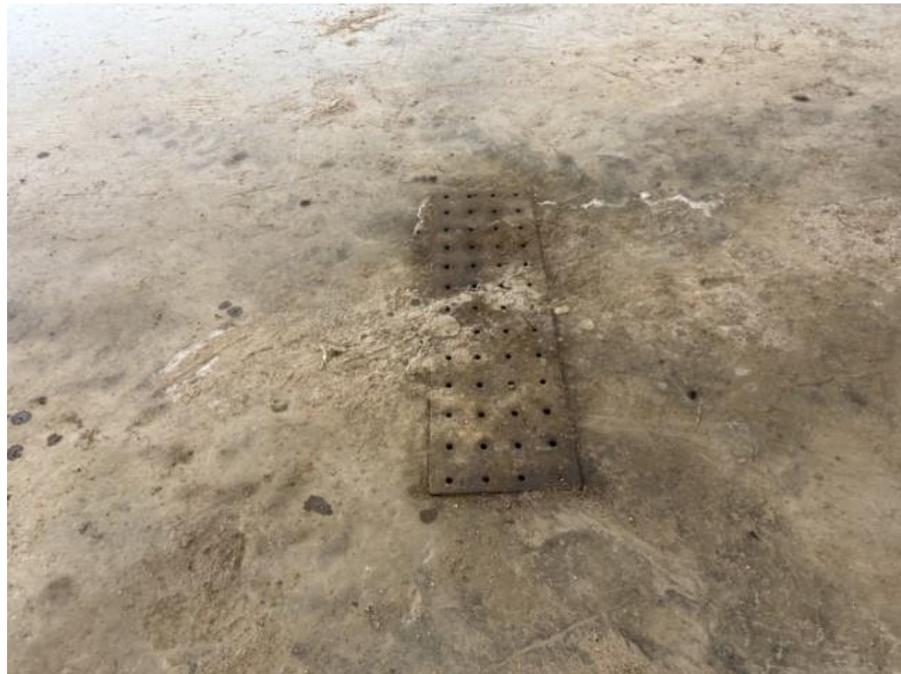
Photo 4: Municipal Garage – Typical Slab Drain

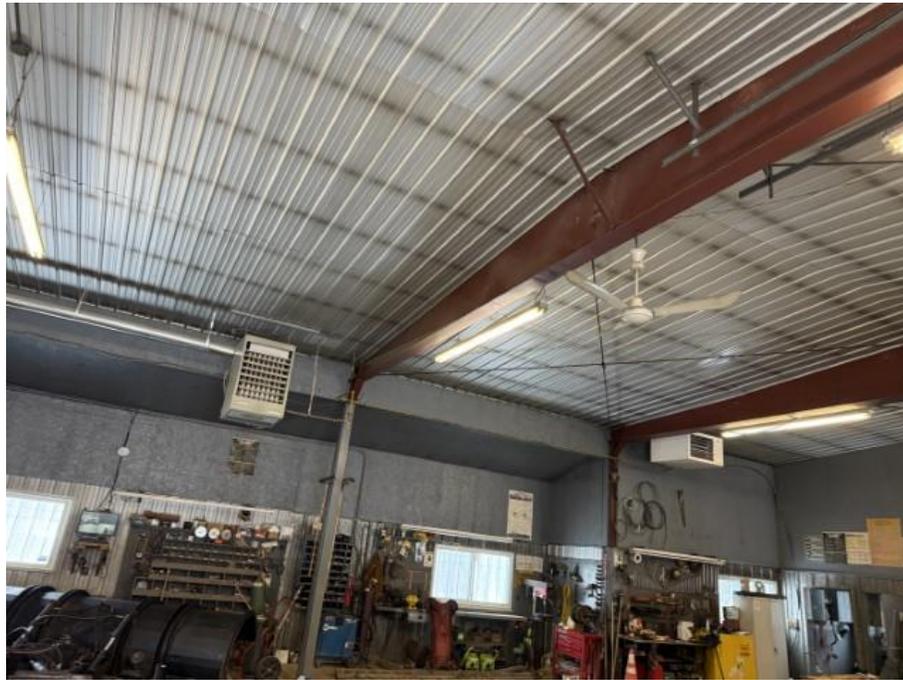
Photo 5: Municipal Garage – Overview of Steel Structure

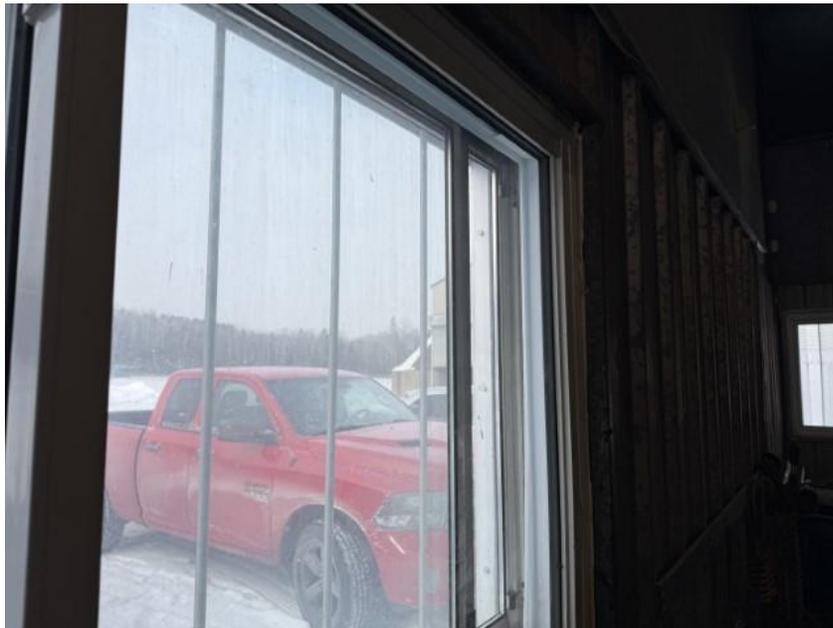
Photo 8: Municipal Garage – Overview of Interior Windows

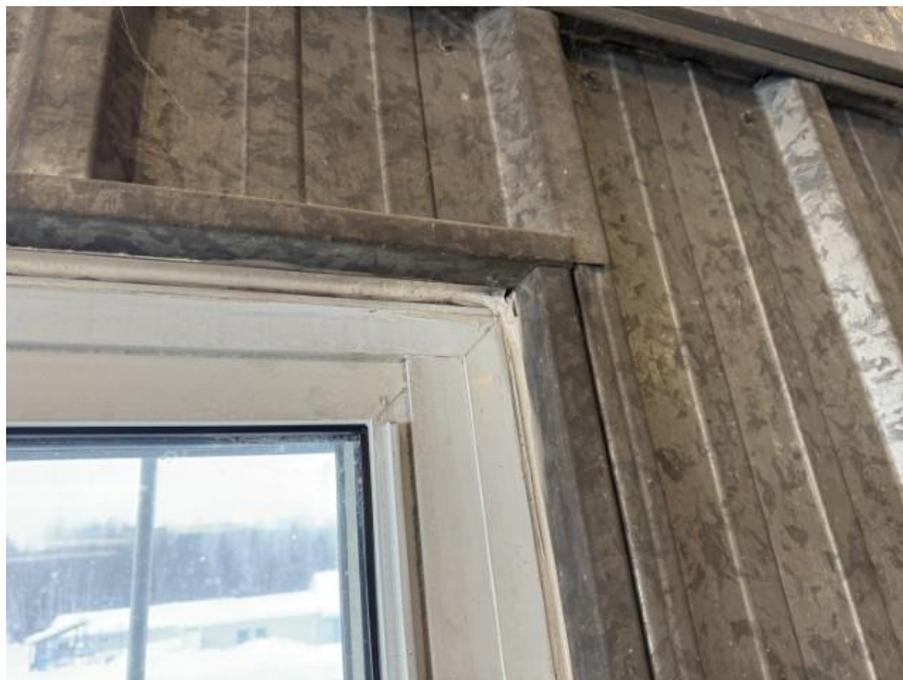
Photo 10: Municipal Garage – Overview of Interior Sealant

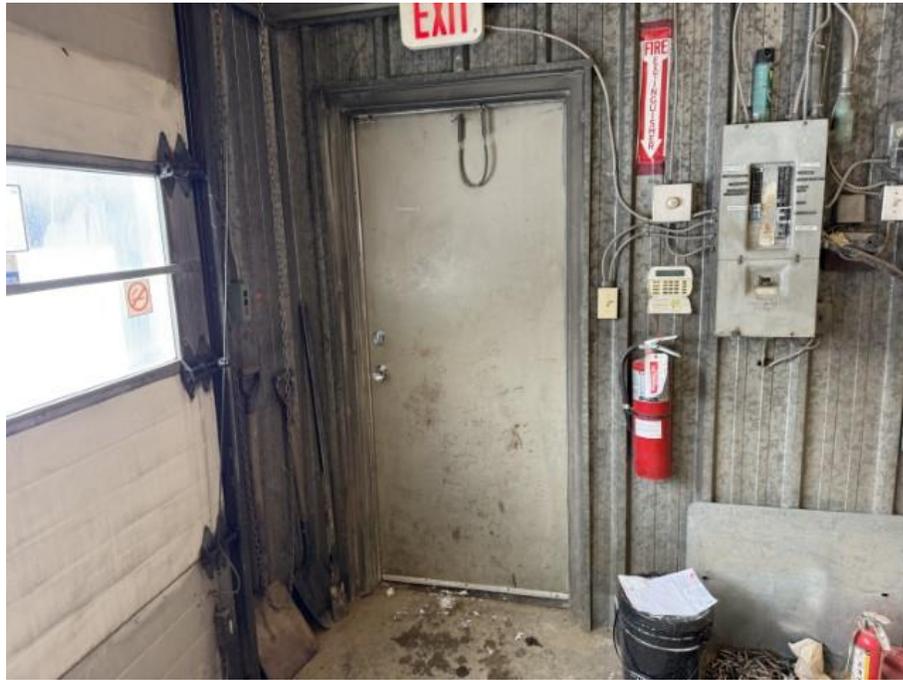
Photo 11: Municipal Garage – Overview of Man Door

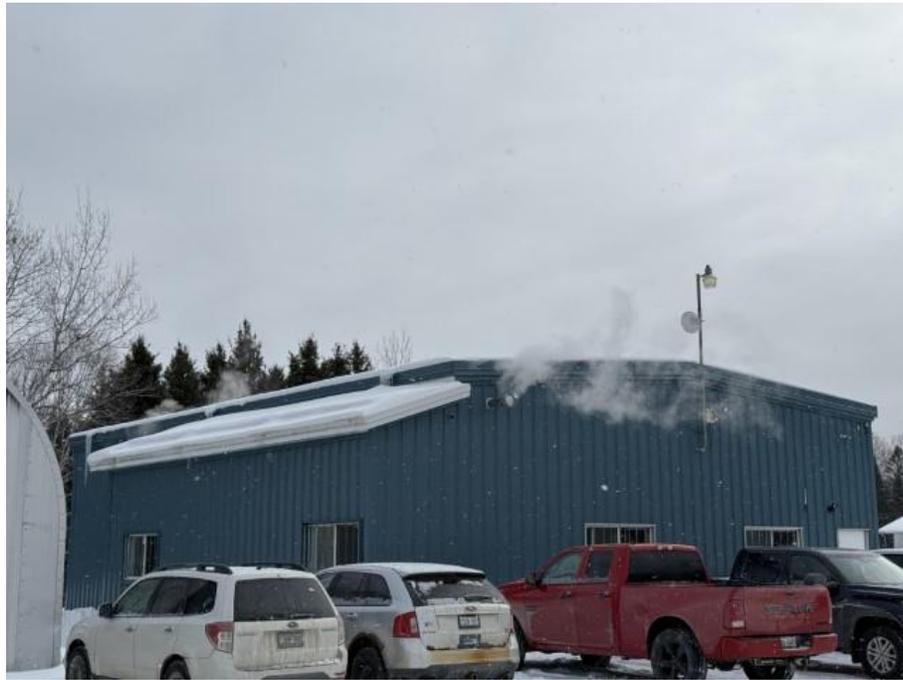
Photo 13: Municipal Garage – Overview of Covered Roof

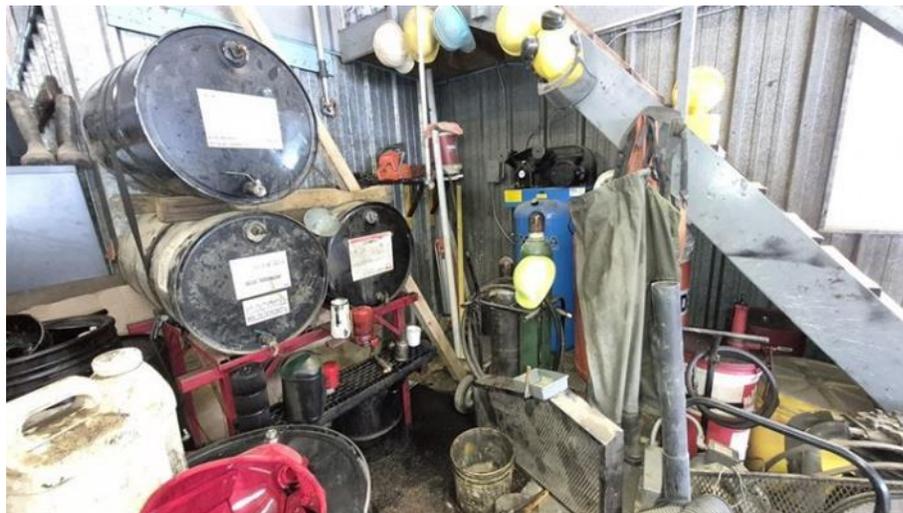
Photo 14: Municipal Garage – Lubricant Storage Obstructing Access to In-Floor Oil Interceptor

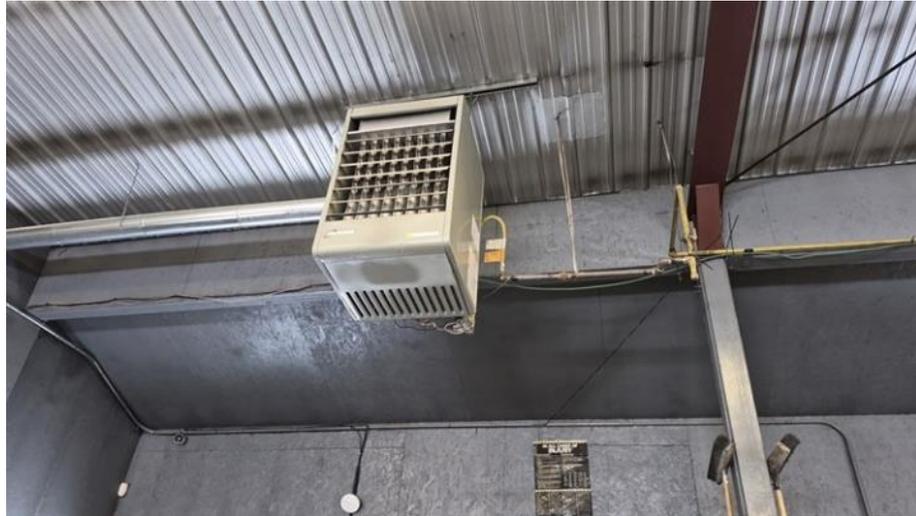
Photo 15: Municipal Garage – Existing Older Garage Area Unit Heater

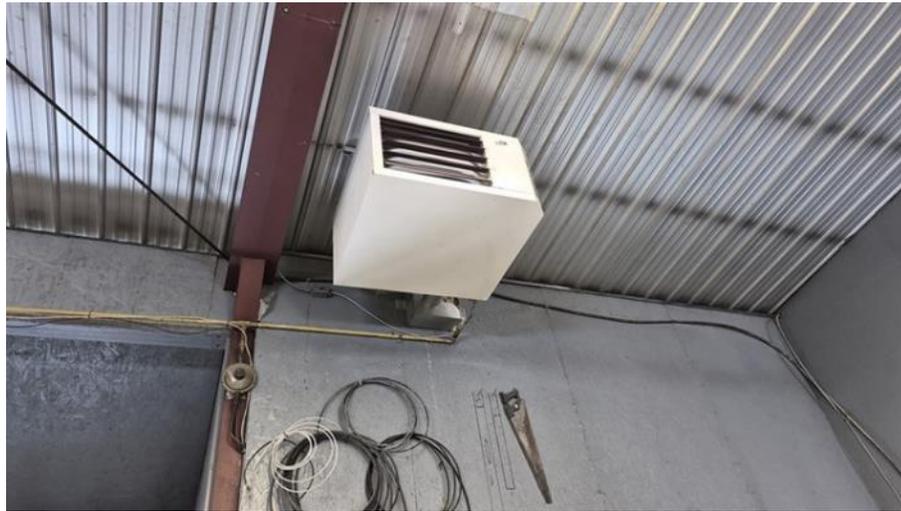
Photo 16: Municipal Garage – Existing Newer Garage Area Unit Heater

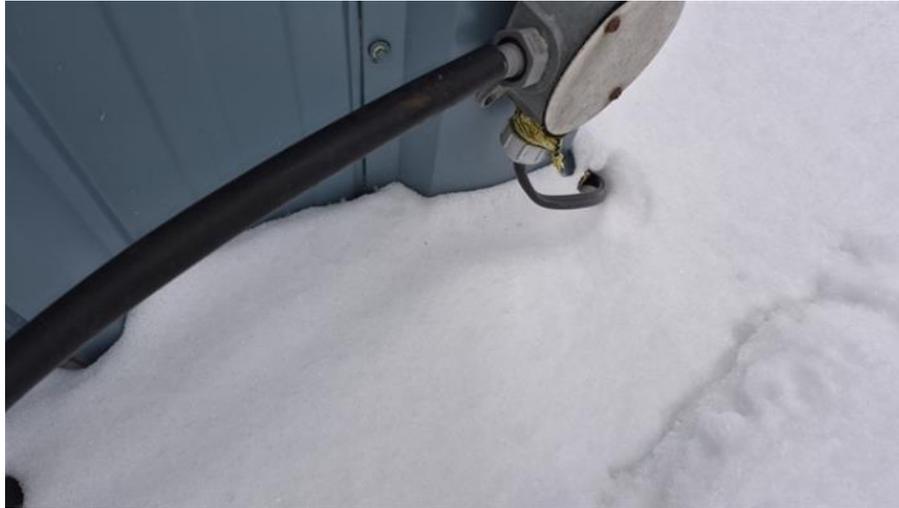
Photo 17: Municipal Garage – Existing Unprotected Power Cabling at Ground Level

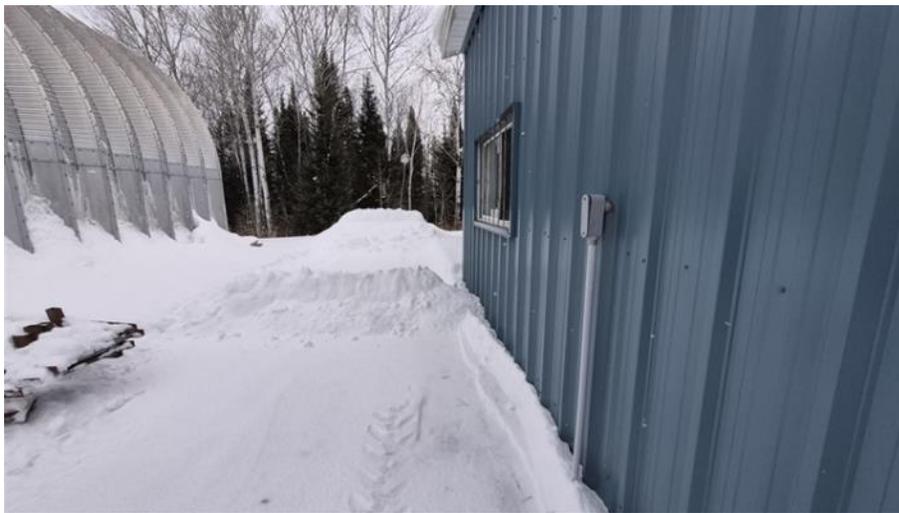
Photo 18: Municipal Garage – Existing Unprotected Power Conduit

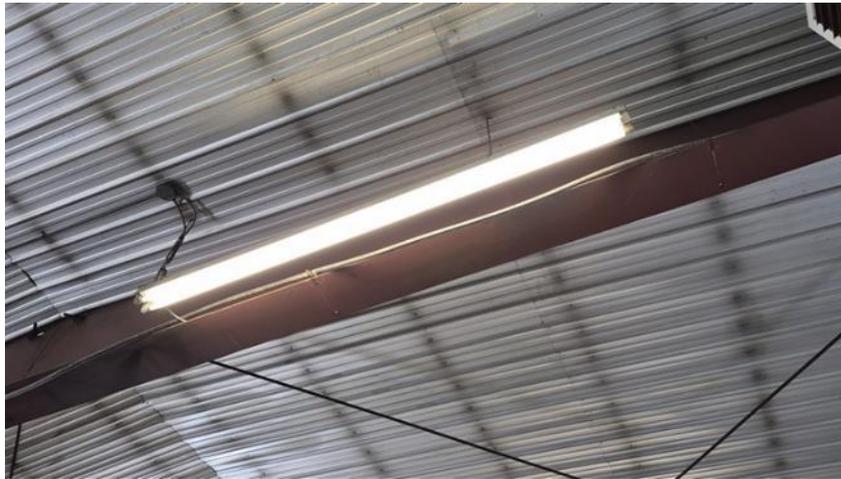
Photo 19: Municipal Garage – Existing Fluorescent Interior Lighting

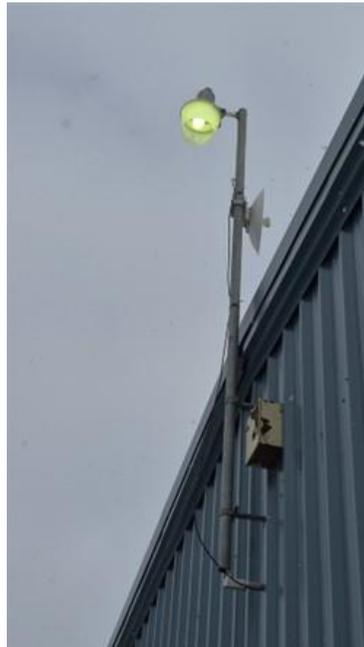
Photo 20: Municipal Garage – Existing HID Exterior Lighting.

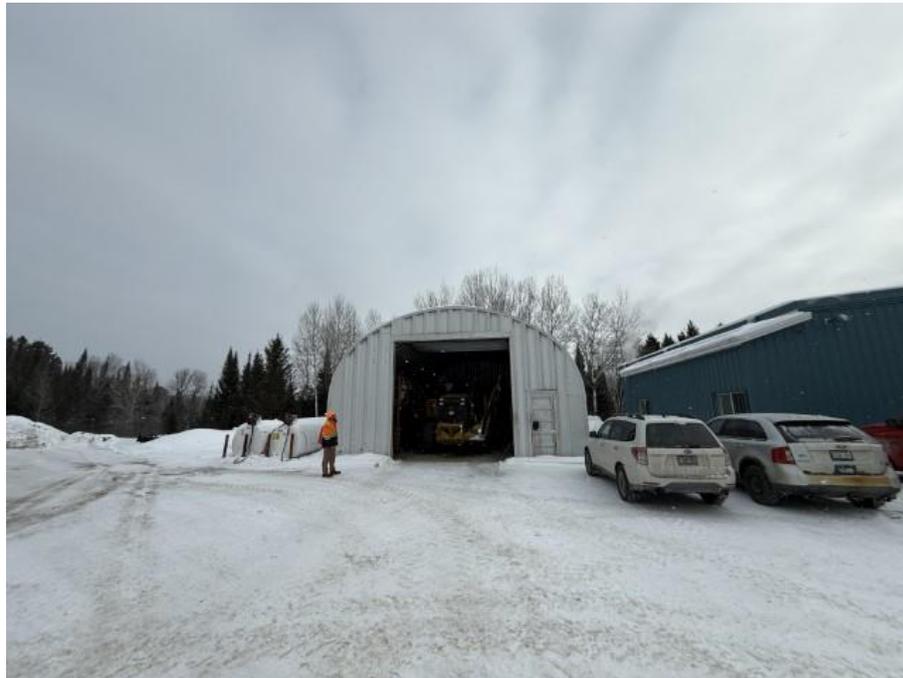
Photo 1: Quonset Hut –Overview

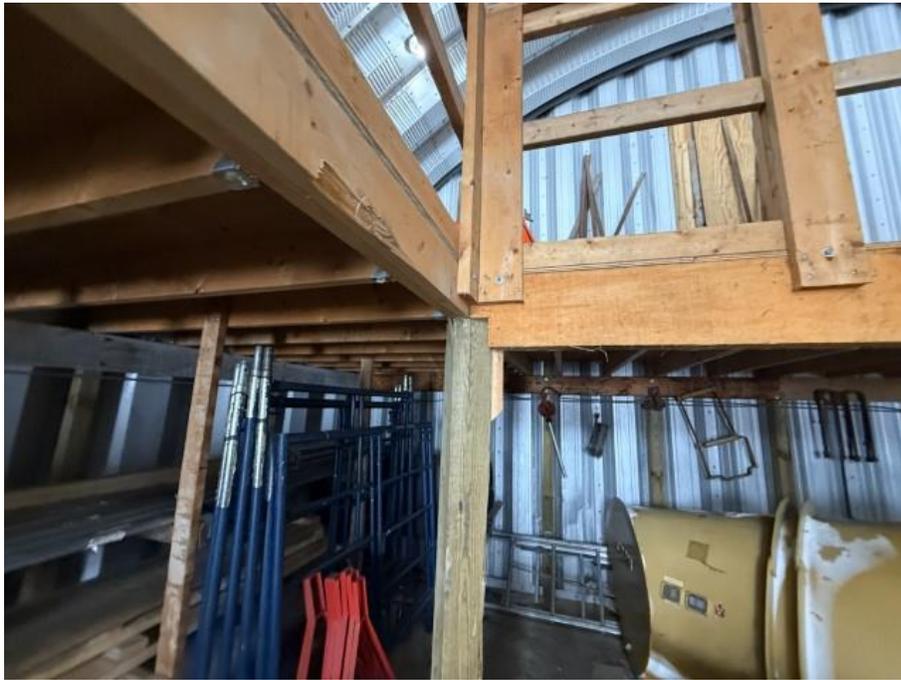
Photo 3: Quonset Hut – Overview of Landing Structure

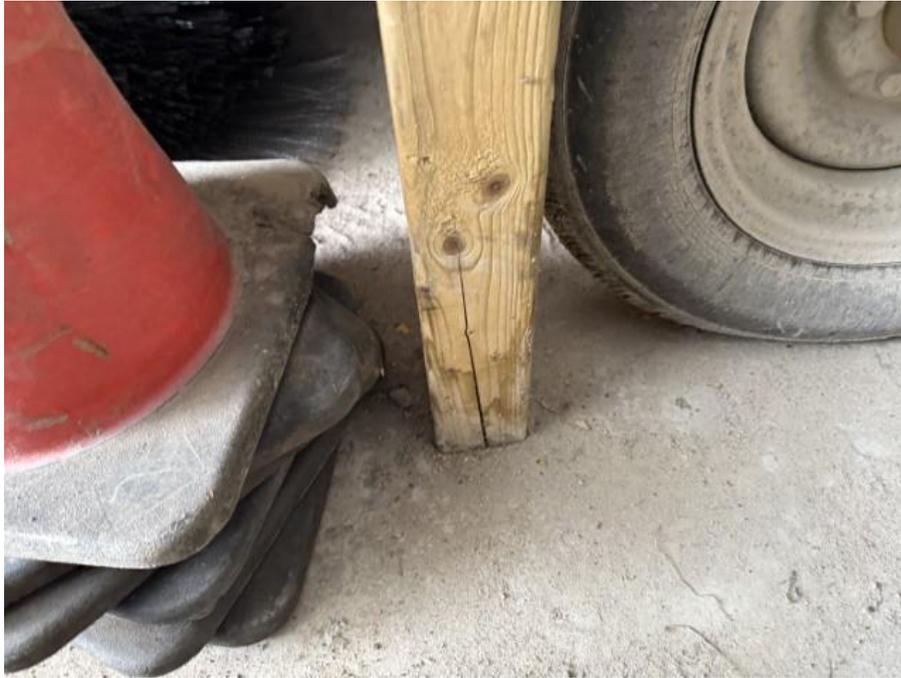
Photo 5: Quonset Hut – Typical Base of Landing Posts

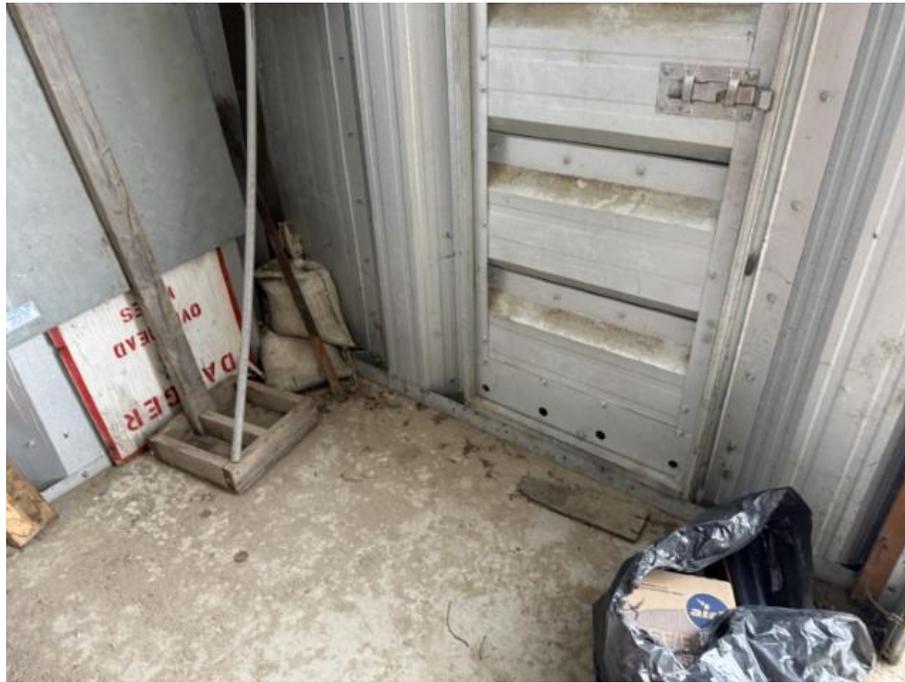
Photo 7: Quonset Hut - Man Door

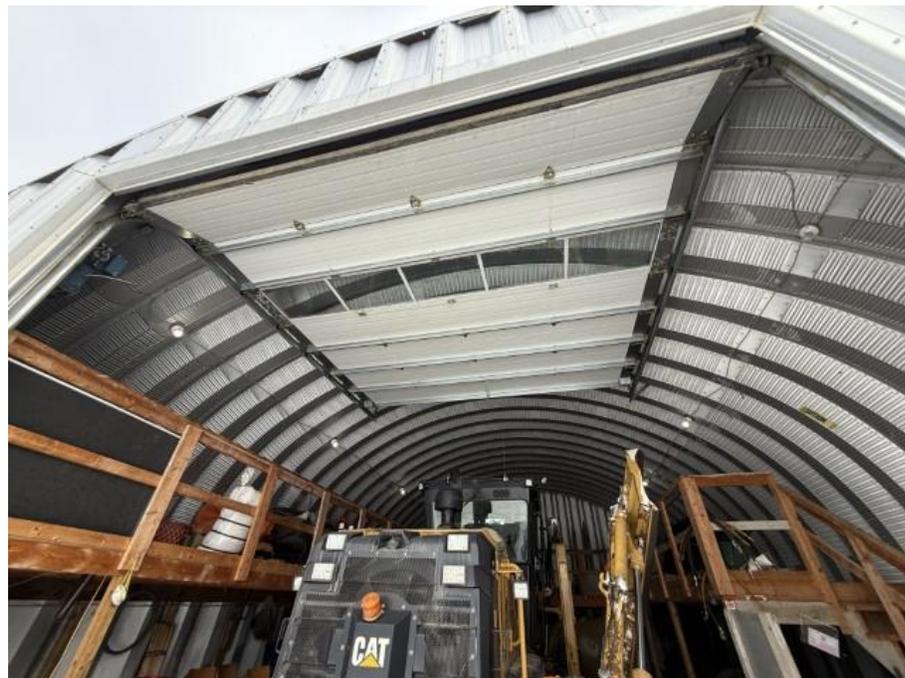
Photo 8: Quonset Hut – Overhead Door

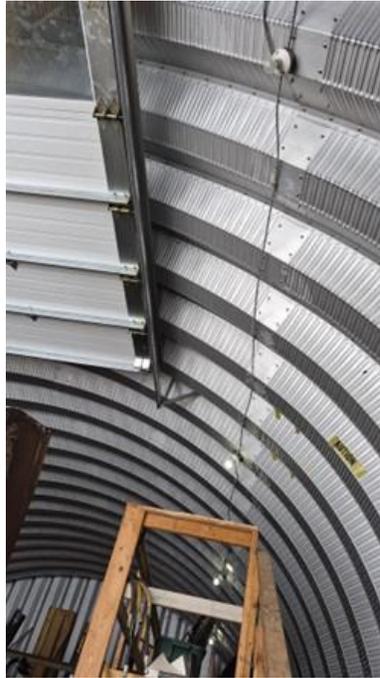
Photo 9: Quonset Hut – Existing Interior Lighting

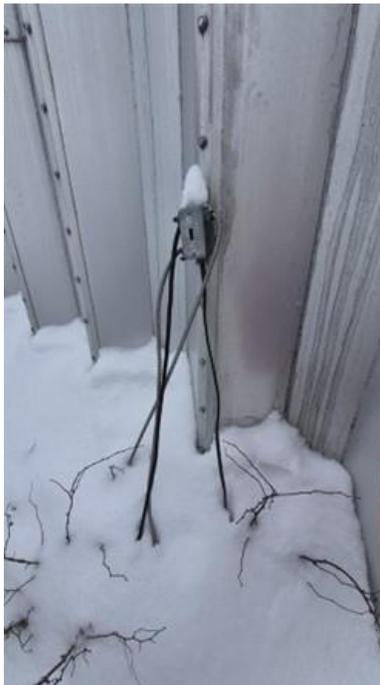
Photo 10: Quonset Hut – Existing Exterior Electrical Wiring

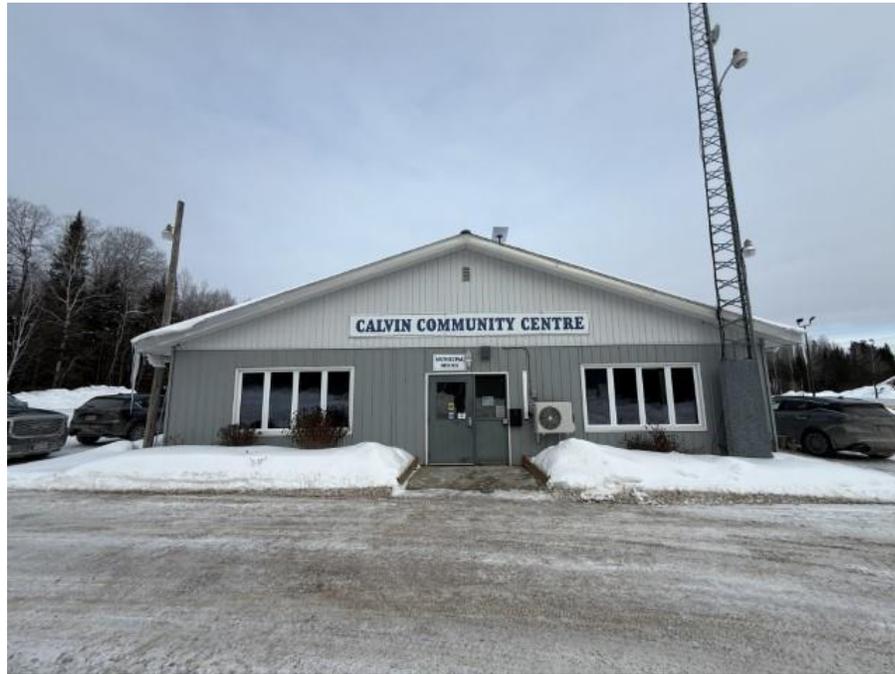
Photo 1: Recreation Hall – Overview

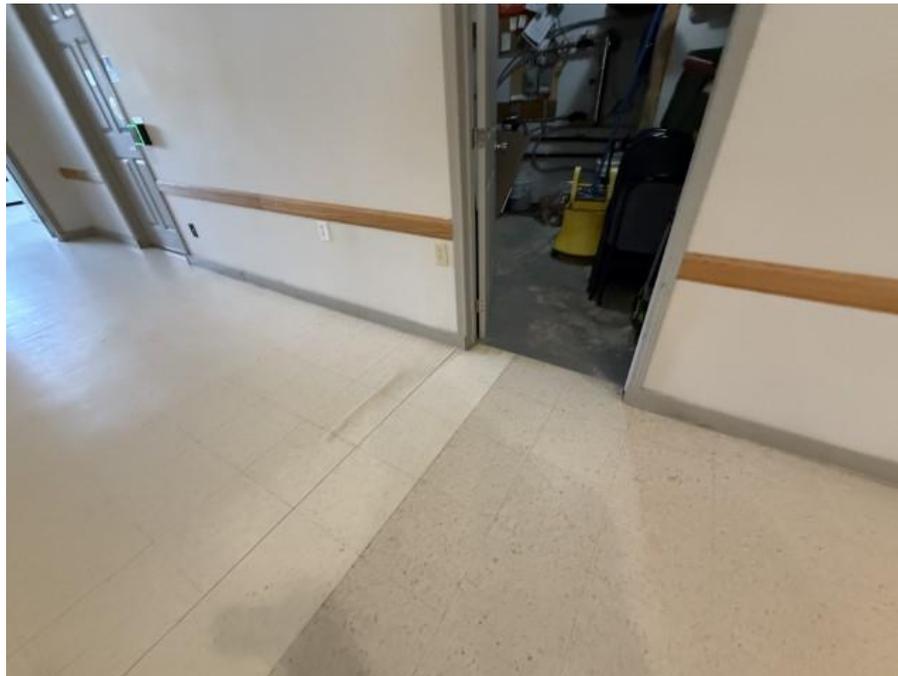
Photo 2: Recreation Hall – Slab-on-Grade Joint Displacement

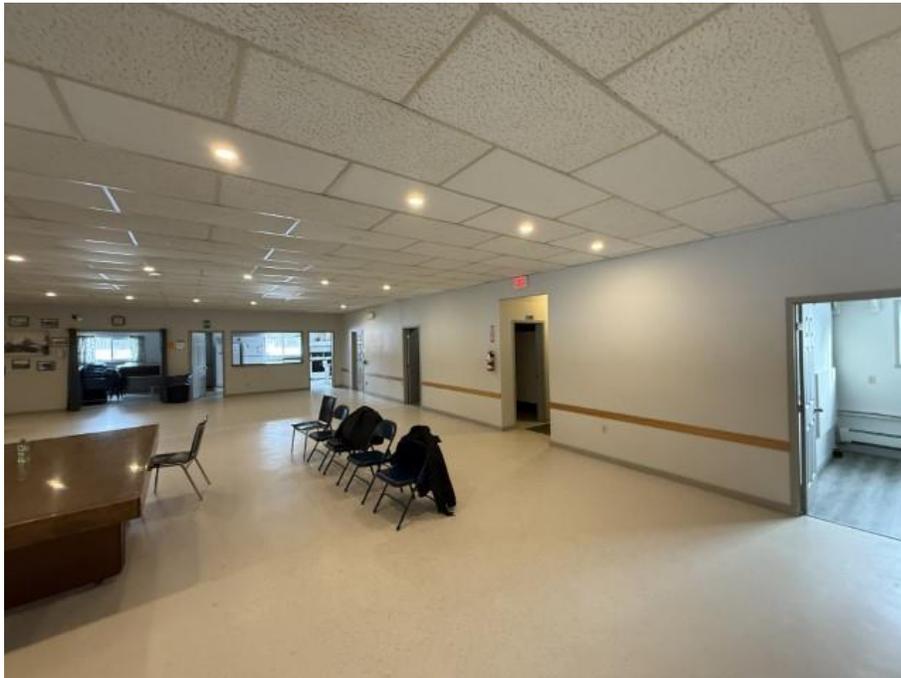
Photo 3: Recreation Hall – Overview of Interior Finishes

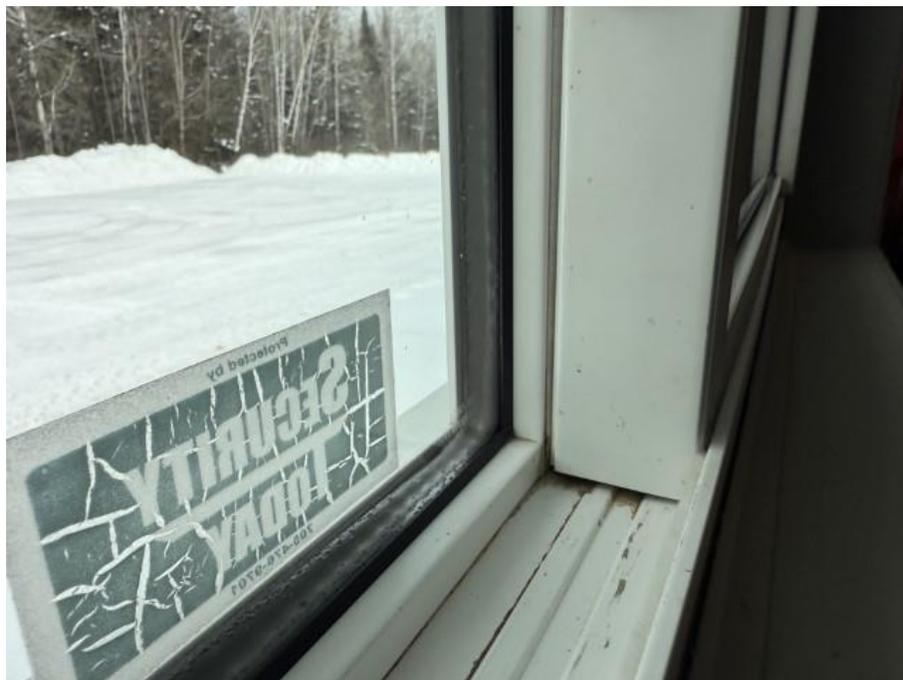
Photo 6: Recreation Hall –Interior Window Condition

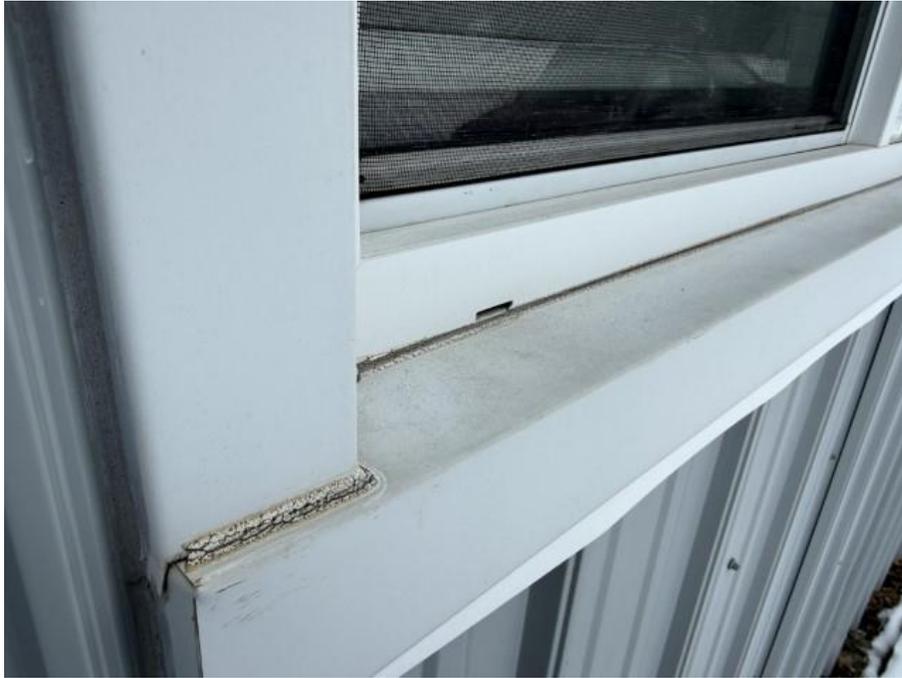
Photo 7: Recreation Hall – Windows and Sealant Exterior

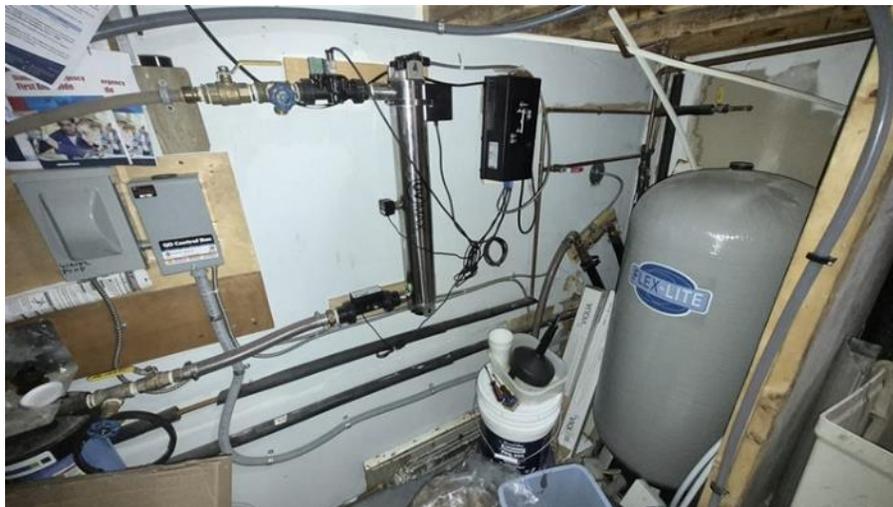
Photo 12: Recreation Hall – Existing UV Water Sterilizer and Associated Plumbing

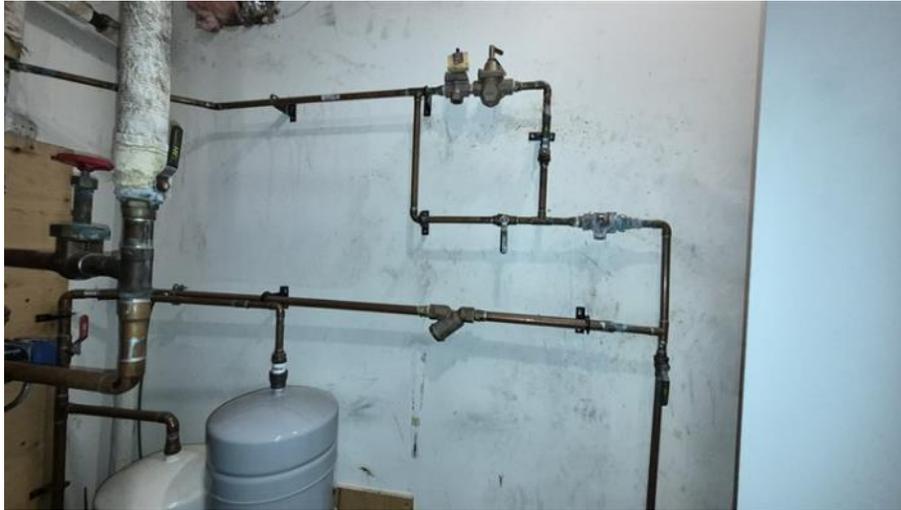
Photo 13: Recreation Hall – Domestic Hot Water Piping Interface to Heating Boiler

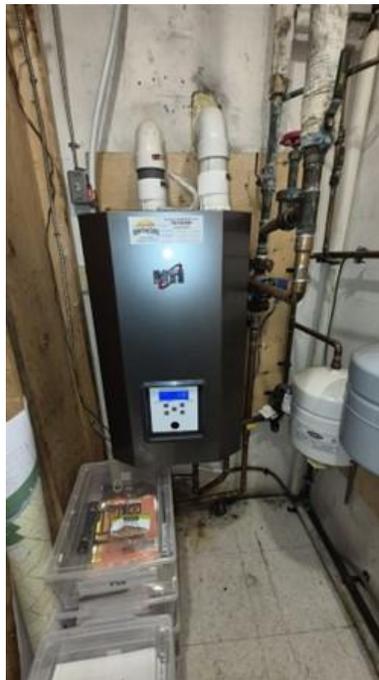
Photo 14: Recreation Hall – Heating and Domestic Water Boiler

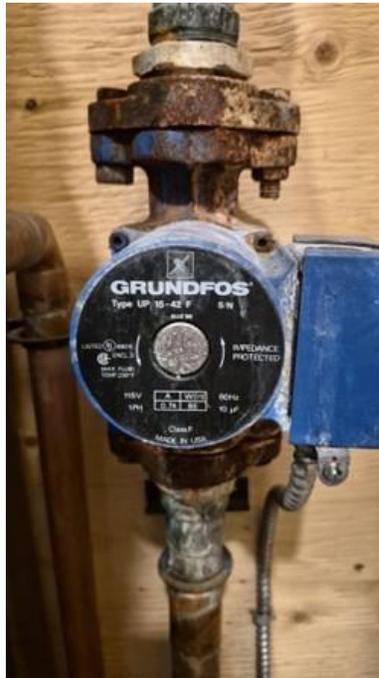
Photo 15: Recreation Hall - Heating Water Circulation Pump

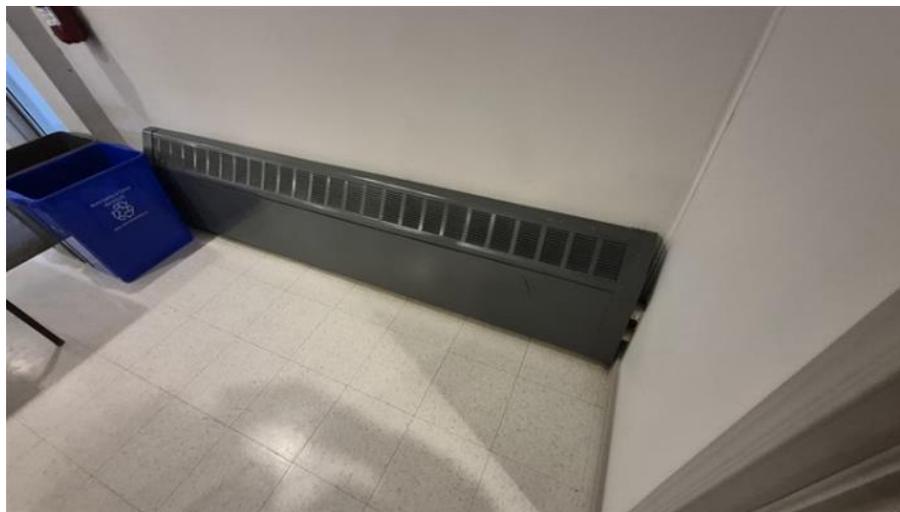
Photo 16: Recreation Hall – Typical Original Fin-Tube Hydronic Heating Convectors

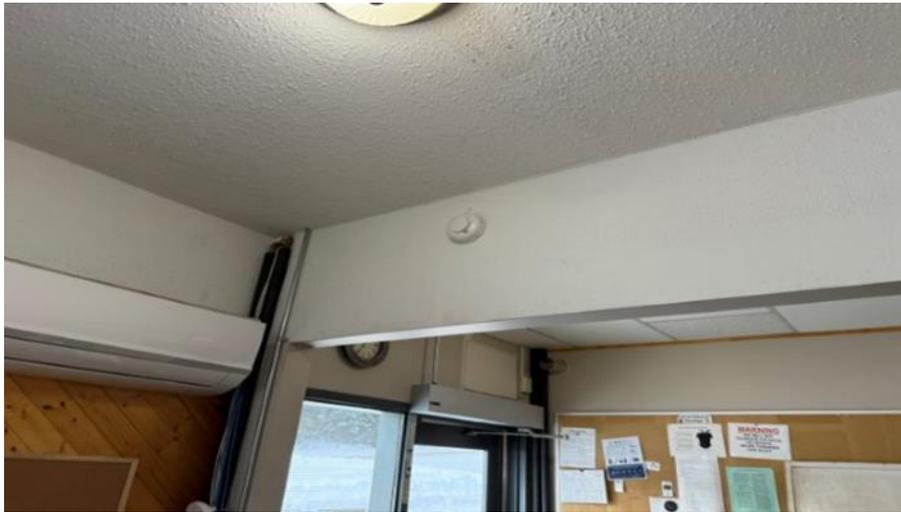
Photo 17: Recreation Hall – Local Smoke Detector. Typical for 2 such Detector Installations

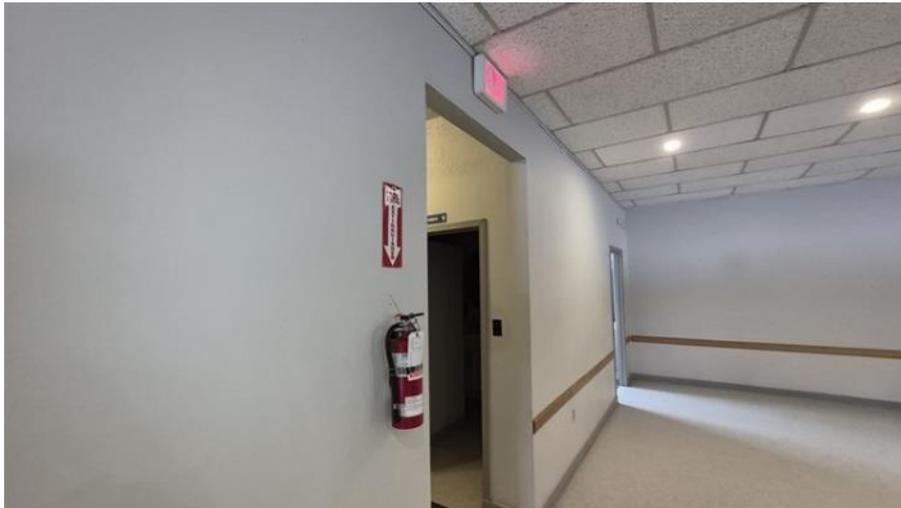
Photo 18: Recreation Hall – Typical Portable Fire Extinguisher

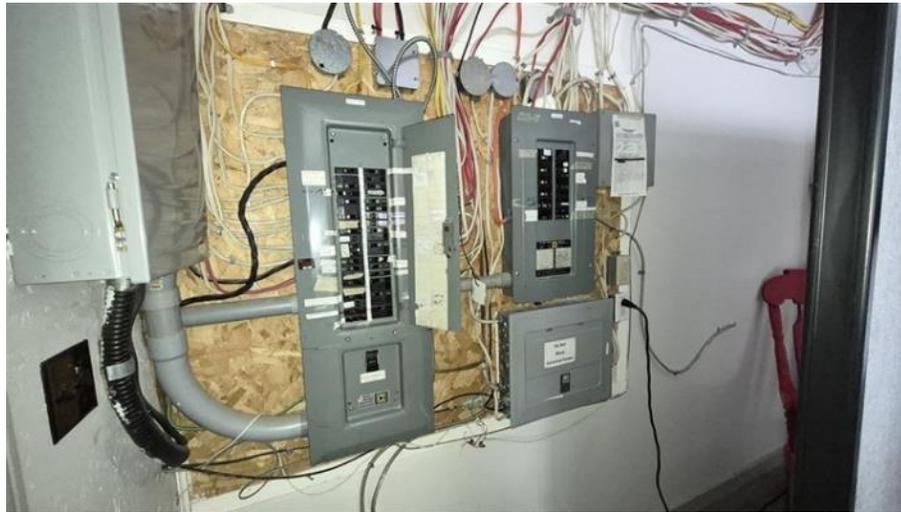
Photo 19: Recreation Hall – Existing Electrical Panels – Circuit Balancing and Identification
