Municipality of Calvin

1355 & 1238 Peddlers Drive Facility and Building Condition Assessment – Draft V2

1355 & 1238 Peddlers Drive
Mattawa, Ontario

March 03, 2026
RJC No. KIN.143609.0001

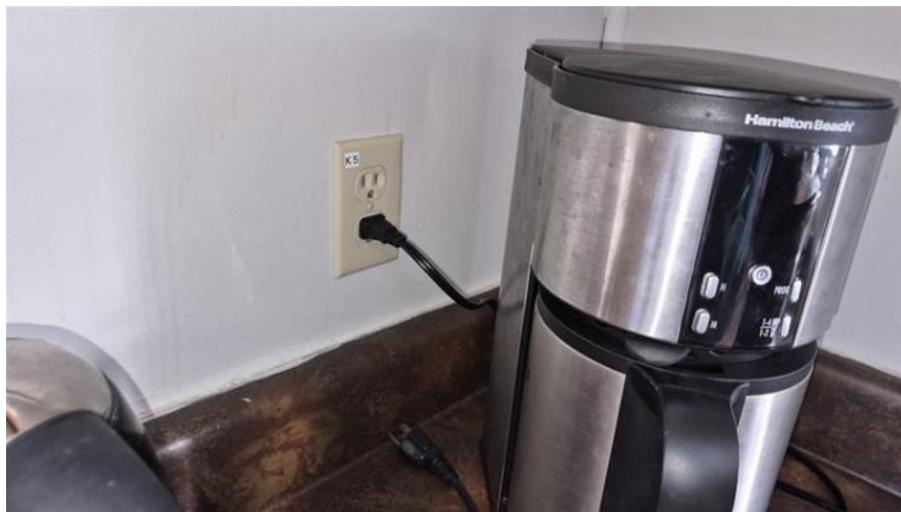
Photo 20: Recreation Hall – Kitchen Power Distribution – Circuit Balancing to permit Multiple Appliance Operation

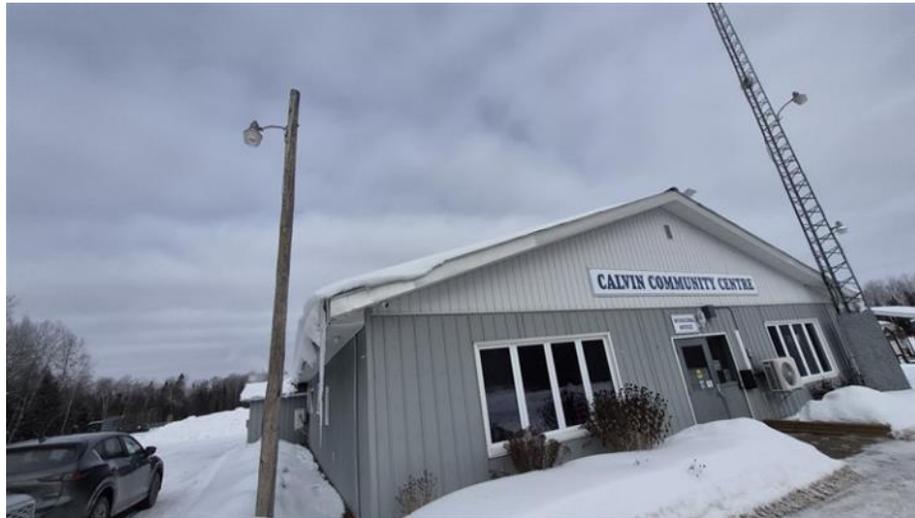
Photo 21: Recreation Hall – Existing HID Exterior Lighting

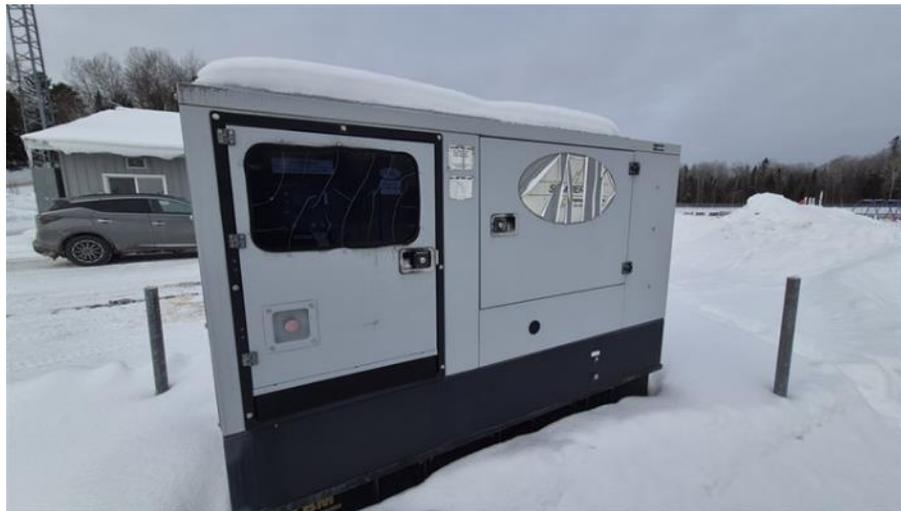
Photo 22: Recreation Hall – Existing Emergency Backup Power Generator

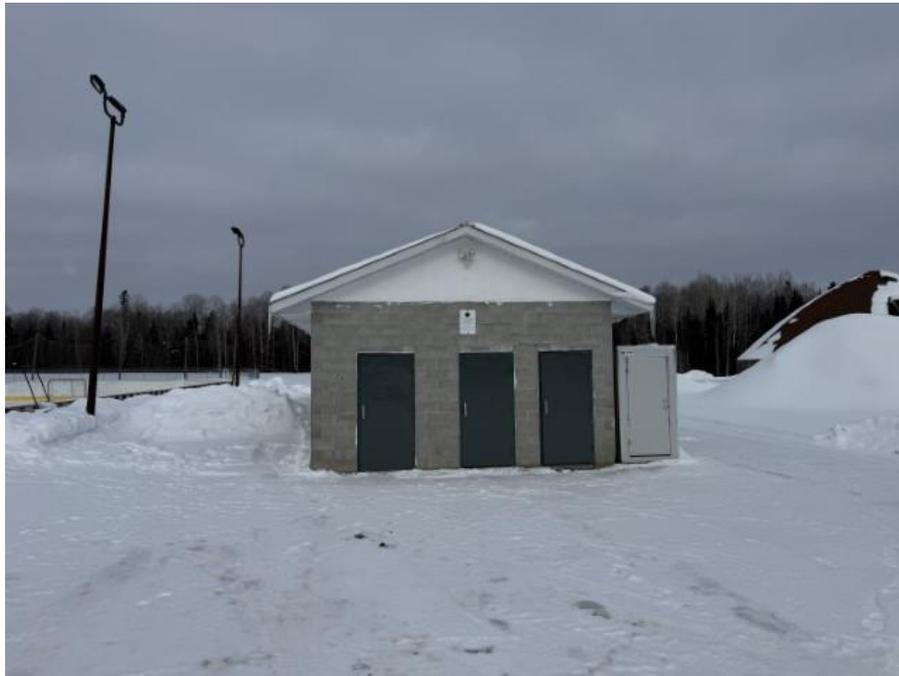
Photo 1: Changing/Storage Building - Overview

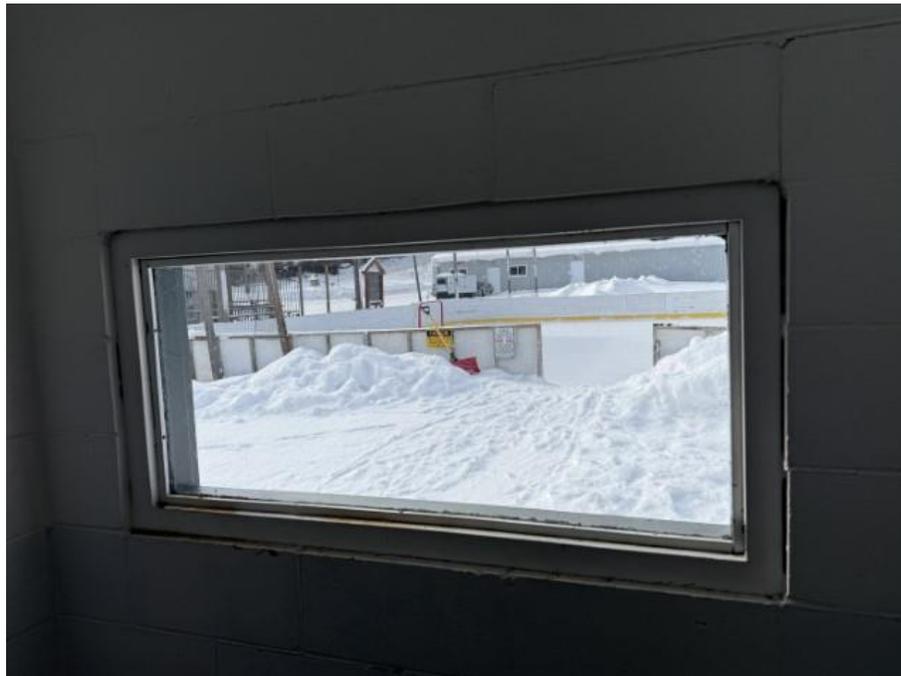
Photo 6: Changing/Storage Building - Windows

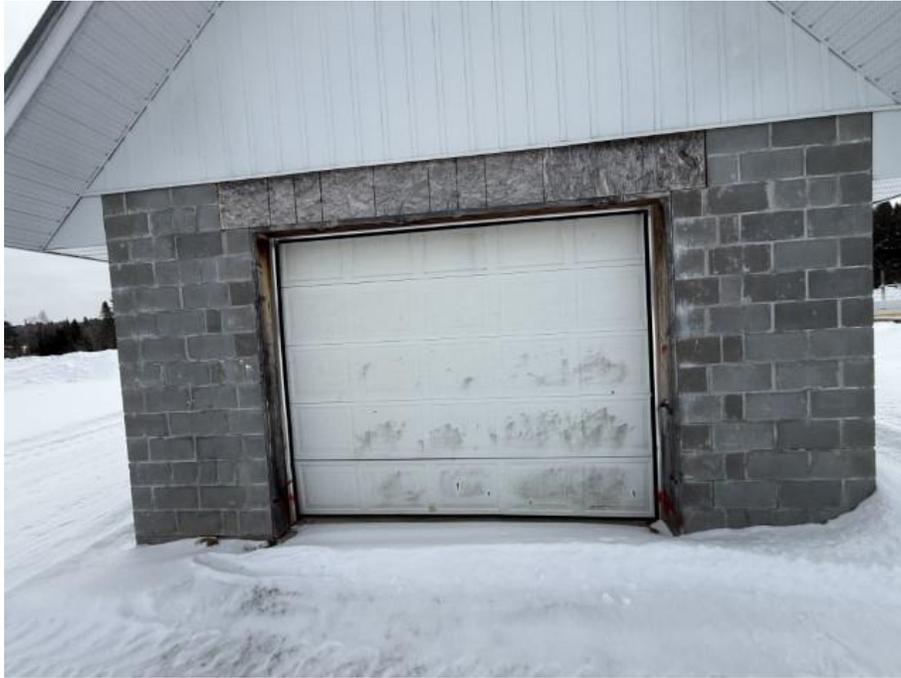
Photo 7: Changing/Storage Building – Garage Door

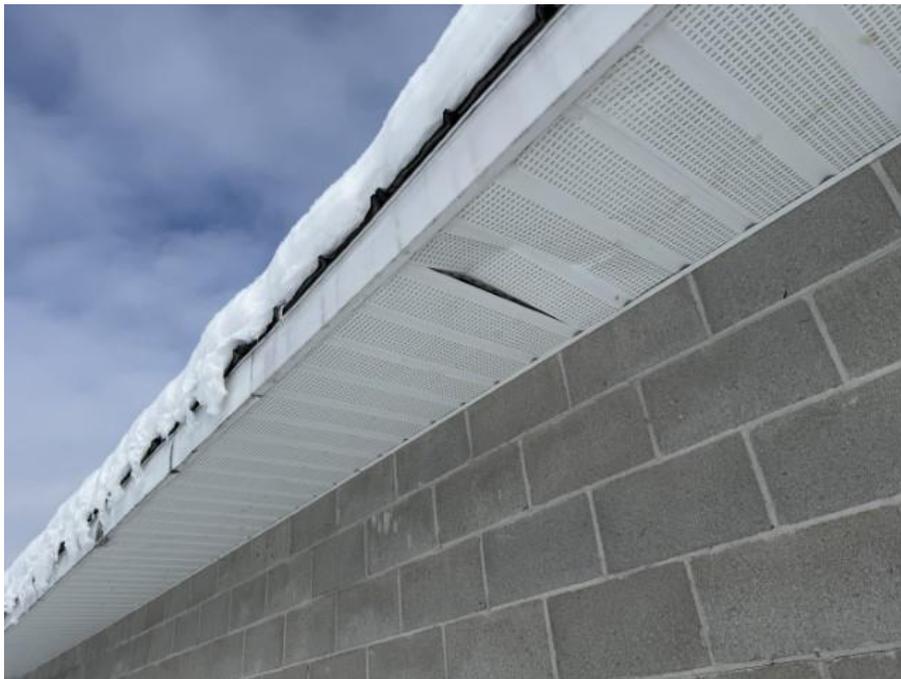
Photo 8: Changing/Storage Building – Metal Soffit

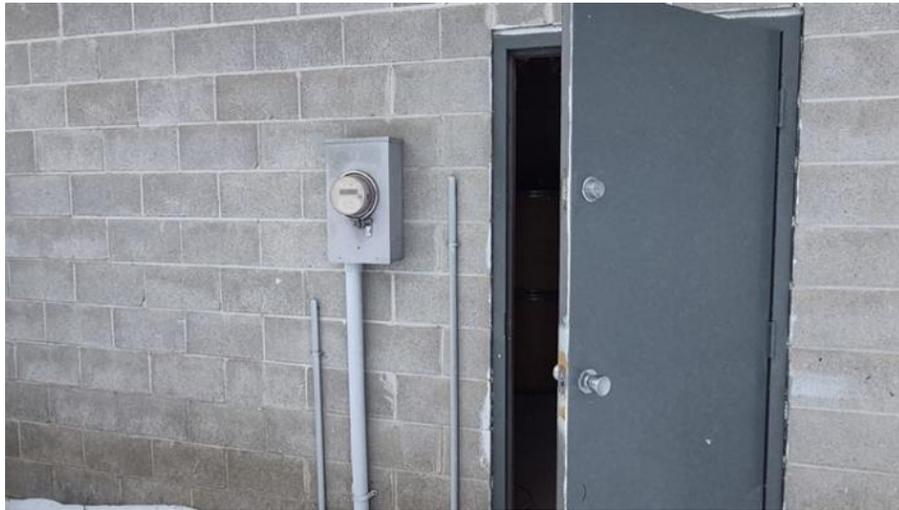
Photo 9: Changing/Storage Building - Electrical Power Service to Recreation Change Room

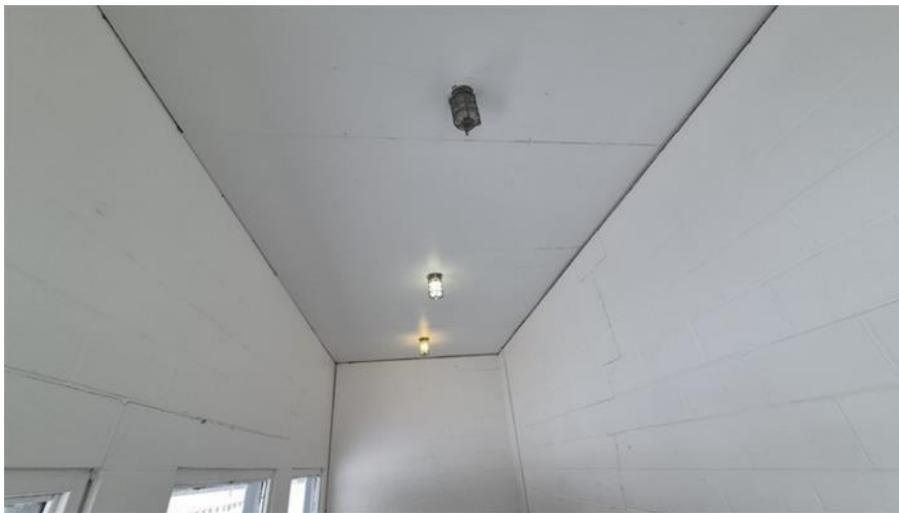
Photo 10: Changing/Storage Building – Changeroom Interior Lighting

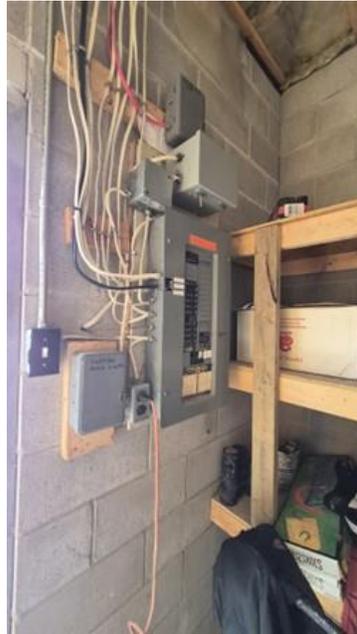
Photo 11: Changing/Storage Building – Electrical Power Distribution and Controls

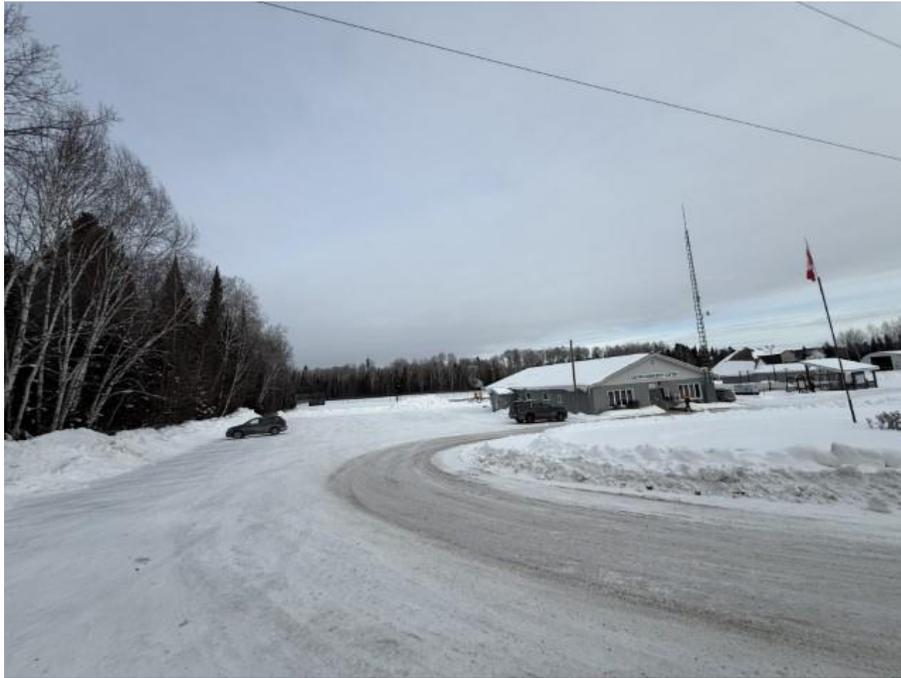
Photo 1: Main Parking Area

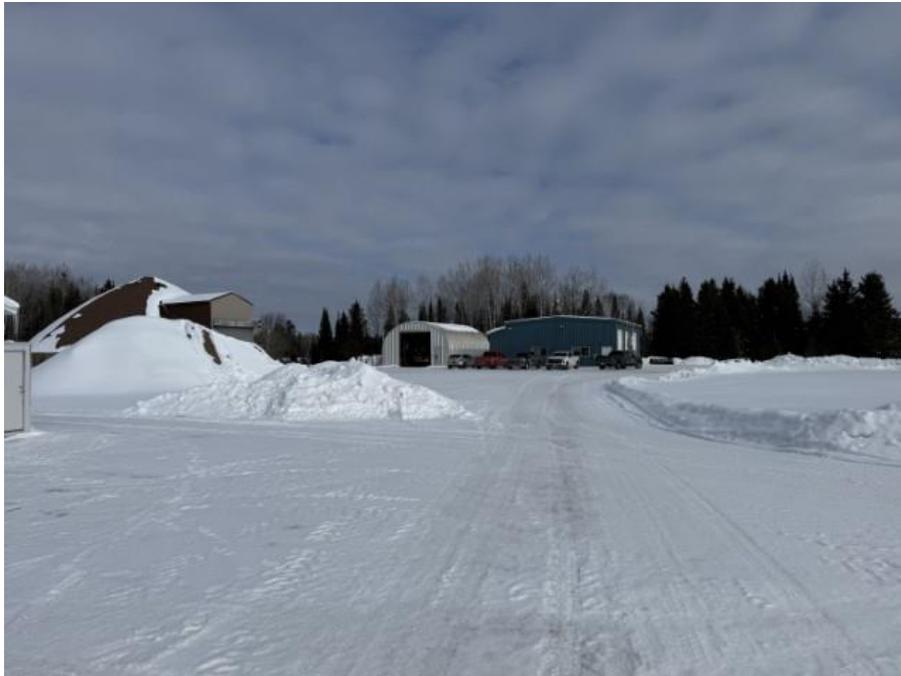
Photo 2: Additional Roadways and Parking Areas

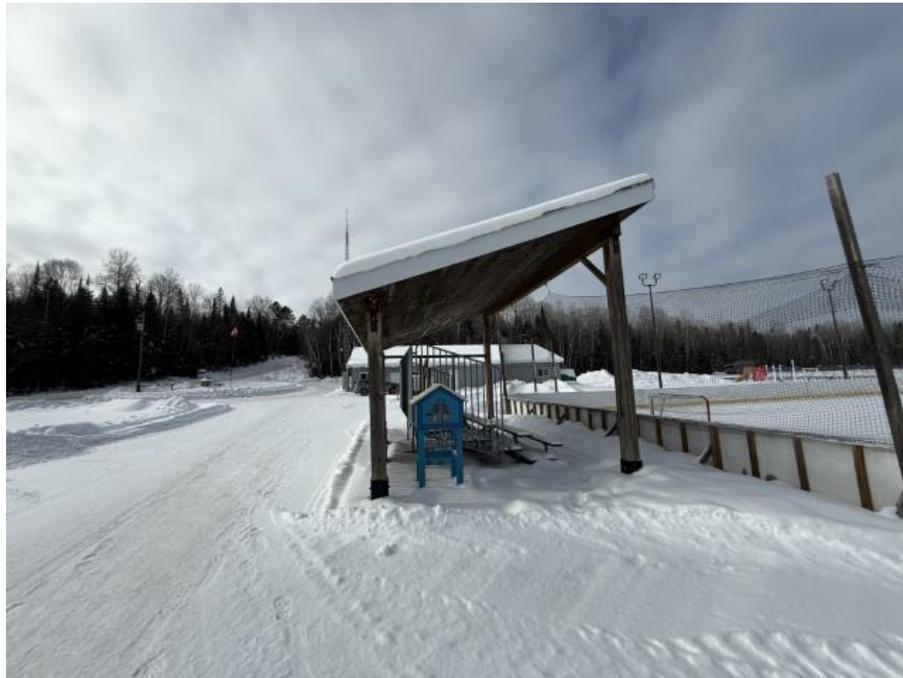
Photo 3: Rink Canopy and Bleacher

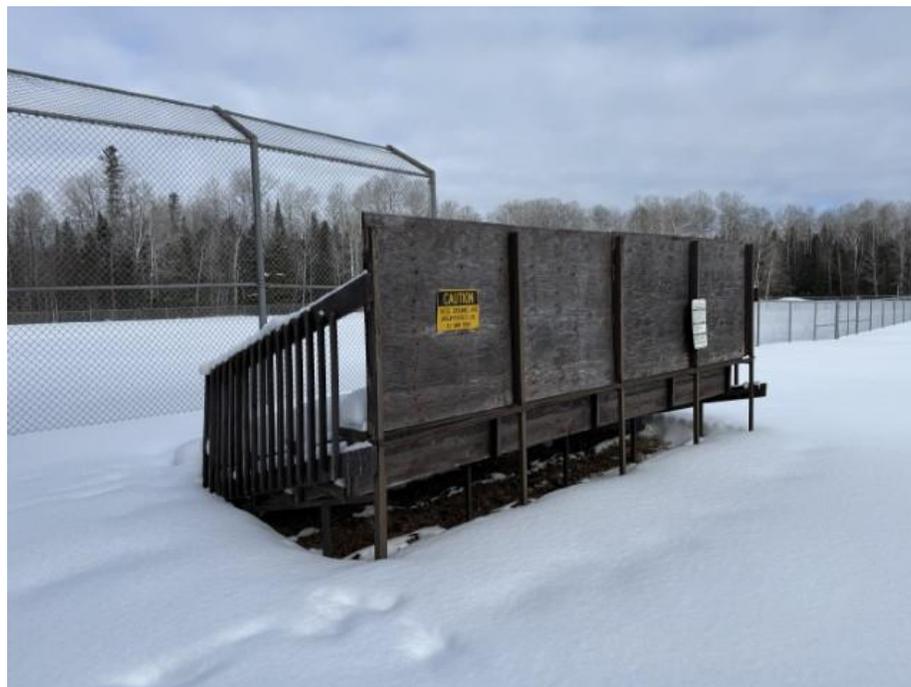
Photo 4: Uncovered Baseball Bleacher

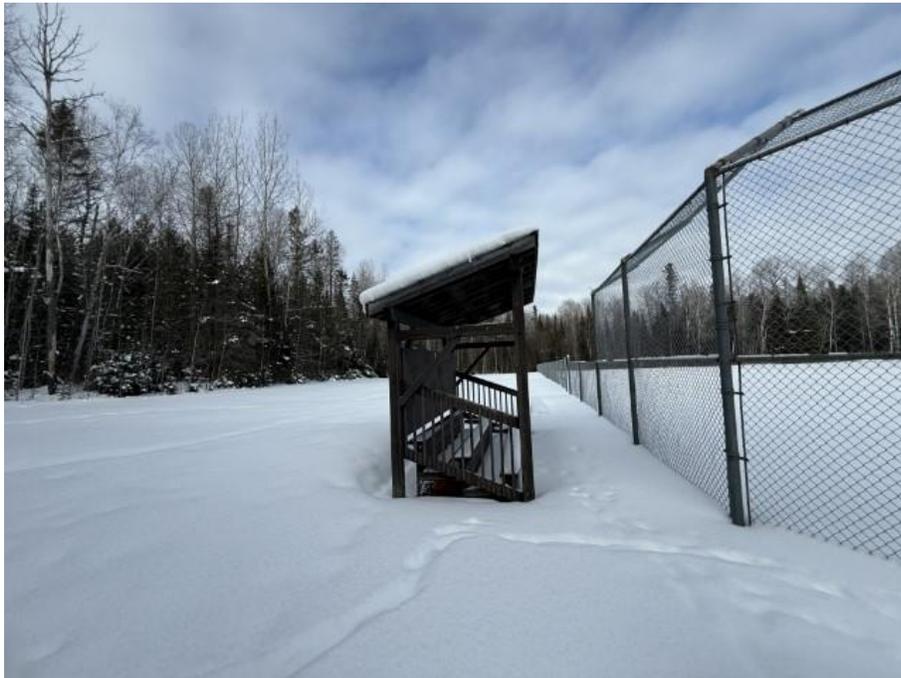
Photo 5: Covered Baseball Bleacher

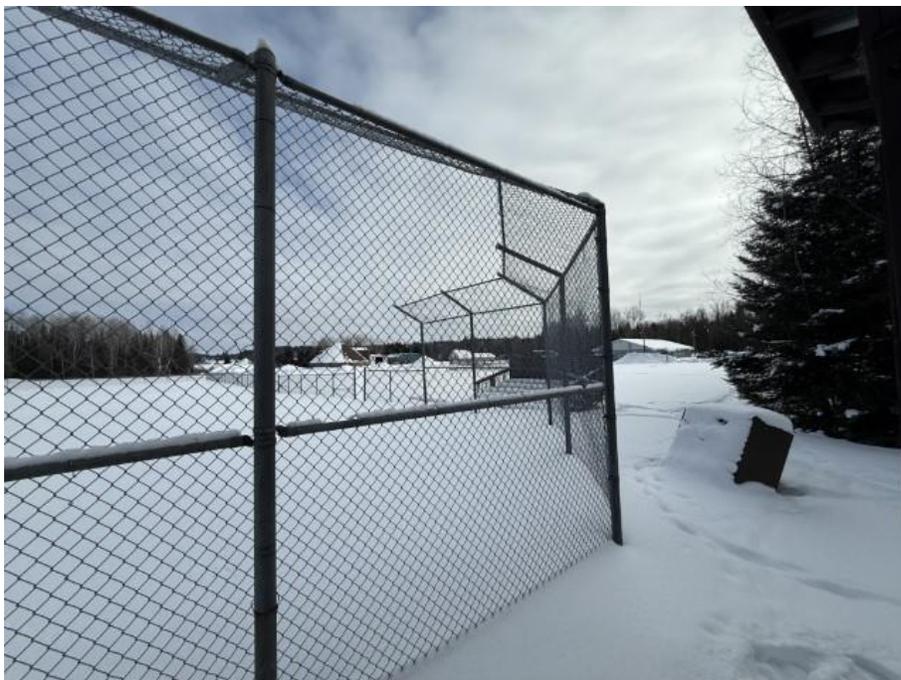
Photo 6: Overview of chain Link Fence

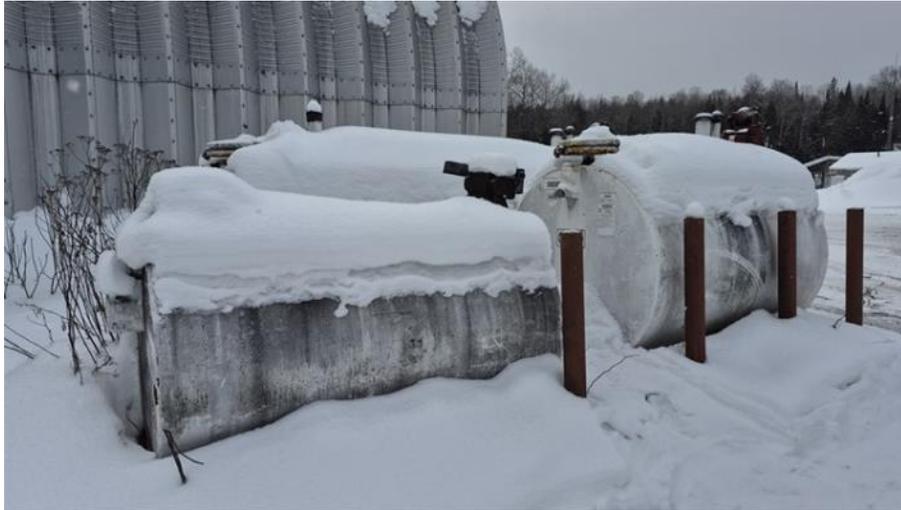
Photo 7: Diesel and Gasoline Bulk Storage Tank Farm

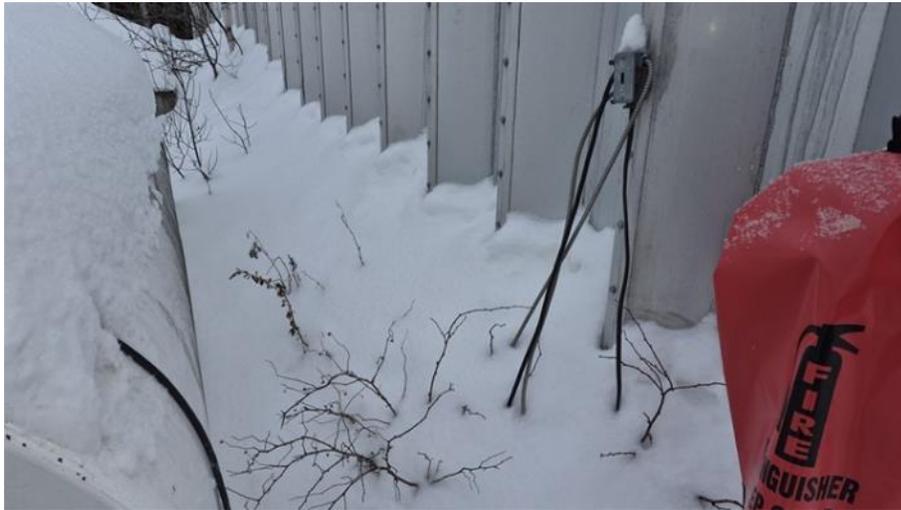
Photo 8: Diesel and Gasoline Tank Dispenser Pump Wiring

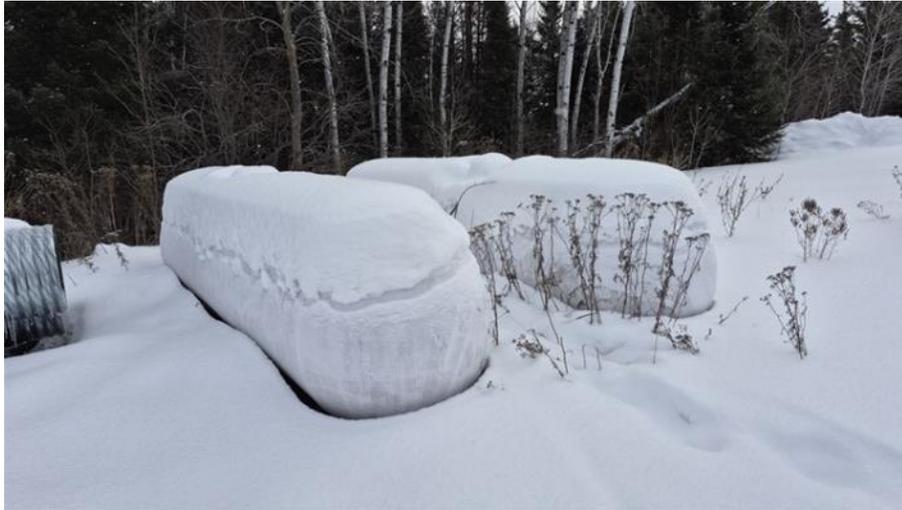
Photo 9: Garage Building Propane Fuel Tank Farm

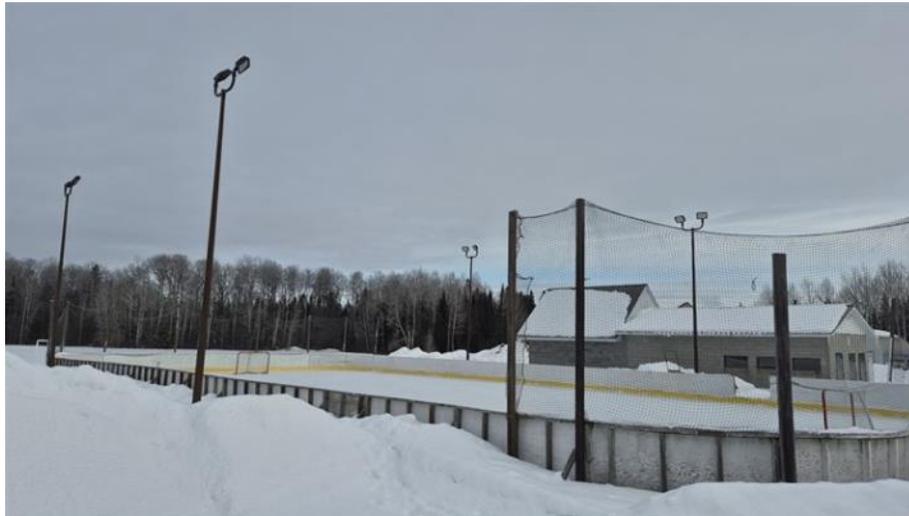
Photo 10: Ice Rink – LED Floodlighting
