THE TOWNSHIP OF CALVIN

BRIDGE MANAGEMENT STUDY REPORT (FINAL)

6 BRIDGES

NOVEMBER 2023

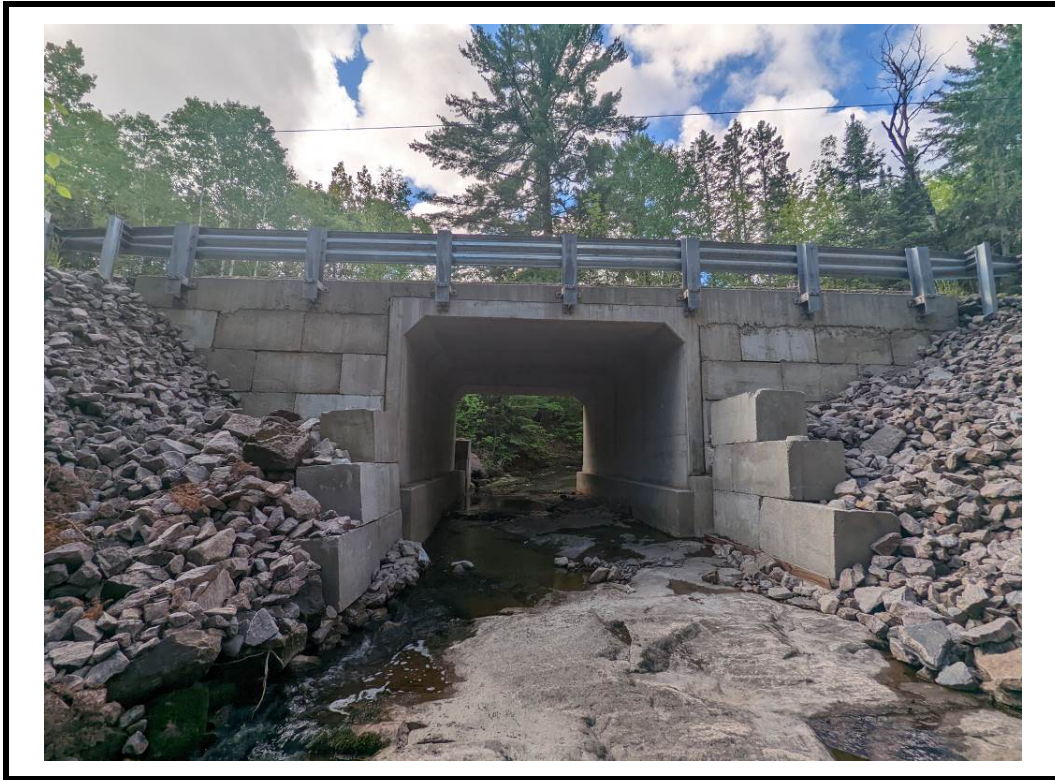
Photo 5 North elevation

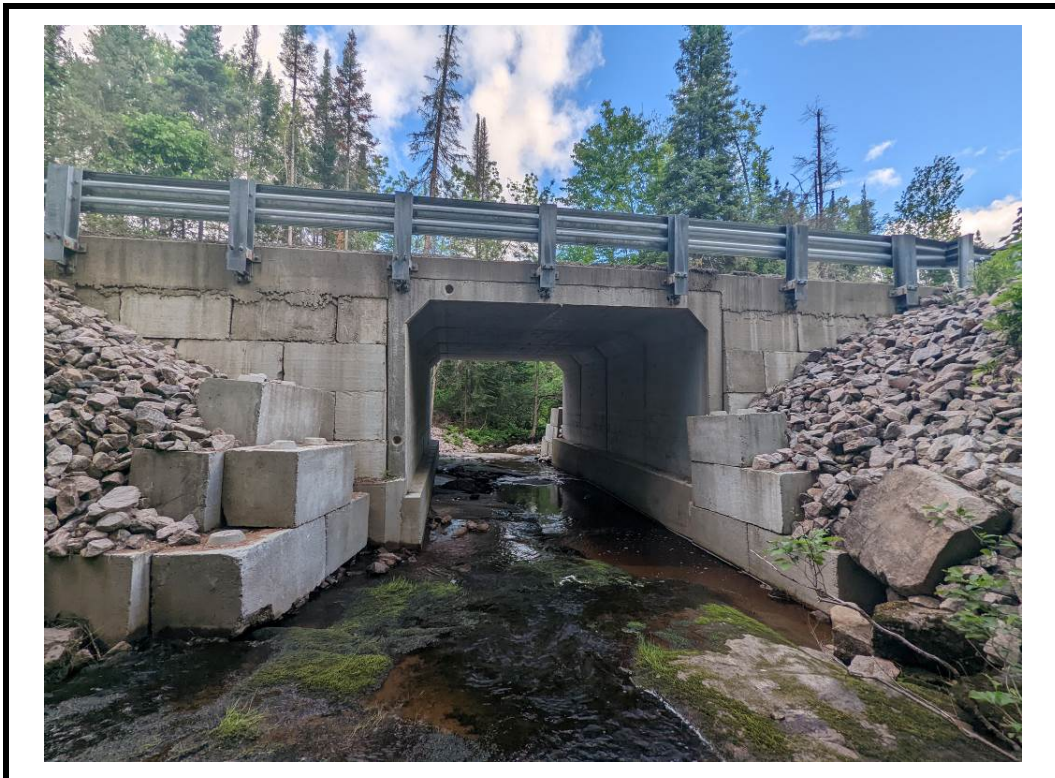
Photo 6 South elevation

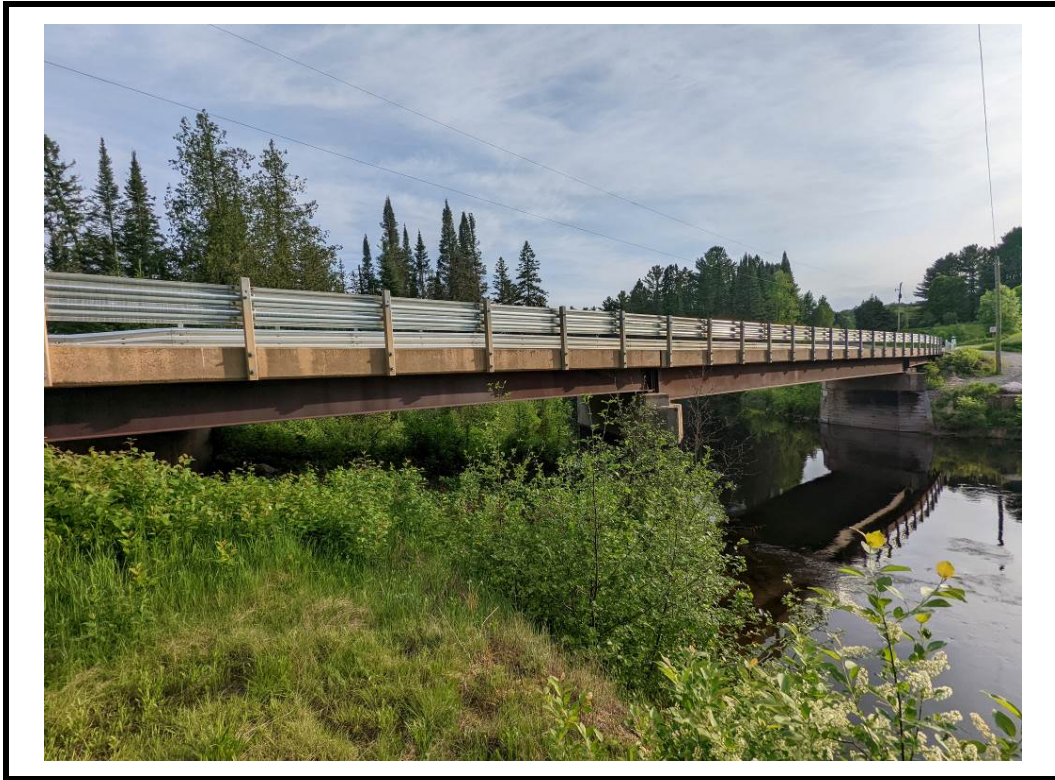
Photo 5 North elevation

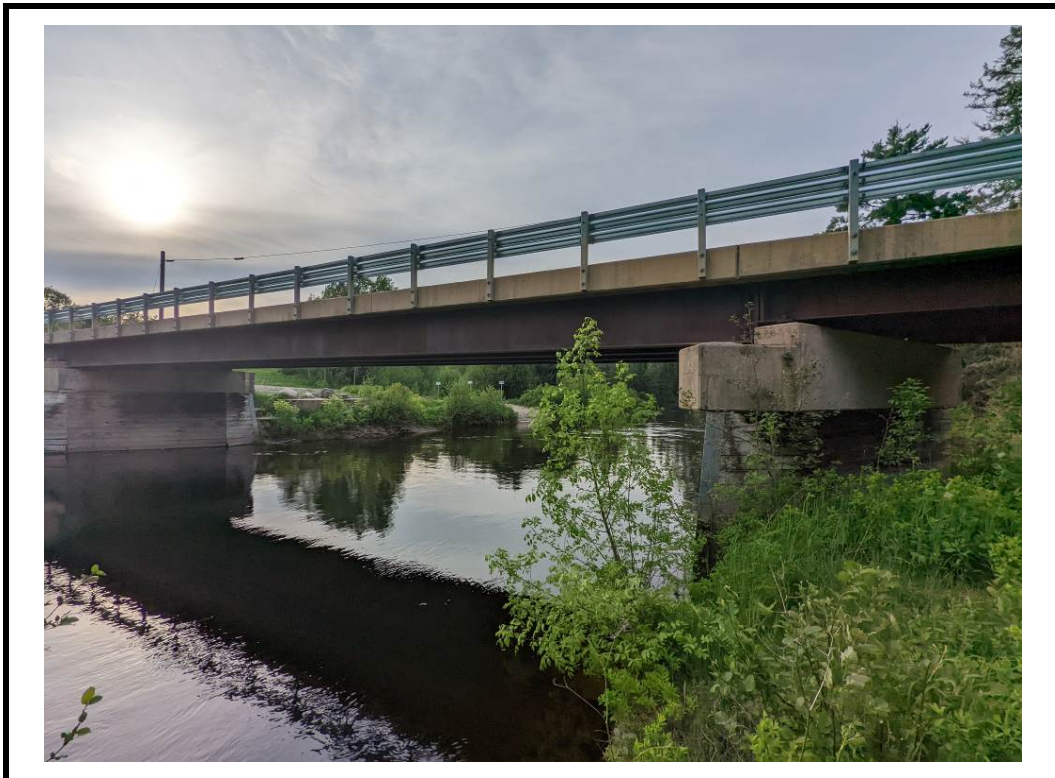
Photo 6 South elevation

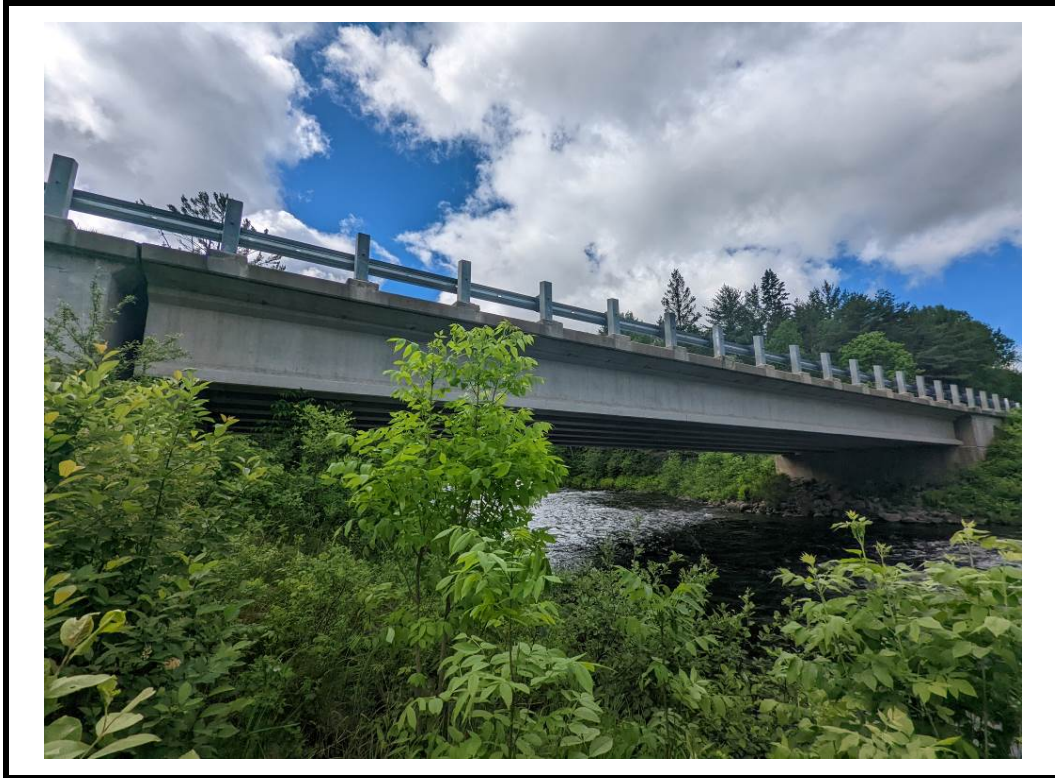
Photo 5 North elevation

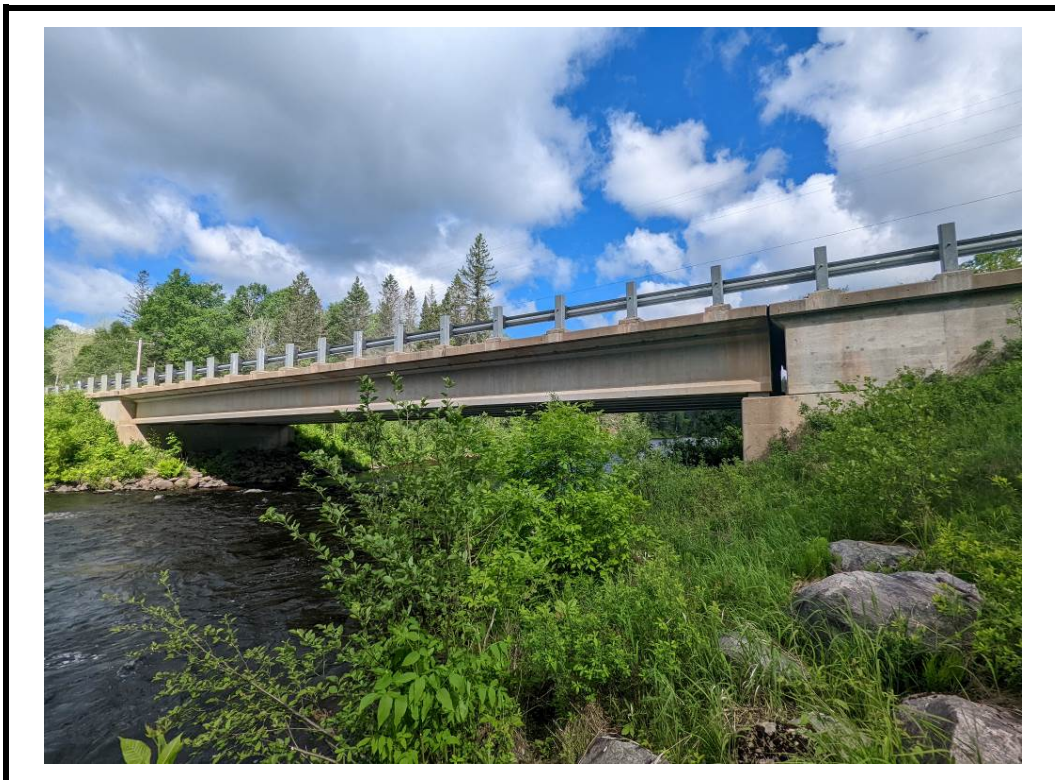
Photo 6 South elevation

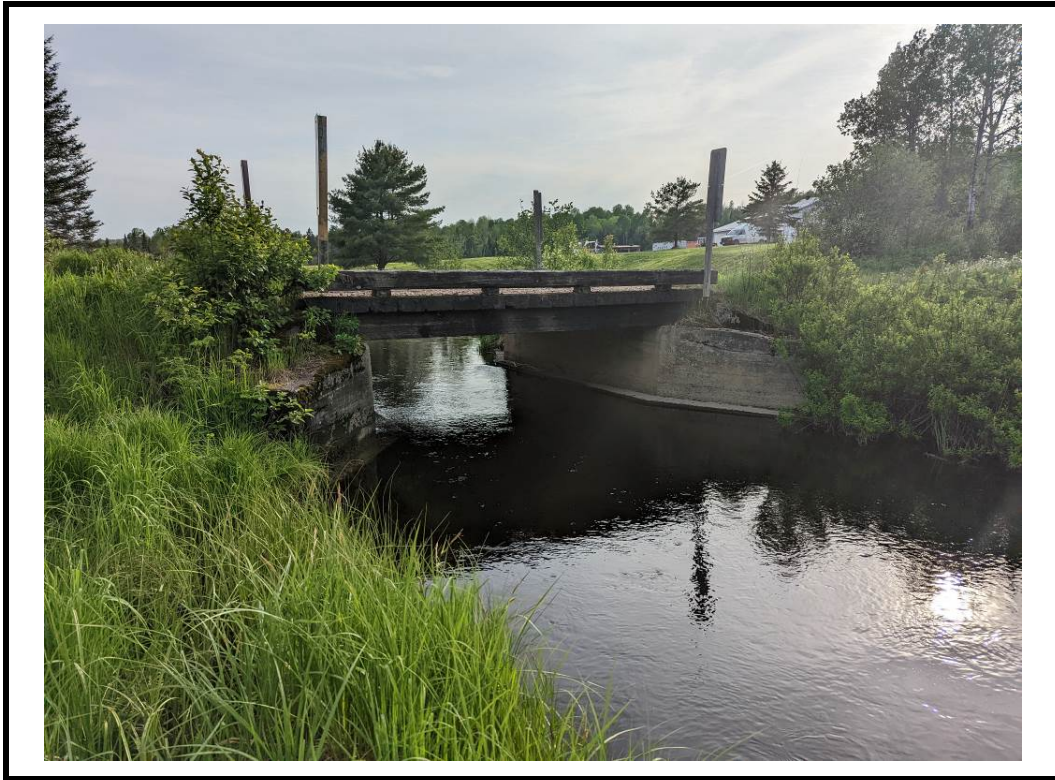
Photo 5 East elevation

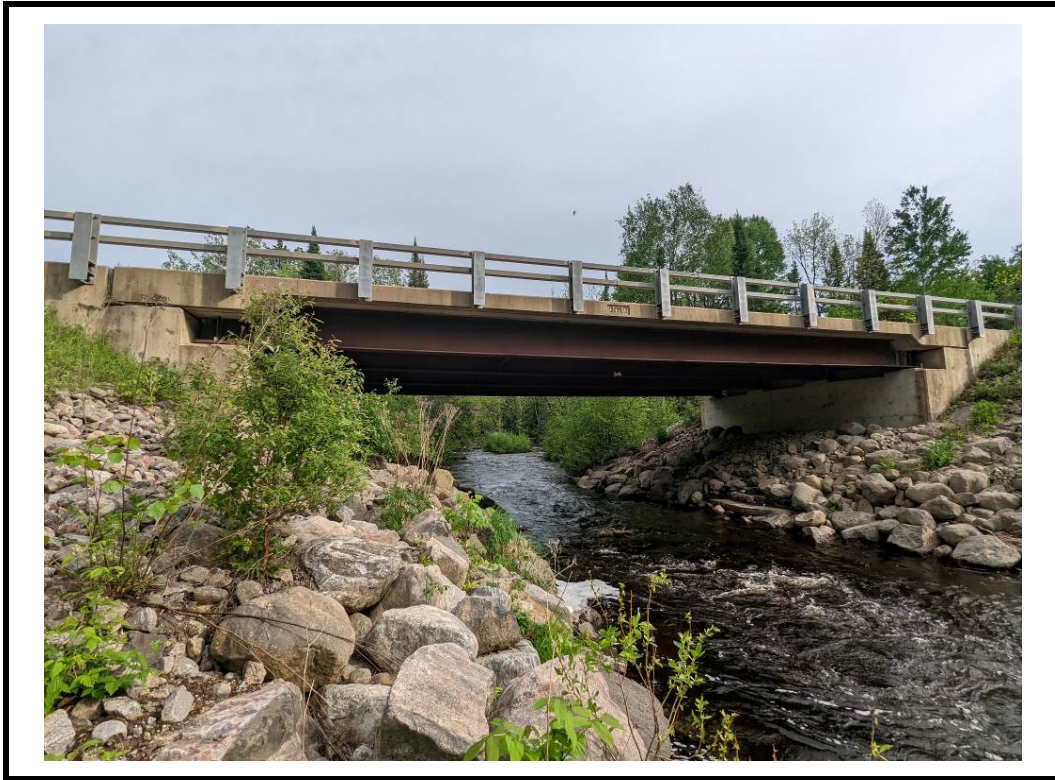
Photo 5 North elevation

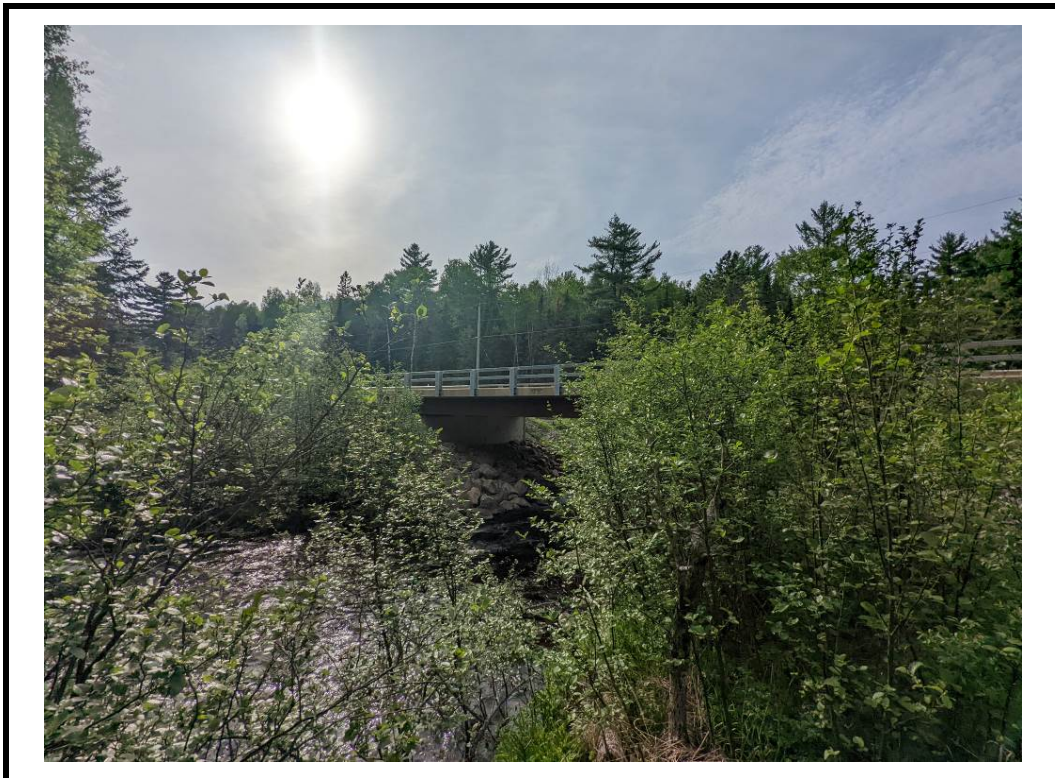
Photo 6 South elevation

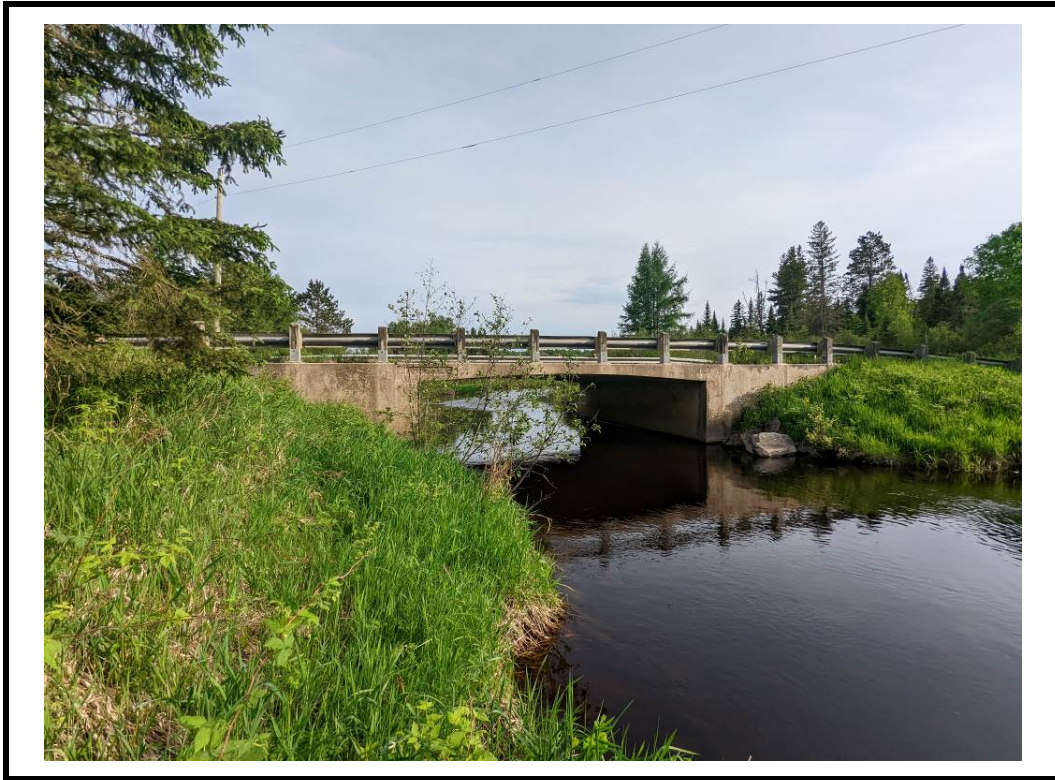
Photo 5 North elevation

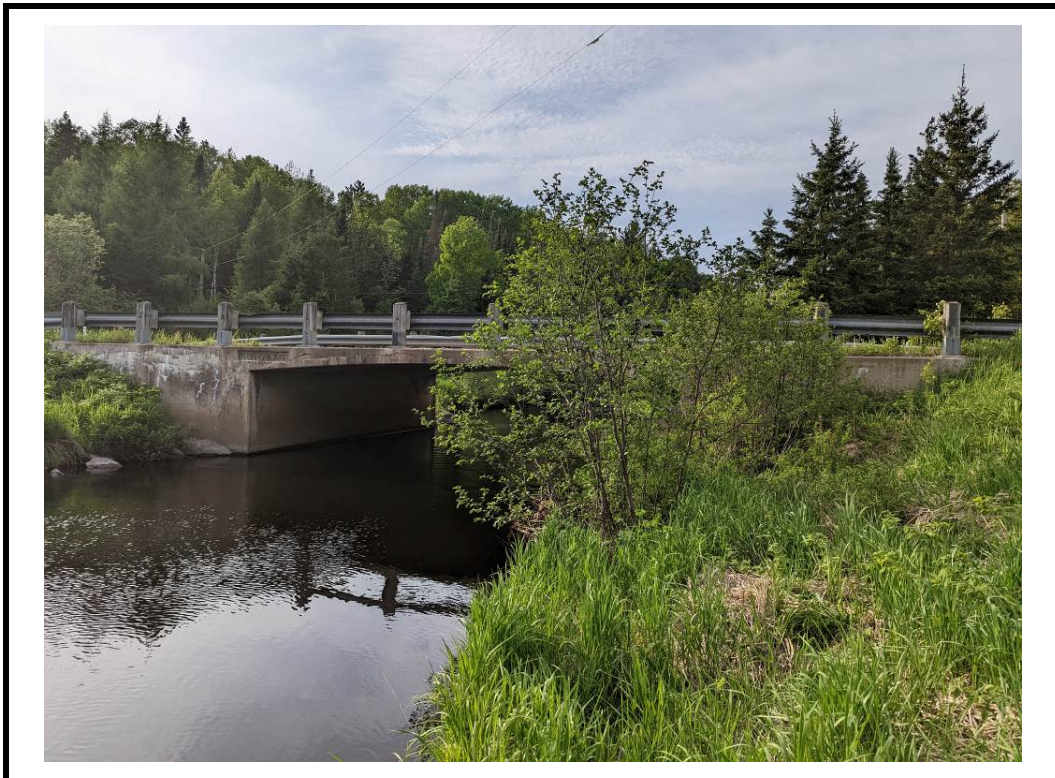
Photo 6 South elevation
